Optera Structural Solutions

Arboricultural method statement to install a compact root barrier to the rear of the property.

POLICY HOLDER ADDRESS: 57 Aberdare Gardens, London. NW6 3AL

Project Description

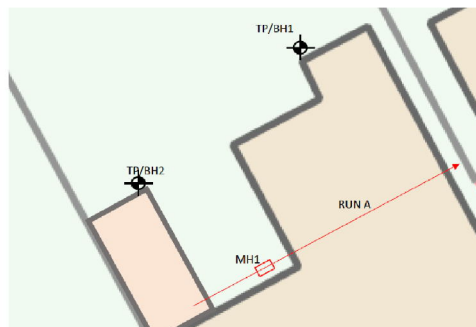
Further site investigations were carried out: the investigations included 2 trial pits and bore holes: the foundation to the rear right extension (BH/TP1) was shown to be 550mm deep resting on clay. The clay was found to be very highly plastic and roots were found to a depth of 1.4m this being slightly shallower than the root depth of 1.8m found in the original investigations. The laboratory testing of the soil samples confirmed a highly plastic clay and a moisture deficiency in the zone of root activity. Roots were tested and found to emanate from the PLATANUS species and LAURUS more commonly known as plane and bay.

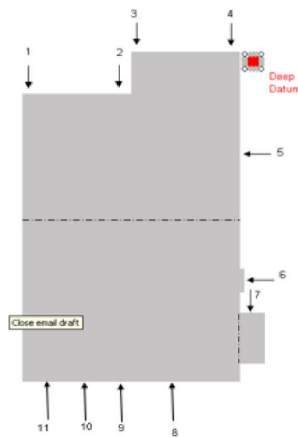
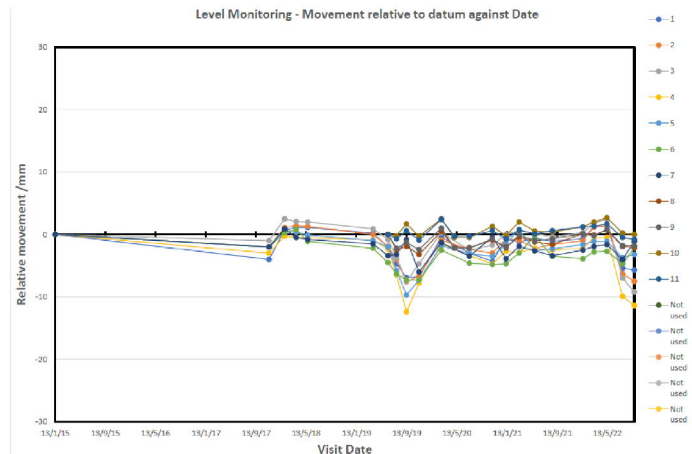
Level and Crack Monitoring - Site Sketch

Level monitoring shows a cyclical pattern of movement consistent with clay shrinkage. The most significant movement and demonstration of subsidence is to the single storey rear right extension. Movement this summer showed downward movement of significance to points 1-5, these extending across the rear elevation of the extension.

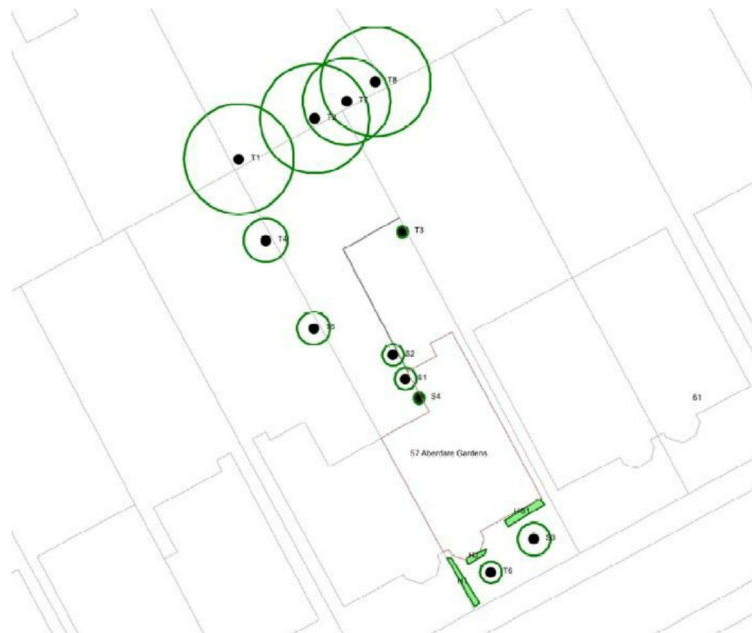
The PRI arborist report details trees to the rear of the property and implicates plane trees T1, T2, T7 and T8 as being the influencing cause on the property with a resulting recommendation to remove them. This is enforced by plane tree roots being found under footing in TP1 along with Bay roots, assumed to link with S2 located on the left fence line.

Root found with BH2 relate to willow/poplar, possibly maple and fig - a willow has previously been removed. We do not know the origin of the maple, but fig could come from T5.

4.2 Recommended vegetation management to address the current subsidence:

Tree No:	Species	Works Required
T1	Plane	Fell and treat stump.
T2	Plane	Fell and treat stump.
T7	Plane	Fell and treat stump
T8	Plane	Fell and treat stump
