**Level and Crack Monitoring**

Date of Issue: 22/09/2022

Occupier:	<b>Removed for data protection purposes</b>
Address:	<b>57 Aberdare Gardens</b>
Address:	
Town:	<b>London</b>
County:	
Post Code:	<b>NW6 3AL</b>
Contact Name	<b>Removed for data protection purposes</b>

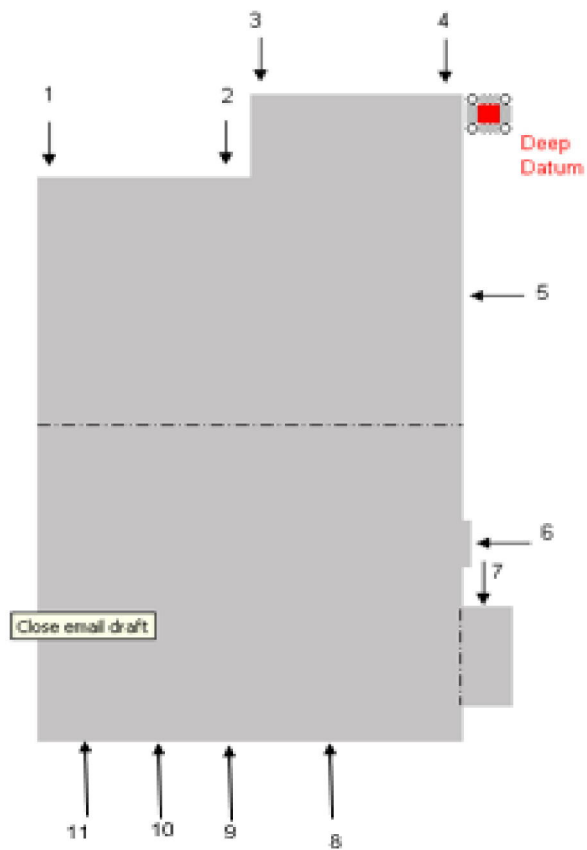
Level and Crack Monitoring - Site Sketch

■ TBM 2  
OUTSIDE NO  
57 IN KERB

1	EXT RH Rear Elevation Junction of Extension/House
2	Flat 2 LHS of party wall
3	Flat 2 Above door RHS dart board
4	INT Flat 4 above bathroom door
5	INT Flat 4 bedroom 2
6	INT Flat 4 first floor hallway
