Arboricultural Appraisal Report

Subsidence Damage Investigation at:

170 Maygrove Road
London
NW6 2EP

CLIENT: Crawford & Company
CLIENT REF: [REDACTED]
MWA REF: [REDACTED]
MWA CONSULTANT: Andy Clark
REPORT DATE: 25/07/2022

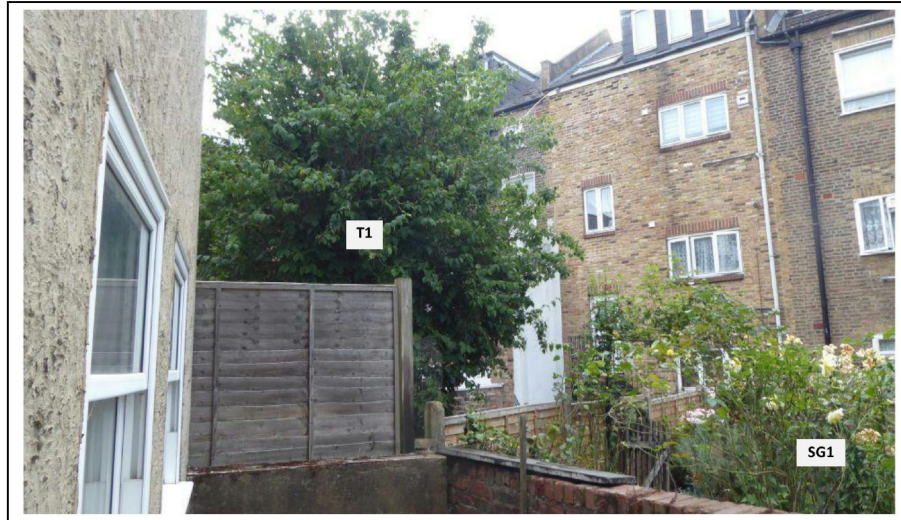
View of T1 Philadelphus with SG1 shrub group visible to right

Tree No.	Species	Ht (m)	Dia (mm)	Crown Spread (m)	Dist. to building (m)	Age Classification	Ownership
T1	Philadelphus	5.0	40 Ms *	4.5	3.1	Younger than Property	Third Party 131 Iverson Road NW6 2RA
Management history		No significant past management noted.					
Recommendation		Reduce height to 1.0m and thereafter re-prune on an annual cycle to maintain at broadly reduced dimensions.					
T2	Ash	9.5	200 *	7.5 *	7.8	Younger than Property	Third Party 168 Maygrove Road NW6 2EP
Management history		No significant past management noted.					
Recommendation		Remove (fell) to near ground level and treat stump to inhibit regrowth.					
T3	Cherry	4.0 *	100 *	3.5 *	8.1	Younger than Property	Third Party 123-127 Iverson Road NW6 2RA
Management history		No significant past management noted.					
Recommendation		Maintain broadly at no more than current dimensions by periodic pruning.					
T5	Crataegus	5.5	220	4.5	11.3	Younger than Property	Local Authority
