Site Investigation Report

Job Information	
Client	Crawford & Co
Client ref	
Visit date	18/03/2022
Report date	21/03/2022

Job Summary	
✓	CCTV survey undertaken. Read more.
!	Drainage repairs required. Read more.
✓	2 trial holes undertaken. Read more.

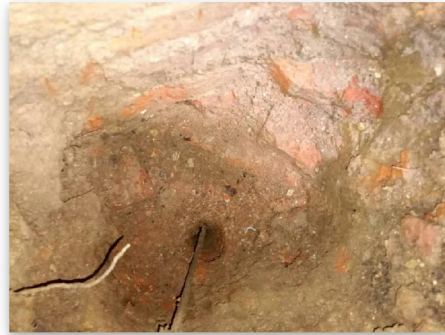
Fig 1.2: Trial Hole 1 Footing

Overview	
Brief	Auger were commissioned by Crawford & Co to undertake a site investigation and CCTV inspection of the underground drainage within the area of concern (AOC) at the property.
Findings	
Trial Hole Findings	<p>Within TH1, we also took footing measurements from the projection of the front elevation. These measurements are shown in Trial Hole Log 1b below. The footings exposed during TH1 were brick step outs on top of loose concrete.</p> <p>During the excavation to expose the footing of the two storey addition we encountered a broken drain pipe, however as this was outside the AOC we did not further investigate this drain, should this be required then a cost and scope for this can be completed on request</p>
Visual Inspection	<p>A visual inspection of MH1 revealed the outlet of this run is an interceptor trap, this was partially blocked and causing the channel of the manhole to retain water. In addition the chamber walls appear to be falling in and the pointing between the bricks are non-existent. We believe a section of the chamber wall has broken off, fell in the channel and caused the blocking of the trap.</p> <p>Furthermore RWG1 was seen to be a back inlet gully whereby the inlet was a 50mm plastic pipe serving the rainwater downpipe and the outlet was also a 50mm plastic pipe leading into (we assume) MH1. However the outlet of this gully was blocked and due to the diameter of the pipe we were unable to cleanse and survey this run. We would inform the client that 50mm pipework should not be used as a substitute to 100mm below ground pipework. Therefore we recommend the downstream pipework serving this gully is renewed in 100mm pipework. This action should however be completed on a private basis as this is classed as poor workmanship.</p>

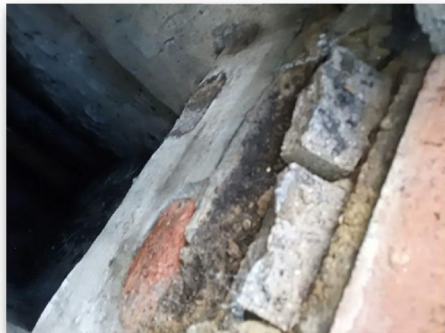
Fig 3.2: Defective MH1 chamber walls

Recommendations	
Refer Back to Client	<p>It is recommended that the following repairs are carried out to prevent an escape of water from the system:</p> <p>Line 1 Install a 100mm patch liner 6m upstream of MH1 to cover the displacement.</p> <p>Manhole 1 Excavate and replace the interceptor trap with 100mm straight pipework. This will involve removing the chamber wall and installing a 100mm patch liner after completion in order to connect the new to existing pipework.</p> <p>Re-bench and re-channel MH1. Also the top of the chamber the bricks are loose, please replace the defective bricks and reform the upper level of the chamber, this may involve lifting/ breaking the paving slabs to facilitate this work. Should this happen then this will prolong the claim and incur further costs.</p> <p>Due to the depth of the chamber special health and safety measures must be undertook.</p> <p>Interceptor traps were originally designed to keep foul smells from entering the property. It is now generally accepted that they should be removed as they are a major cause of blockages within a drainage system. Auger like most drainage contractors and Water and Sewerage Companies replace these traps with a straight section of pipe to prevent blockages. In some circumstances this does result in smells becoming apparent in the property as it occasionally highlights existing defects with internal traps and seals. Auger is unable to take responsibility if this happens after work is completed. Smells in the house will not be covered under policy terms and if this occurs customers will need to employ their own plumber to resolve the issue. If this is of concern please discuss the matter with your account manager before repairs commence.</p> <p>We will now refer back to the client in order to progress the claim.</p>

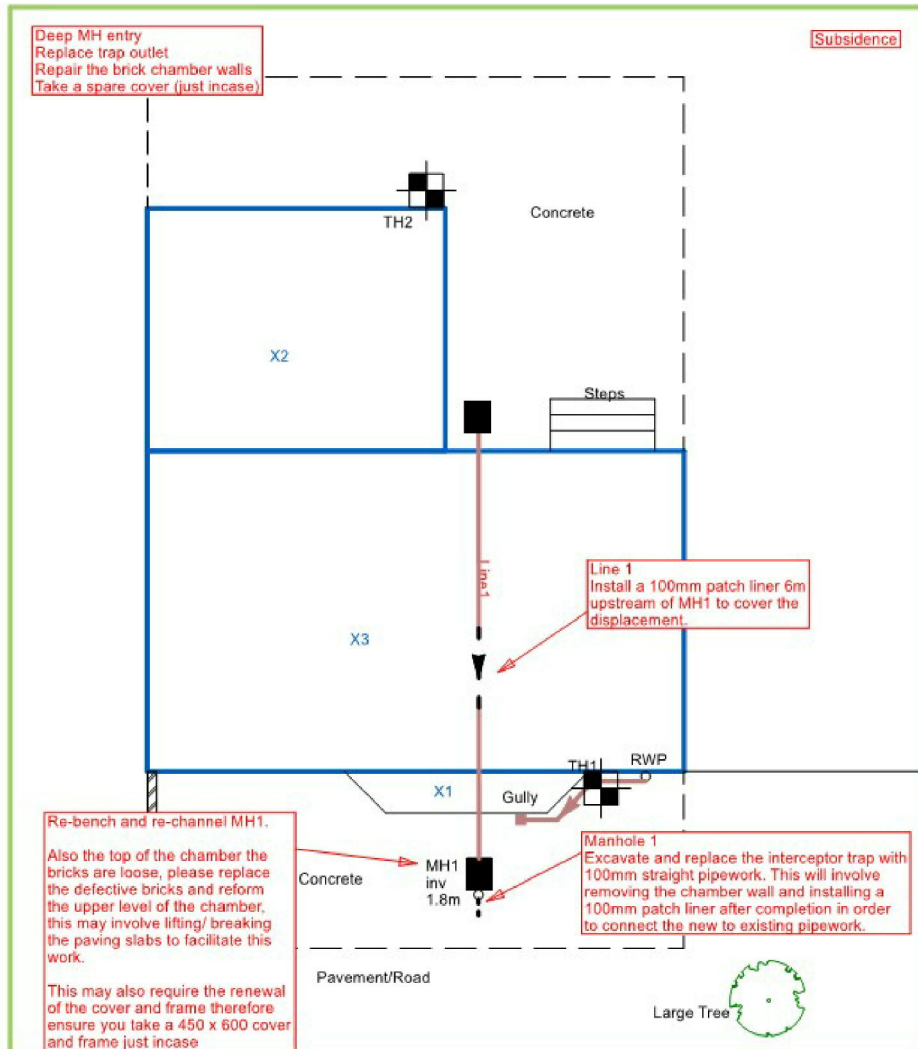
Drain Survey	<p>We carried out a CCTV survey of the below ground drainage system, our findings of which are as follows:</p> <p>Line 1 - From MH1 upstream to Outside AOC Our survey of line 1 revealed joint displacements.</p> <p>The above mentioned defects to the below ground drainage system have been caused by ground movement.</p>

L1			
Direction	Upstream	From	MH1
Pipe Size (mm)	100	Depth (m)	1.8
Pipe Material	PF	To	U/S
0.0m	Start of Survey Length		
4.8m	Joint Displacement - Medium		
5.9m	Deformed 10%		
5.9m	Finish of Survey Length
