## KNAPP HICKS & PARTNERS LTD

37990/L/001/A/S/JFM/jm

29<sup>th</sup> March 2022

**RE: 35 GREAT QUEEN STREET, LONDON WC2B 5AA**

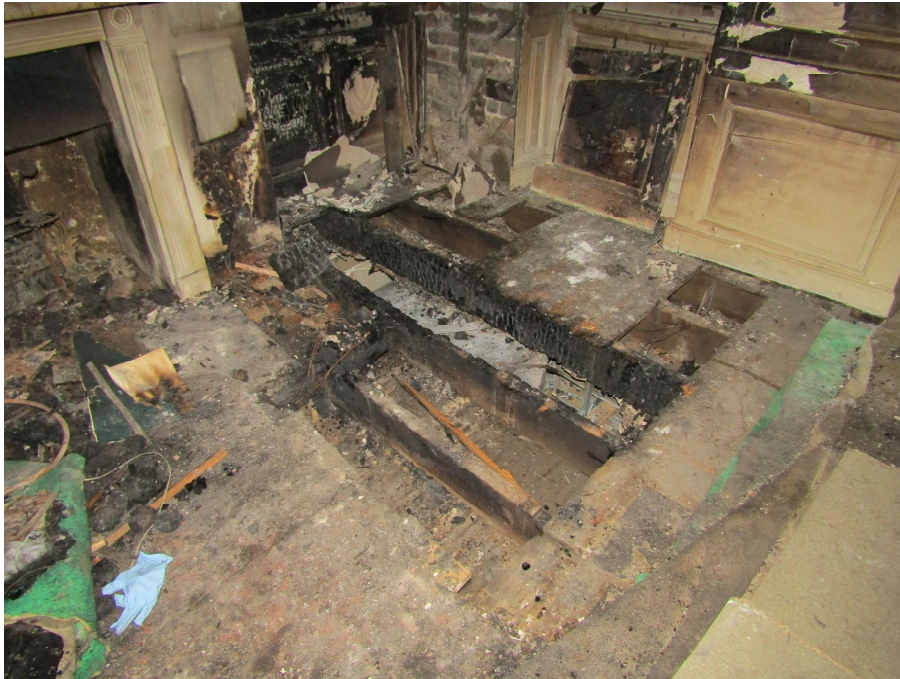
In addition to the timber floor boards being locally burnt away at the front right-hand corner of the first floor flat, the front chimney breast trimmer is severely charred, along with the end of the adjacent trimming joist across the front of the breast and the end of the adjacent floor joist. Further localised charring of the side faces of the adjacent floor joist and main floor beam up to 10mm depth has also occurred.

Plate 1 – General view of fire damage

Given the extent of the fire damage observed to the timber floor joists and trimming members, in addition to the replacement of the destroyed timber floor boarding, it is recommended that these members be replaced, which will also require the replacement of the hearth and adjacent un-affected floor joists across the front of the chimney breast.

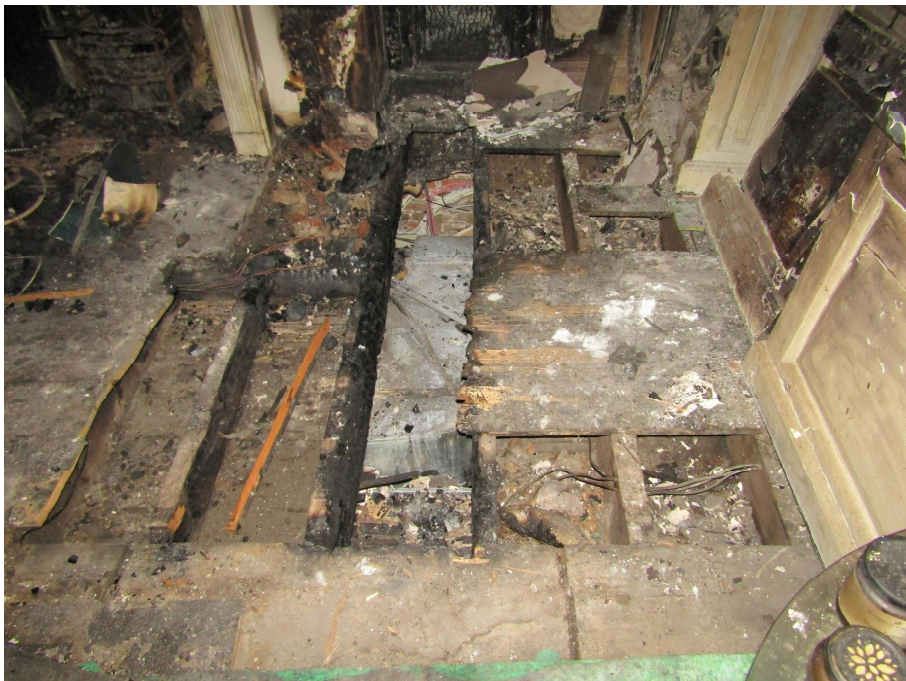
The timber internal cladding to the front wall has also been locally burnt away, along with charring to the party wall panelling.

Plate 2 – General view of fire damage

The damaged internal decorative timber panelling and supporting studwork framing will need to be replaced, along with the disturbed plasterboard ceiling over. As part of these works, although not associated with the fire damage, it is also recommended that the front wall void be suitably infilled brickwork and that the crack damage between the front and party wall be repaired to reinstate the overall structural integrity of the property, which is likely to require the provision of restraint strapping and/or bed joint reinforcement.

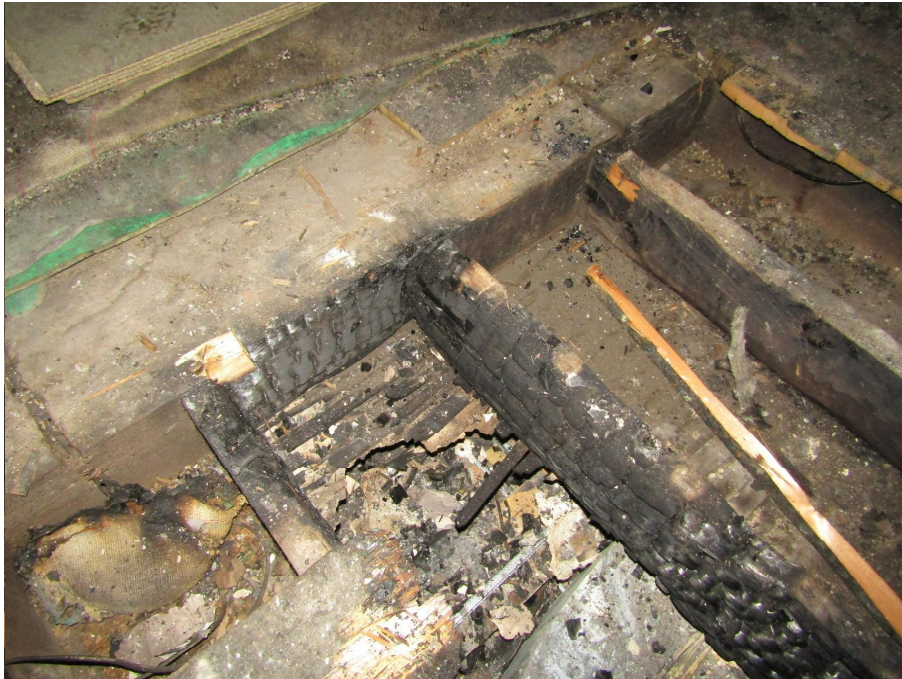
Based on a preliminary structural assessment of the existing first floor beam, it has not been possible to justify this member in accordance with the modern design codes, which is likely to account for the excess deflection noted during our inspection. Consequently, the localised charring of the floor beam will result in a further reduction in its load capacity which, in-turn, is likely to result in additional deflection of this member.

Plate 3 – Charring to main floor beam and chimney trimmer

Given the above, it is recommended that the localised area of charring be removed from the existing floor beam and that suitable strengthening works be undertaken, rather than completely replacing this member.

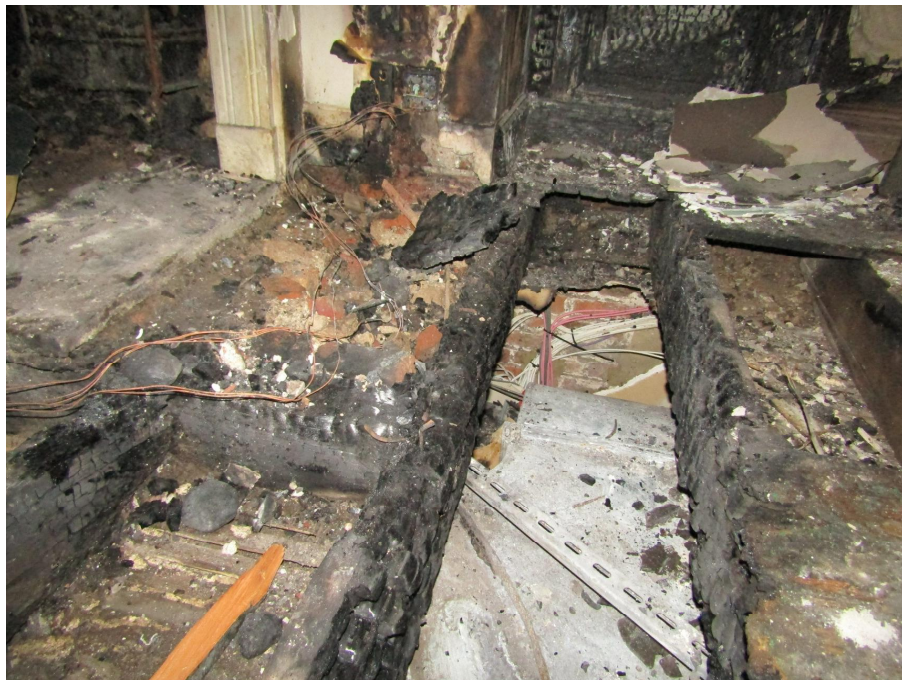
Plate 4 – Charring to chimney trimming and floor joists

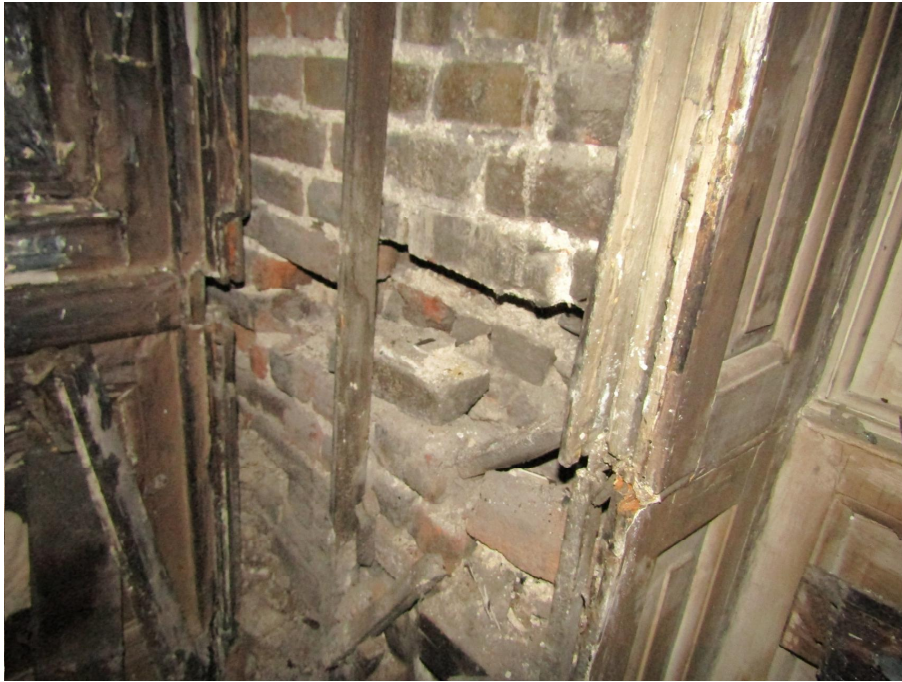
Although not associated with the fire damage, the missing timber cladding to the front wall has revealed a significant 700mm long x 225mm high x 130mm deep void to the inner face of the brickwork front wall between the right-hand party wall and the adjacent window opening, 700mm above floor level.

Plate 5 – Front wall void

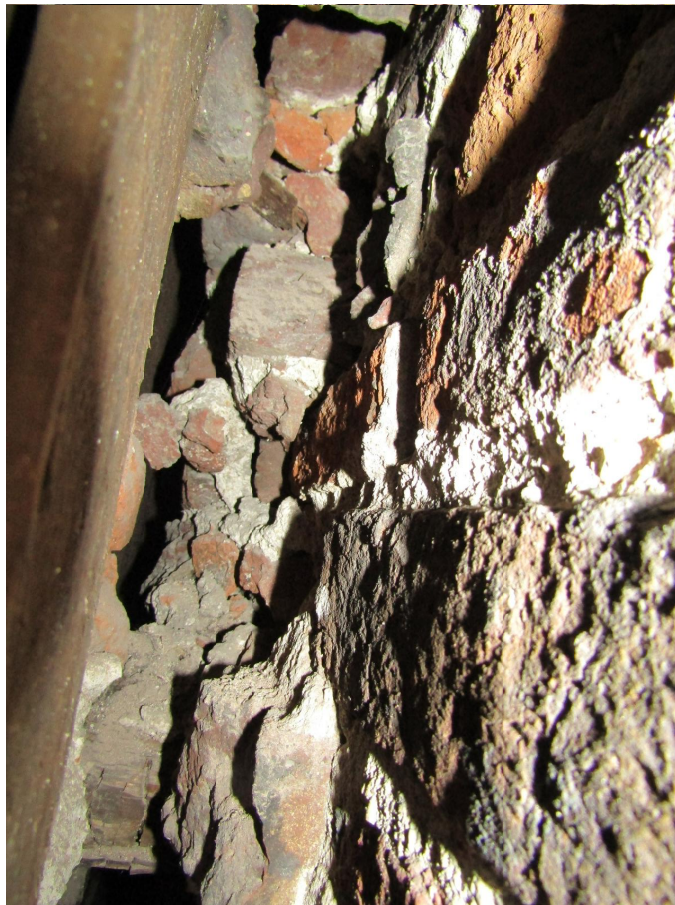
Plate 6 – Crack damage to chimney stack
