Ref 2277 – R1a

March 2023

Structural Report for the redevelopment of 26 Netherhall Gardens, NW3 Front Steps

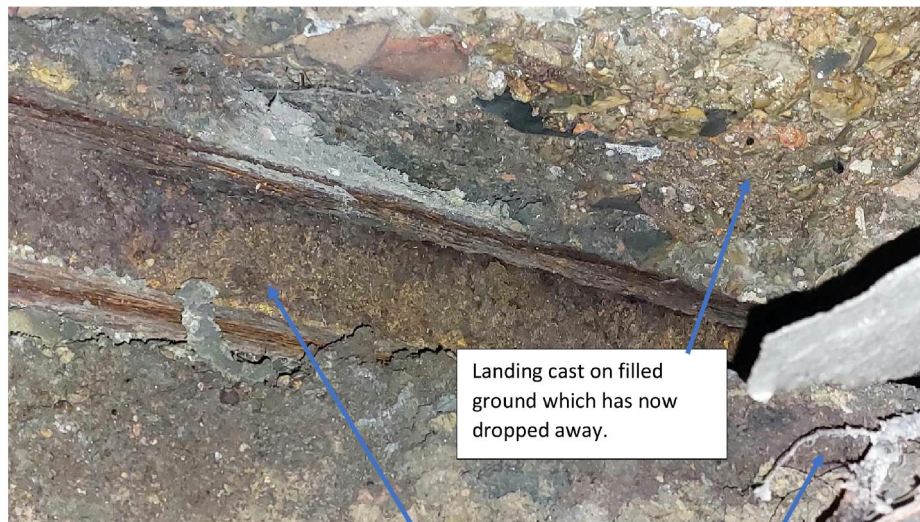
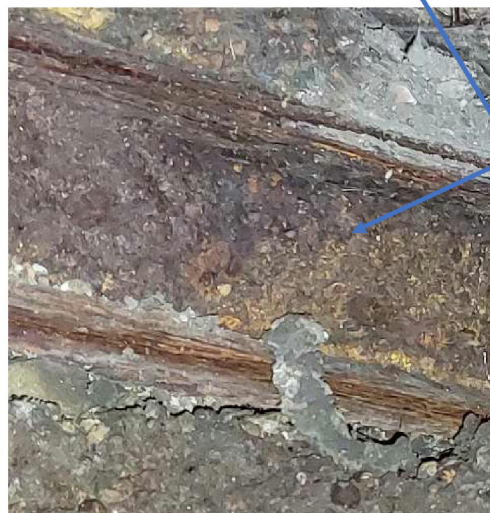
was used as a substation. The stair visible within the store are supported by steel beam placed below the stair section on the line of the riser. The remainder of the stair was built up with masonry walls on nominal foundations and back filled with clay and soil, probably obtained from the preparation of the house development. The Quarter landing was cast on the ground which has now dropped away leaving the slab suspended. The stairs are within this space also supported on steel beams and these beams have corroded excessively, to the point that there is minimal thickness of section left in place leaving the stairs unsupported. See photos below.

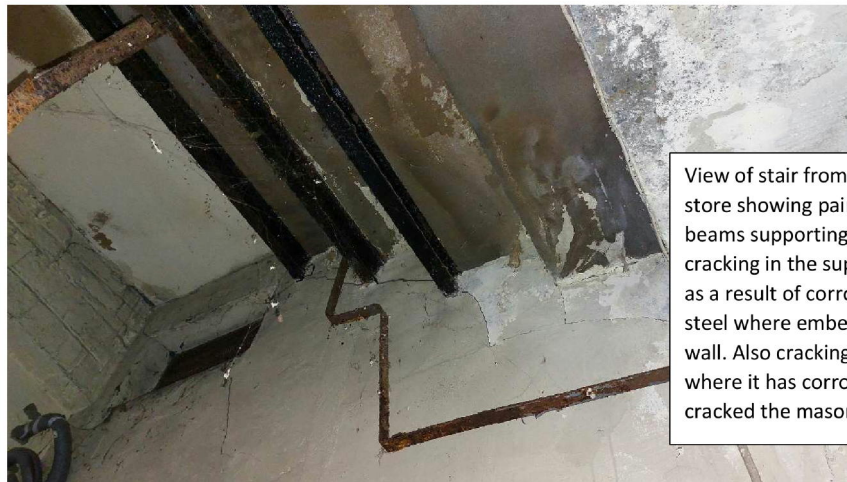
View of stair from within the store showing painted steel beams supporting the stair and cracking in the supporting wall as a result of corrosion of the steel where embedded in the wall. Also cracking around vent where it has corroded and cracked the masonry.

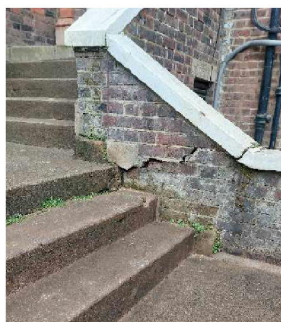
The external stairs forming the entrance to the front door of the property are in a very poor condition with the parapets badly cracked and moving away from the stair. There are also significant cracks between the earth filled sections of the stair and the old store room due to the earth pressure on these walls and minimal foundation. The wall movement is ongoing and propping is required to restrain the walls facing the car park area where the movement is creating an unsafe condition with the potential for the wall / parapet to fail and collapse into the space and steps to drop further. The steps have dropped significantly as can be seen below.

Line of weather sealing to tread left in place.

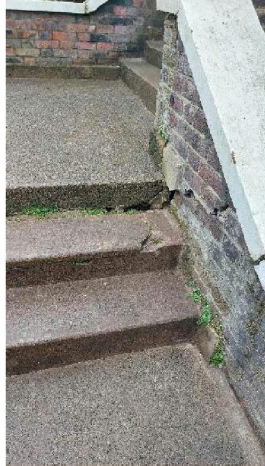
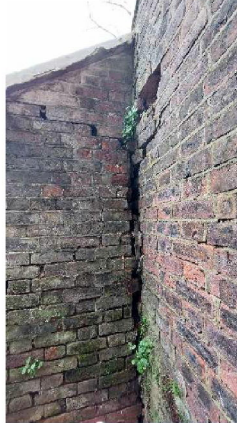
This movement is due to ground movement associated with the changes in subsoil moisture caused by the adjacent trees which are of a significant size. The foundation to the stairs has also been affected by the lowering of the ground to form a parking area which has exposed the original foundations.

As stated above the existing stair is in a very poor condition and remedial propping is required to restrain the enclosing walls and parapets. All as can be seen in the attached pictures Shoring to the walls should be provided as they wall condition is unsafe and temporary handrail barriers should be provided if this stair is going to remain in use during the construction phase of the project.
