TECHNICAL REPORT ON A SUBSIDENCE CLAIM

Flats 1 - 9
8 Compayne Gardens
NW6 3DH

Prepared for

Allianz Commercial

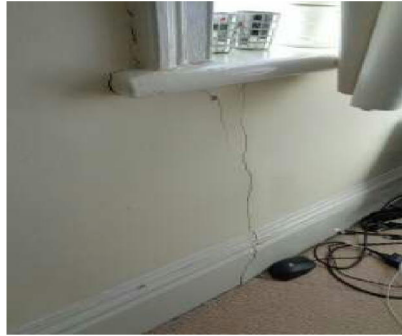
Cracking beneath the front window in flat 3

Crack to left hand side of bay window below cill extending through the skirting board approximately 3mm width and hairline crack over window.

Crack over right corner of bay window extending to right hand return wall at a width of 3/4mm.

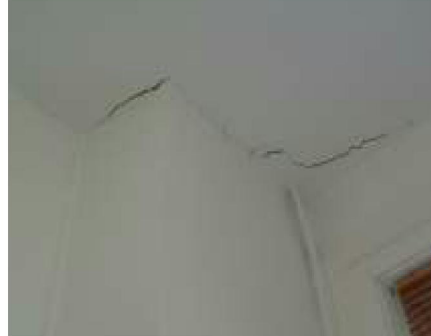
Cracking to the bathroom in flat 4

Vertical crack approximately 5mm wide from floor to ceiling and around wall ceiling junction to front corner (at front projection junction).

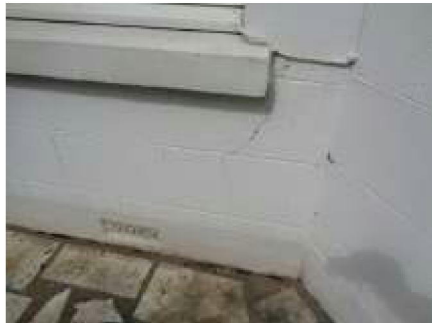
Cracking to the right side of the front bay

Crack below right corner of ground floor bay cill at a width of approximately 1mm.

Crack to right hand side of ground floor bay cill but were also noted to the first floor central bay cill.

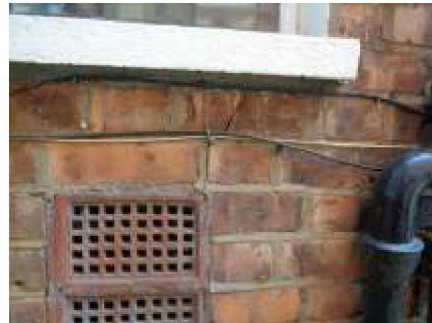
Cracking to the left elevation below the foremost window

Crack below ground floor bathroom window at a width of 3mm extending through an air brick.

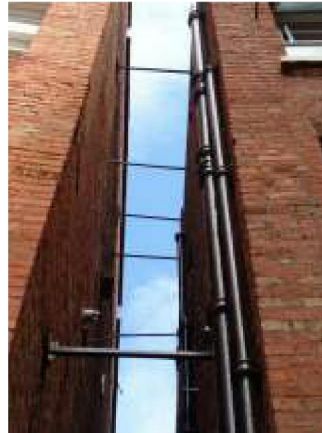
Significant historic bow in the flat wall at high level which has been historically retained by steel bars spanning between the subject property and No. 10 Compayne Gardens. This has been in place for well over 20 years.

We also noted some quite significant deflection of the flank wall at high level. This is clearly an historic problem due to lateral restraint issues with the masonry. Attempts have been made to support the deflection in the past by installing steel bracing between the subject property and the adjoining property at No. 10 Compayne Gardens.

Deflection of the flank wall showing bracing bars in place

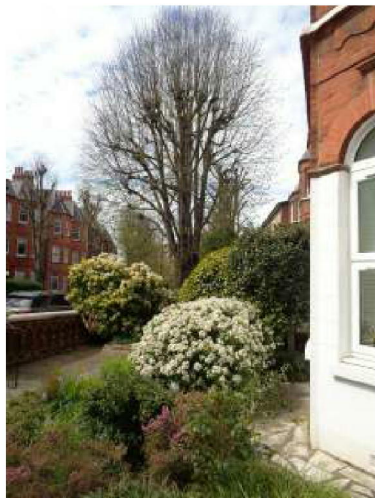
The timing of the event, the presence of shrinkable clay beneath the foundations and the proximity of vegetation where there is damage indicates the shrinkage to be root induced. This is a commonly encountered problem and probably accounts for around 70% of subsidence claims notified to insurers.

Vegetation close to the front left corner

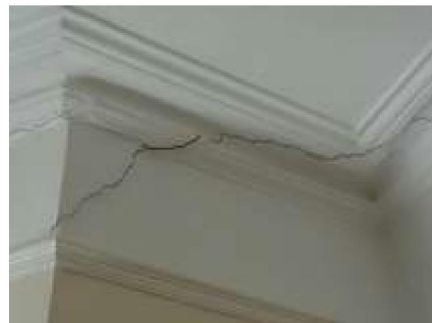
Typical internal damage
