**CHESTER TERRACE**  
**BALUSTRADES**

ADDENDUM REPORT

CROWN ESTATE PAVING COMMISSION

**26<sup>TH</sup> NOVEMBER 2020**

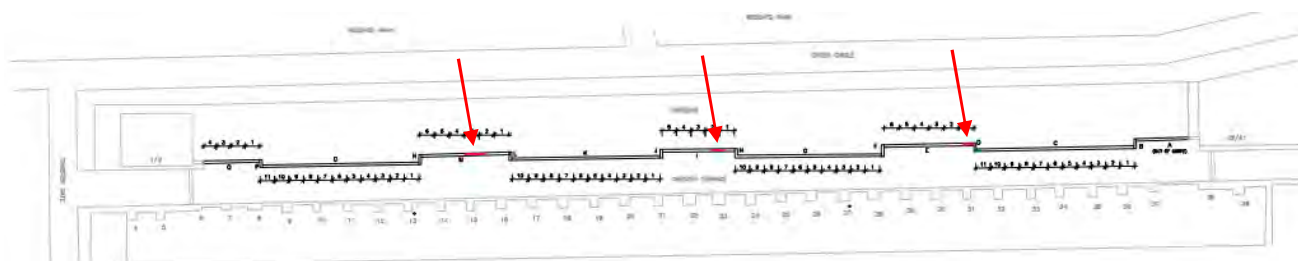
- 5.1.1 The brief was to review the deconstruction of three lengths of balustrades to establish how the balustrades were originally constructed.
- 5.1.2 The balustrades at three locations, as identified below with the red bars and arrows, were deconstructed down to the top of the retaining walls, and inspected. The location furthest to the right (or to the north) is above a concrete retaining wall, whilst the two other locations are above brickwork retaining walls.

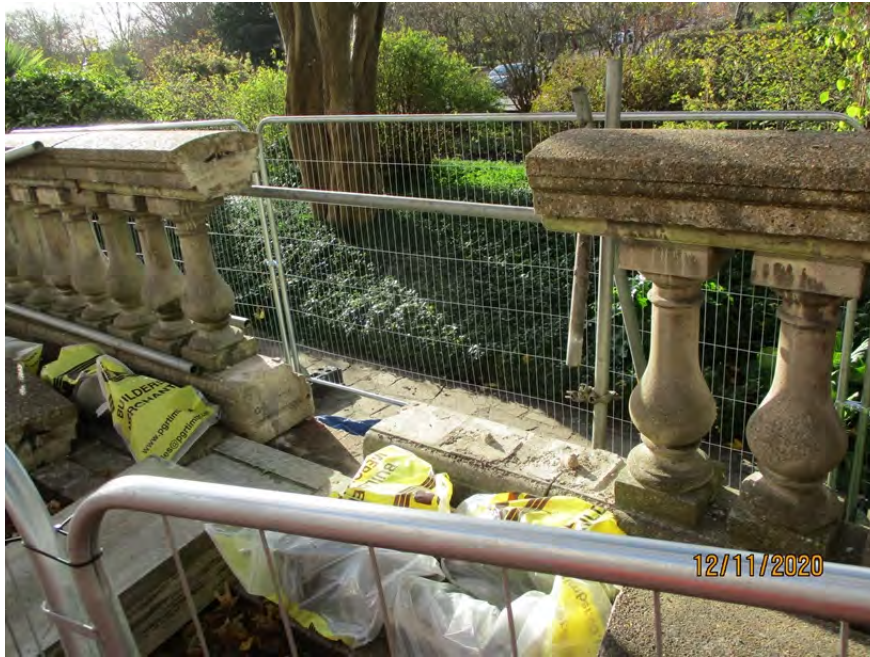
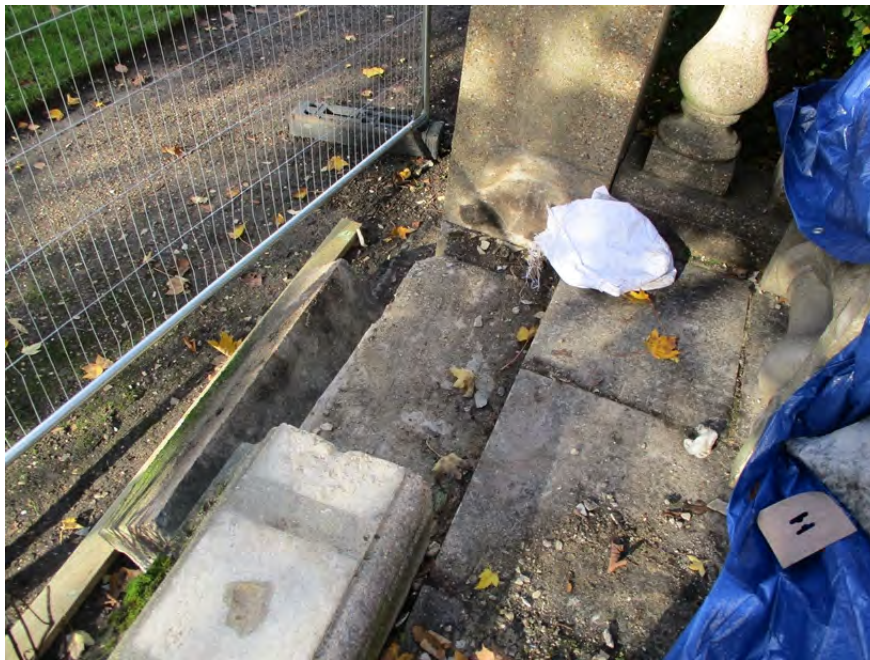
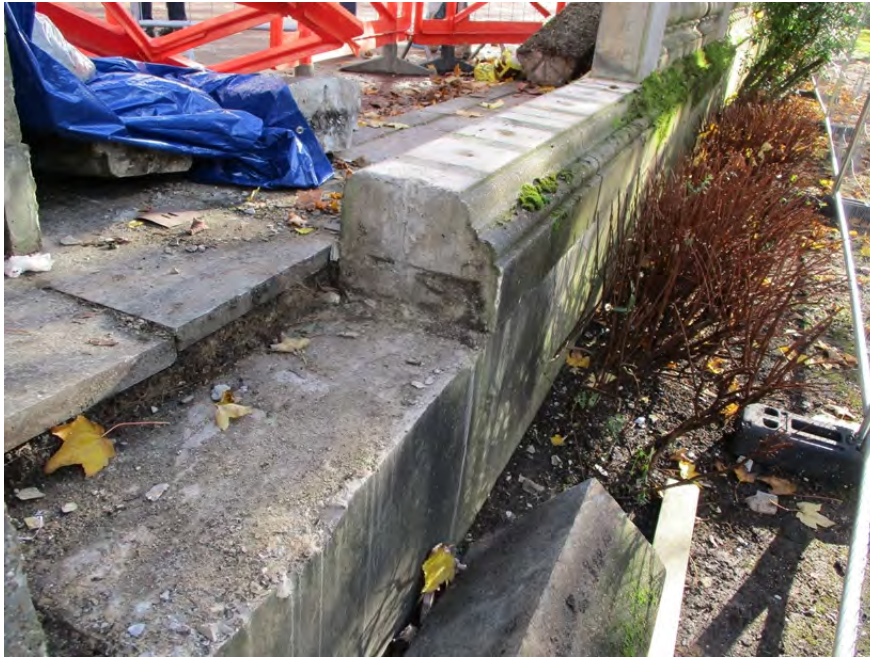
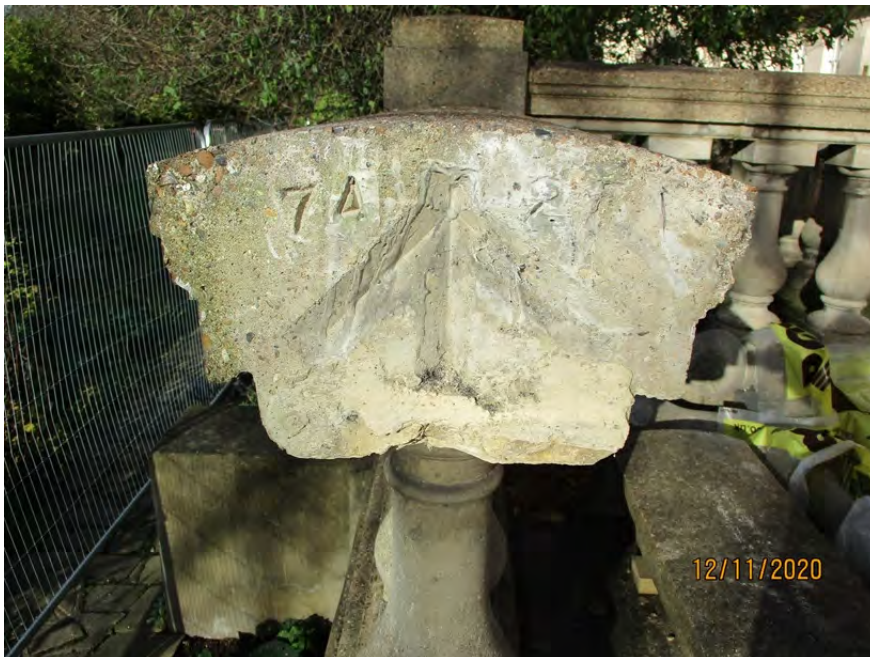
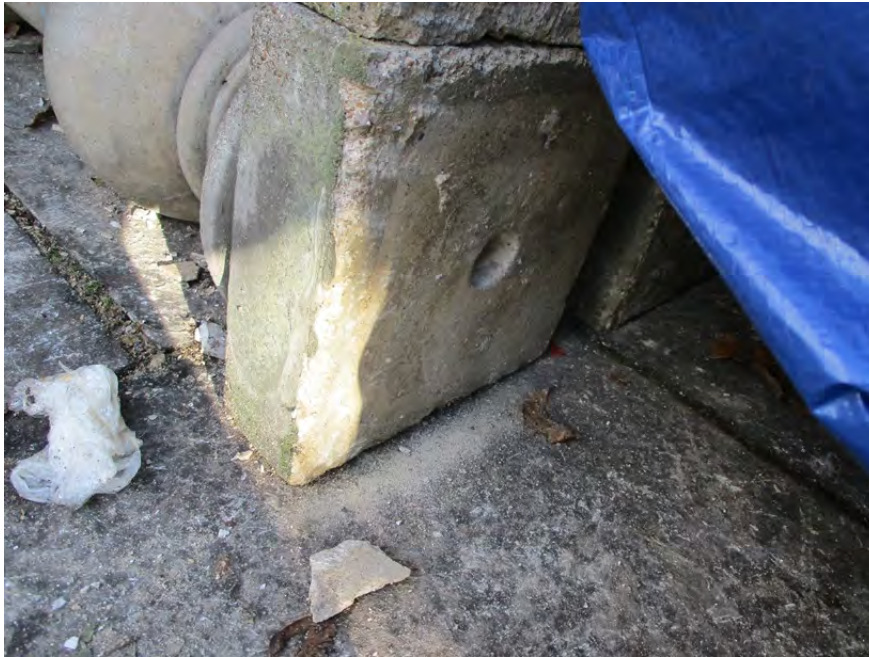
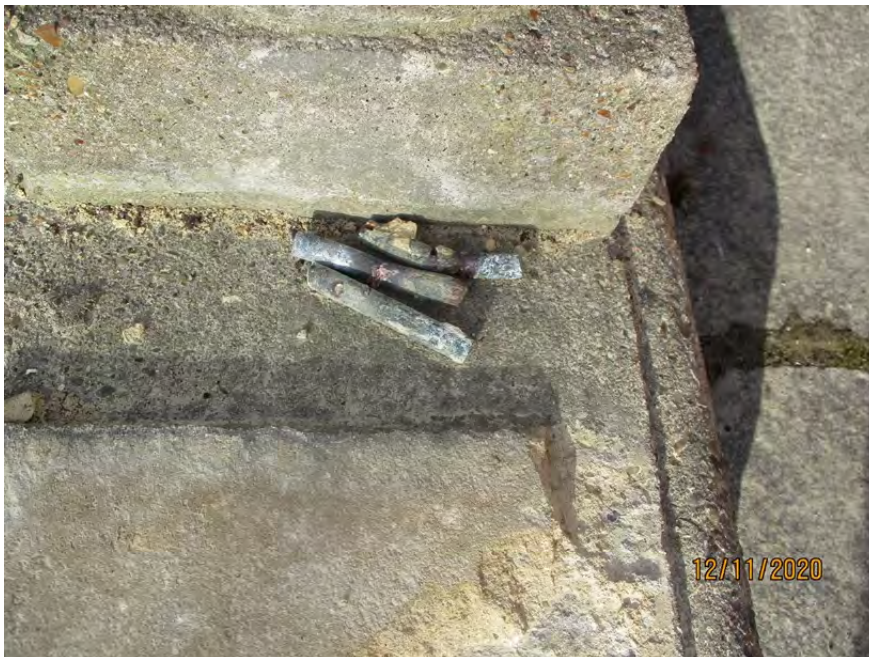
- 5.2.1 The details of the balustrades are identical at all locations. The plinths at the bottom sit on the retaining wall below on a bed of mortar and without any dowels. The bottles have small bronze pins below to the plinths and above to the coping stones. The plinths and copings have recesses on the sides, which when filled with mortar, provide keys for adjacent plinths or copings to work together. Below are photos taken during the inspection:

- 5.3.1 The deconstructed balustrades indicate that the balustrades are being held only by the bond of the mortar (which is not very strong in tension) and by the self-weight of the individual components and when dislodged, only by the self-weight. This is as assessed in the original report when the lateral loading capacity of the balustrades was calculated.

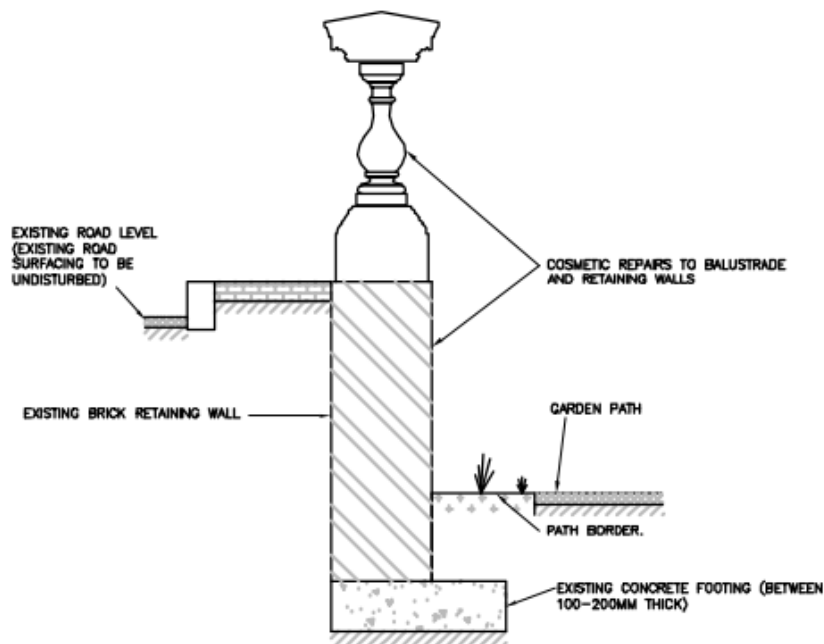
- 7.1.1 Repair Scenario 1 relates to the elemental repairs of the damaged elements of the balustrades and retaining walls. Repair Scenario 1 does not attempt to deal with the structural engineering issues and therefore is more or less a cosmetic repair. Below is a sketch showing the intent.

- 7.3.1 Following the repairs, the balustrades can be as strong as when they were originally constructed. As established in our original report, the balustrades will however not have sufficient strength to resist contemporary lateral loads.

- 7.3.2 In addition, the retaining walls and foundations will be subject to ongoing movement as a result of inadequately sized foundations, foundations being founded on made ground, tree root action on the clay type ground and lateral loading arising from surcharge on the road. Therefore, ongoing repairs will be required.

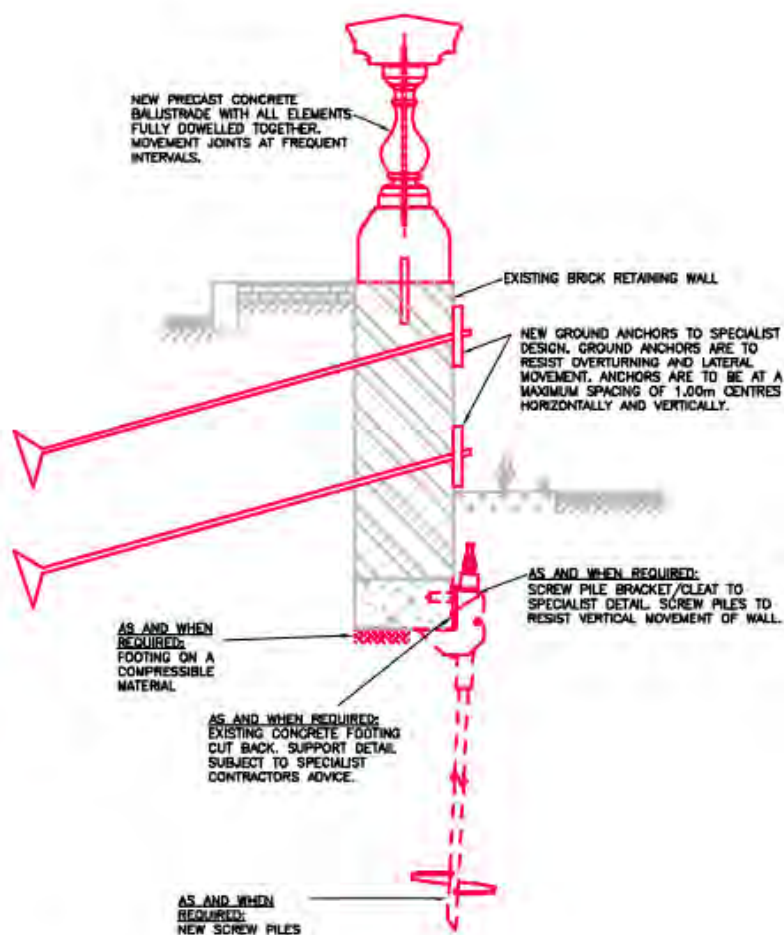
8.1.1 In repair scenario 2, new balustrades designed to resist contemporary lateral loads will be installed and the retaining walls restrained with new ground anchors.

8.1.2 In this scenario, the vertical movement of the retaining walls (due to the presence of made ground and trees) will not be dealt with at the outset, but underpinning will be undertaken to bays that exhibit movement.

- (a) Vertical movement of the retaining walls and balustrades will be ongoing and will need to be dealt with by underpinning as and when required.
- (b) Partial underpinning is likely to lead to differential settlement between the underpinned and non-underpinned sections
- (c) Damage may occur to the new balustrades, which will be stiffer than the current ones. Ongoing repairs may therefore be required.
- (d) If significant portions of the retaining walls need to be underpinned and/or damage occurs to the balustrades, the overall cost could end up being higher than Repair Scenarios 3 and 4.
- (e) There is a risk element associated with the use of ground anchors and the presence of services and extents of vaults in Chester Terrace. Further surveys will be required.
- (f) Damage to trees and vegetation is likely.

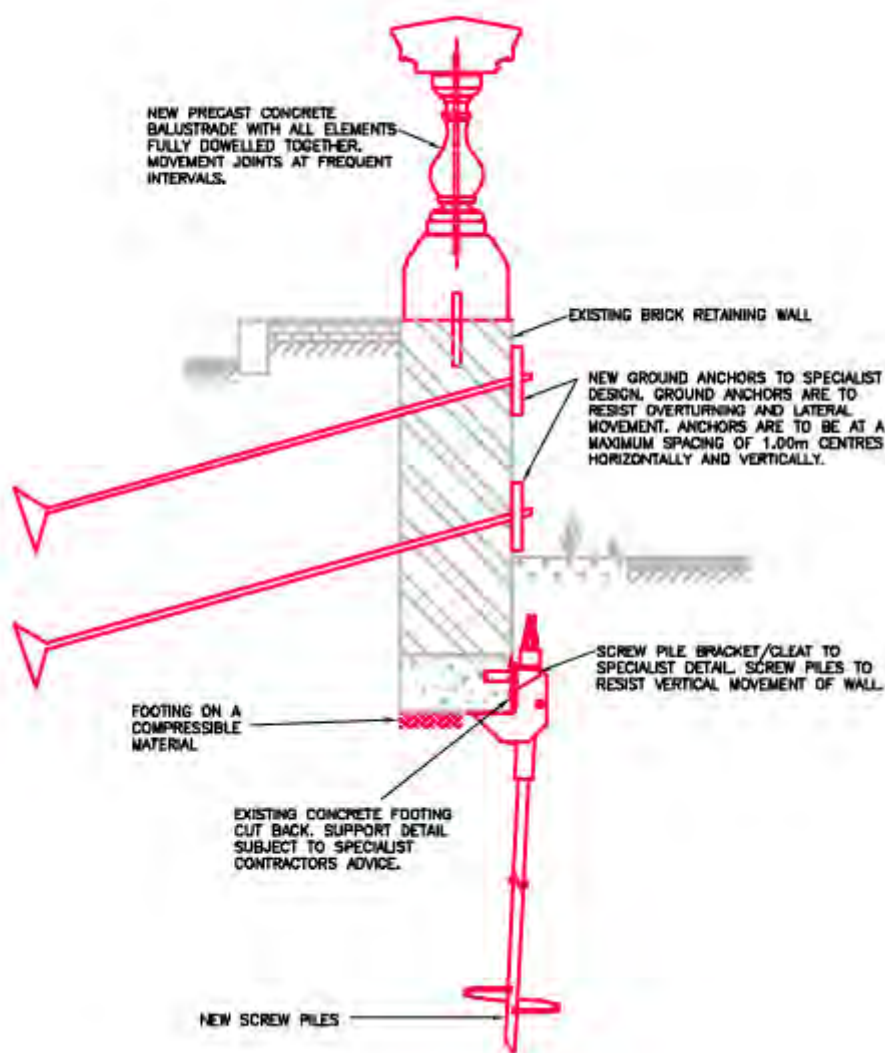
9.1.1 Repair Scenario 3 is similar to Repair Scenario 2, except that the underpinning to the retaining wall is undertaken from the outset. Repair Scenario 3 involves the installation of new balustrades, the use of ground anchors to restrain the retaining walls and the use of underpinning to deal with the vertical movement of the foundations.

- (a) The cost of the works will be one of the highest, perhaps on par with Repair Scenario 4.
- (b) There is a risk element associated with the use of ground anchors and the presence of services and extents of vaults in Chester Terrace. Further surveys will be required.
- (c) Damage to trees and vegetation is likely.

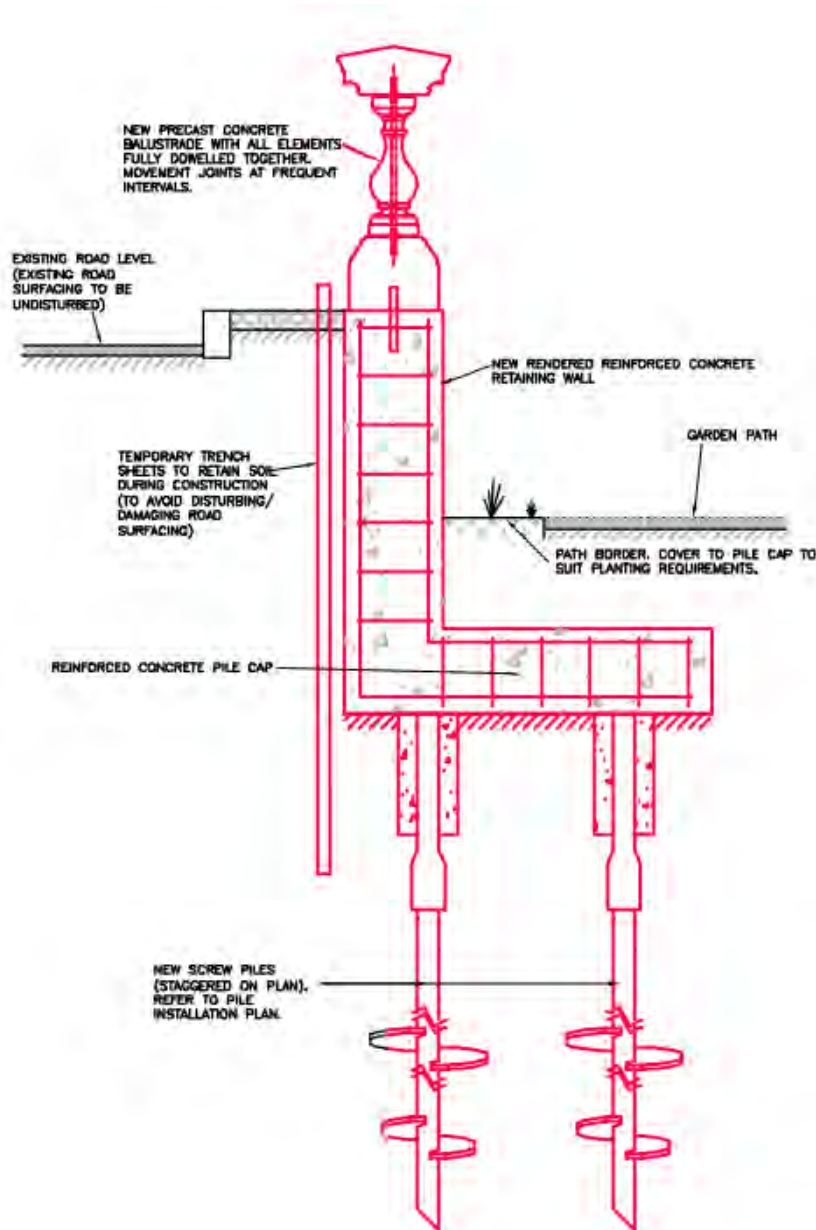
10.1.1 In Repair Scenario 4, the existing retaining wall is removed and replaced with a new reinforced concrete retaining wall supported on piled foundations. New balustrades are also installed.

### 10.3.1 With this repair scenario, the cost of the works will be one of the highest. The cost for this scenario was previously assessed to be circa £1.7M (excluding contingency and VAT), but this figure will need to be adjusted to omit the run outside no.2 Chester Terrace (which is outside the scope) and to include the additional cost for disposing of hazardous waste from the excavation.

### 10.3.2 This repair scenario is the most intrusive, both on the trees and vegetation in the garden and the footpath along Chester Terrace.
