Document type  
**Structural Review**

Date  
**August 2021**

# CHESTER TERRACE RETAINING WALL REMEDIATION STRUCTURAL REVIEW

Project name **Chester Terrace Wall Remediation – Structural Review**  
Project no. **1620012XXXX**  
Recipient **Nick Packard <Nick.Packard@cepc.org.uk>**  
Document type **Structural Report**  
Version **Rev01**  
Date **13/08/2021**  
Prepared by **Scott Brookes**  
Checked by **Jackie Heath**  
Approved by **Jackie Heath**  
Description **Structural assessment and review of current remedial strategy**

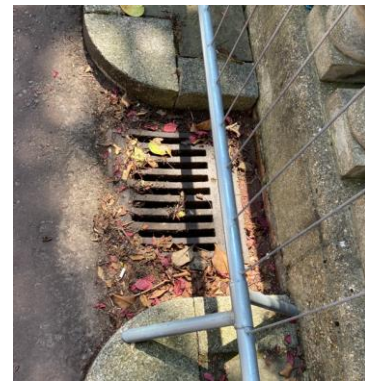
**Figure 3 Drain grilles roadside of the balustrade plinths**

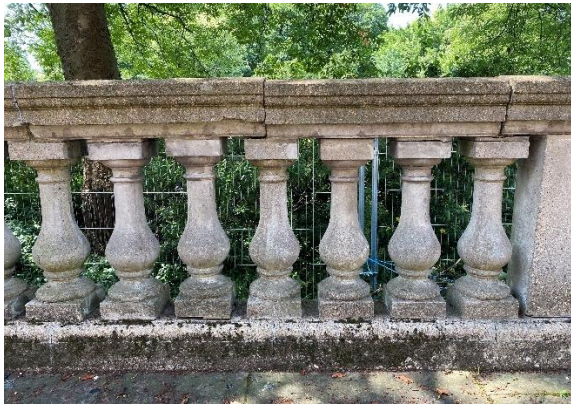
**Figure 4 Balustrade as viewed from Chester Terrace. Note the step in coping level.**

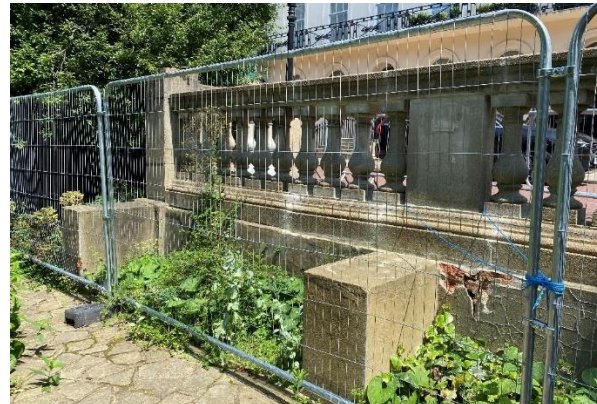
**Figure 5 Balustrade as viewed from within the gardens. Note the kentledge blocks to resist lateral wall loading**

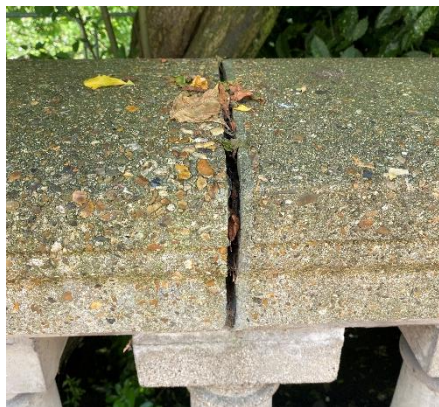
| DEFECT | PREVELANCE (HPM) | STRUCTURAL RISK (1 -lowest,5 - highest) | URGENCY (1 -lowest,5 - highest) |
|---|---|---|---|
| Open joints between coping stones | 93% | 2 | 3 |

Figure 7 Open joints between coping stones

- Thermal: cyclical expansion/contraction of the balustrade concrete along its length will generate stresses, particularly at changes in direction such as inlet bays. This has led to distortion of corner returns and displacement and cracking of coping to release build-up of stresses.

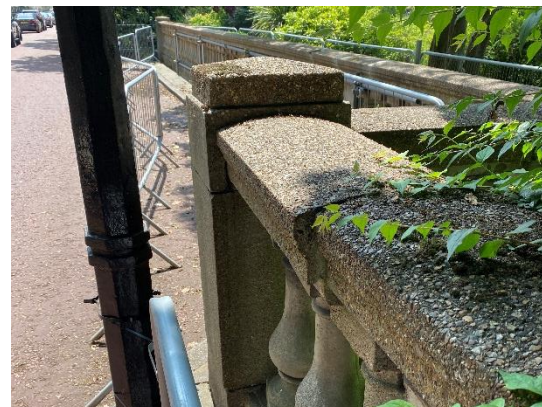
| DEFECT | PREVELANCE (HPM) | STRUCTURAL RISK (1 -lowest,5 - highest) | URGENCY (1 -lowest,5 - highest) |
|---|---|---|---|
| Balustrade able to be moved | 13% of bays | 4 | 5 |

Figure 8 Dislocation of coping stones -able to be moved by hand

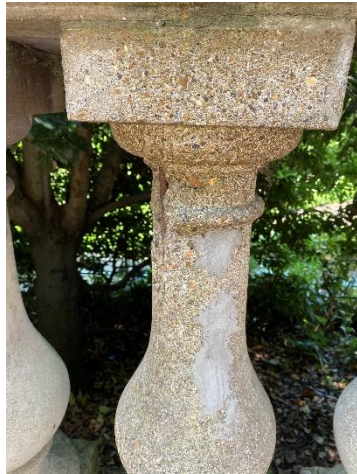
| DEFECT | PREVELANCE (HPM) | STRUCTURAL RISK (1 -lowest,5 - highest) | URGENCY (1 -lowest,5 - highest) |
|---|---|---|---|
| Fractured/Spalled bottles | 9% | 3 | 3 |

Figure 9 Fracturing/spalling of bottles

- Construction Detailing: There are thought to be missing pins between bottles and plinth to provide positive fixity and improved resistance to overturning and sliding failure – frequency unknown. There are no movement joints allowing the aforementioned thermal ratcheting to be released. Even though there is mortar loss between plinth/rail units, the position of these open joints over bottles will resist longitudinal thermal movement. There is low cover for bottle reinforcement between 7mm and 62mm) – lack of quality control on positioning reinforcement bar when casting. Low chloride content in the concrete suggests low cover depth, possibly accentuating the effects of carbonation, is the primary cause of fracturing/spalling.

Whilst there is spalling/fracturing of approximately 1/3 of all bottles, HPM's investigations and associated concrete testing tell us this correlates with poorly positioned reinforcement and low cover. Chloride tests did not show this to be critical factor at this stage, and on this basis the retention of the intact 2/3 of bottles would be by consideration of the position of the reinforcement relative to the carbonation front. At its greatest depth, the carbonation front is at 33mm, and an exercise to replace bottles where the reinforcement cover is below this threshold, could be undertaken to maximise retention in line with good conservation practice. We agree that application of a coating such as Fosroc Dekguard CP to these retained bottles would be appropriate.

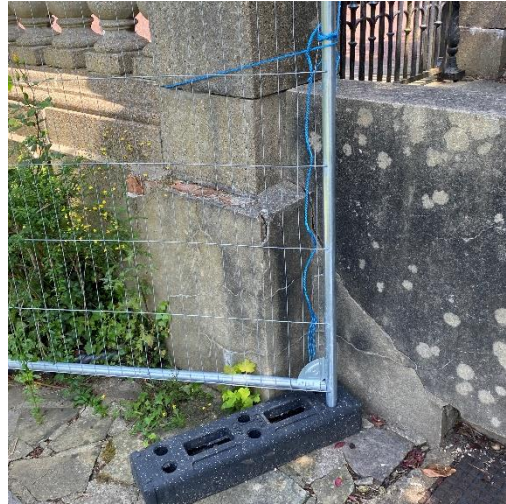
| DEFECT | PREVELANCE (HPM) | STRUCTURAL RISK (1 -lowest,5 - highest) | URGENCY (1 -lowest,5 - highest) |
|---|---|---|---|
| Cracking/separation towards base of wall | 28% of bays | 4 | 4 |

Figure 10 Cracking at wall low level

- Ground Support: The made ground bearing material (to 2-3m depth) is partially granular and is known to contain brick fragments, suggesting a high likelihood of void pockets and/or washout/scour of the granular material. This may be allowing relative ground movement, causing wall level steps manifesting as undulations in the coping line and steps at the joist locations. The soft landscaping at the garden side (versus hard at the pavement), may allow localised soil saturation and softness, contributing to relative differences in earth bearing capacity on each side of the wall, promoting base rotation.

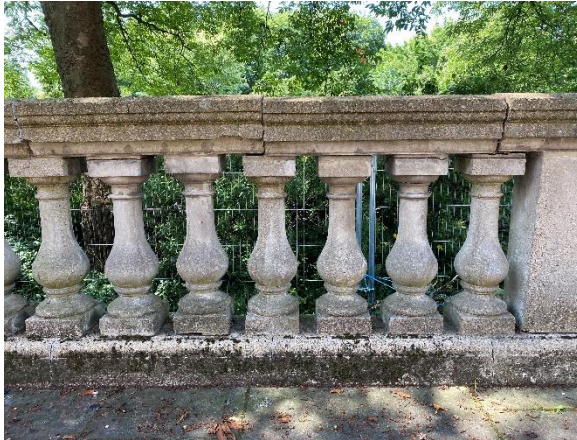
Figure 11 Differential coping levels

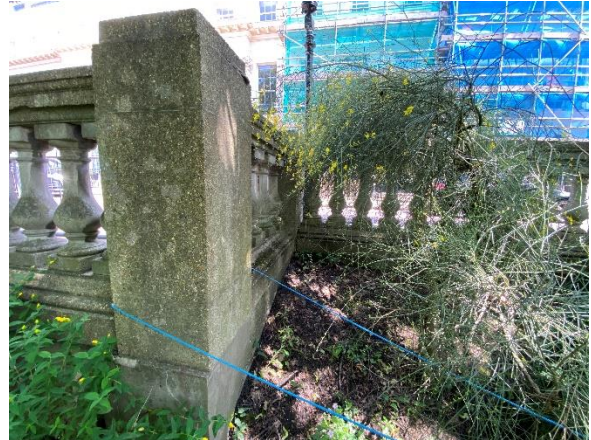
Figure 12 Banked earth at garden side

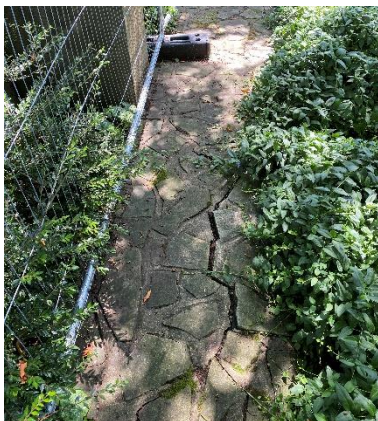
Figure 13 Stress fractures through paved pathway from tree roots

- Trees/Vegetation: Roots were recorded down to a depth of 2.2m by Listers Geo. Trees close to the wall may cause significant damage through root tendril growth, direct pressure from roots, as well as promoting desiccation of the clay- sub-strata (which has high volume change potential) local to each tree, allowing local subsidence and heave. That being said, there is no visual evidence of advanced deterioration/movement local to the trees. Furthermore, we understand the made ground (with only moderate volume change potential) extends to below 2.2m below ground level, suggesting clay desiccation may not be a primary factor.

Referring to the CEPC survey drawings provided (200944) and our visual inspection, certain larger trees in close proximity to the wall hold a potential risk to the wall's performance and integrity through surcharge and ground volumetric changes, although wall damage local to trees is typically low. Specialist advice should be sought from an arboriculturist to proactively manage water demand and subsequent impact, moving forward, even after underpinning/wall reconstruction. Trees in close proximity include:

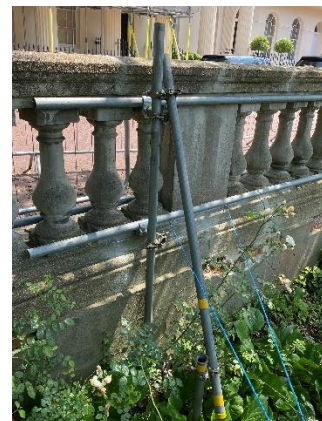
Figure 14 Scaffold buttress installed towards south end

Should the work be phased by certain lengths of wall, it may be advisable to commence works at the southern end of the wall, in particular focussing on the inset section which is currently buttressed and showing significant movement. The central and north sections present significantly lower short to medium term risk, where the wall is in adequate condition and the soil retained is much lower. Accordingly, at these lengths and there is much greater flexibility in the approach taken, particularly if as part of the southern section works, a movement joint is introduced to isolate.
