Photographic Condition Survey

3-6 Guilford Place, Camden
for Paragon Asra Housing Limited

Location: 3-6 Guilford Place, Camden
Date: 7th October 2021 & 13th April 2022
Surveyed By: Duncan Reynolds & Danny Treherne

This survey of the four six-storey terraced houses located in Guilford Place, Camden was undertaken by Churchill Hui on behalf of Paragon Asra Housing Limited to ascertain the condition status of the four independent roofs and determine the extent of any necessary maintenance works required. The document forms part of a Listed Building Consent application and should be read in conjunction with all other specification items and drawing information.

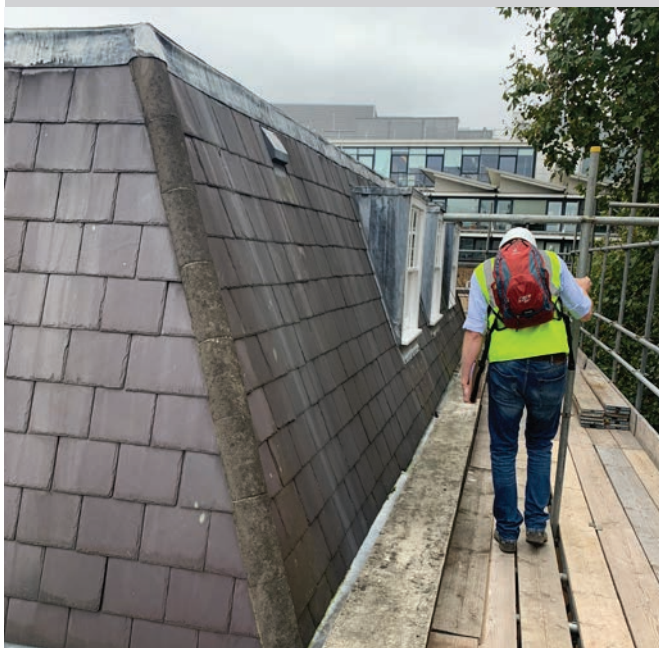
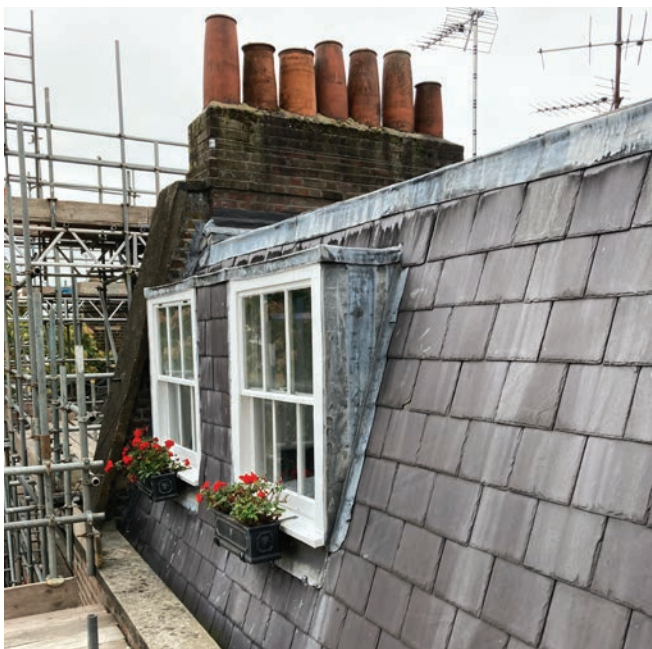
1. Mansard Roof Hips and Slates

The pointing to several of the half round hip tiles to the front and rear of the mansard roof is loose or missing. There is moss and lichen growth to the hip tiles which is encroaching from the parapet gutters and coping stones.

The lead flashings over the ridge of the mansard are lifting where it laps, but generally this is securely fixed.

Several slates have been displaced as a result of past remedial works with some towards the top of the mansard have fallen out of line with those below. Some of these show signs of becoming unsecured. Where in-line ventilation and lead flashings have been introduced there are broken and lifted slates that are not securely fixed to the roof structure. In some individual instances synthetic tiles have been used as a replacement for the original natural slates.

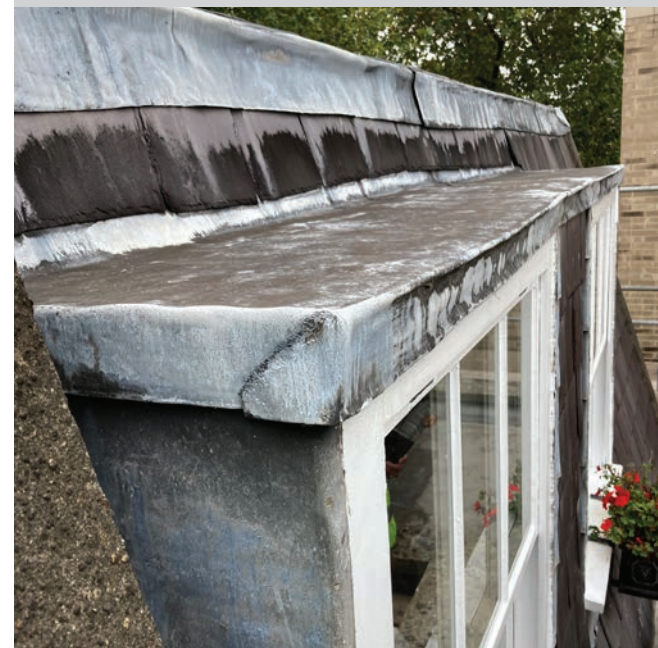
3. Leadwork Detailing to Mansard Dormer Windows (cont.)

The dormer abutments to the mansard at both the head and dormer cheeks appear to be sound. The profile of some dormer heads bow slightly towards the centre of the window, forcing ponded water to drip down the face of the glazing; however, water damage is restricted by the shallow depth of the dormer heads. The leadwork flashings to the cheeks have been renewed more recently than other elements, and these appear to be without fault.

Several slates have been displaced as a result of past remedial works. Where lead flashings have been introduced there are broken and unsecured slates that do not align with others.

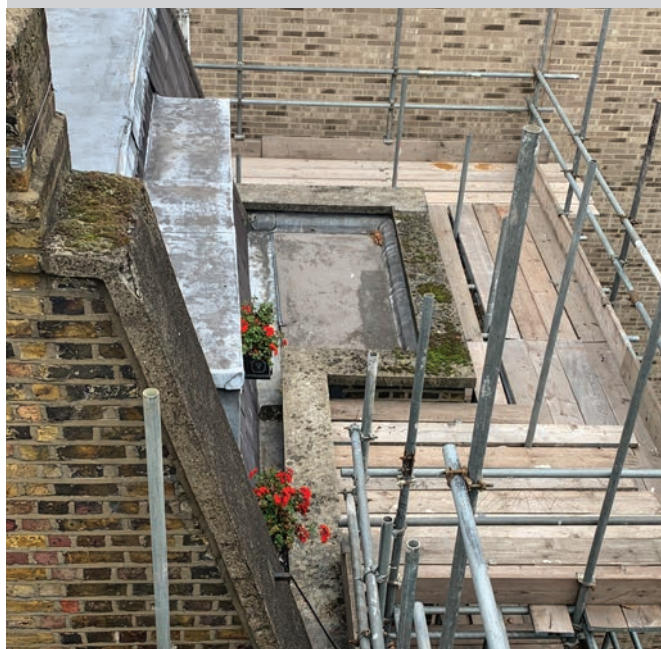
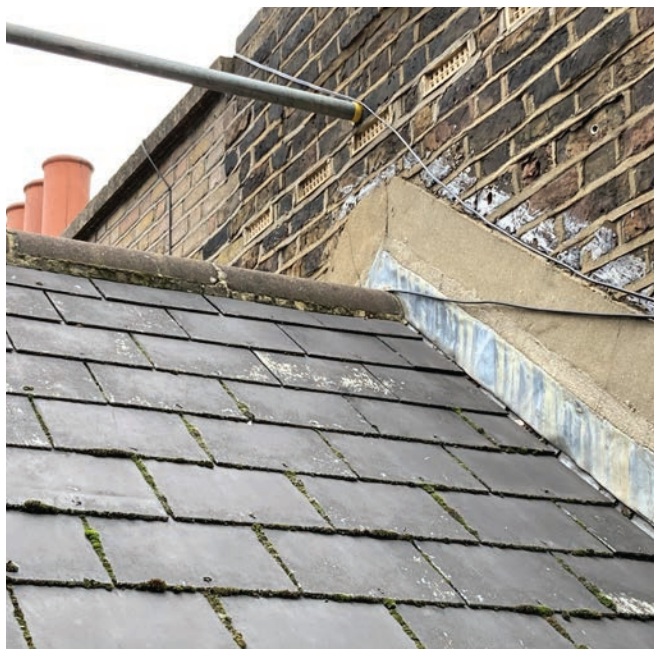
4. Flat Roof and Concrete Coping Stones

There is moss and lichen growth to the concrete coping stones surrounding the rear of No.3 Guilford Place, although some lengths of copings show evidence of having recently been cleaned.

The asphalt flat roofing to the rear stairwell laps over the leadwork of the parapet gutter. In the location of the stepped leadwork the asphalt has become damaged with a tear to the surface. It is unclear if water ingress to the property has occurred at this location.

The flat roof also appears to have suffered from ponding damage in the corner of the parapet where surface water has not drained efficiently. This has led to discolouration of the asphalt and increased moss growth where leaves and other natural debris has collected.

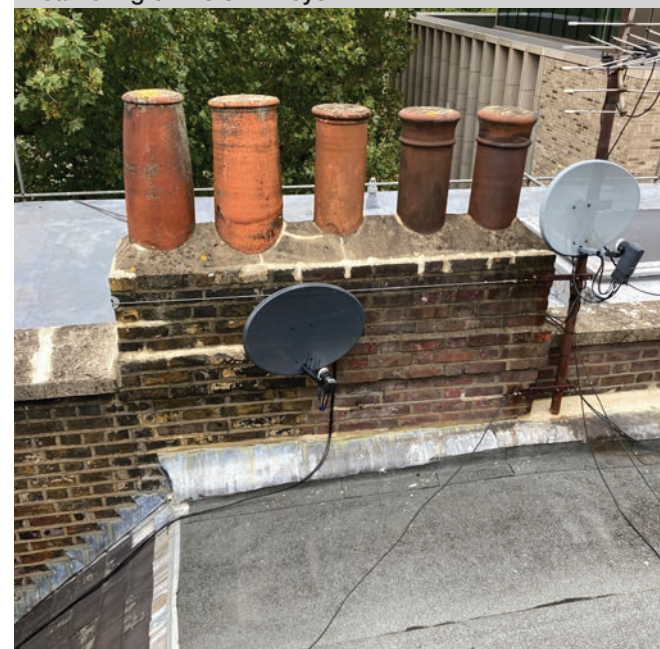
6. Chimney Stacks, Pots and Flaunching

The condition of the flaunching to all chimney stacks is good, with all pots appearing to be secure in their bedding. Some flaunchings are covered with slight lichen growth on the northern face which should be removed during the course of any works.

All chimney pots have been filled with a mortar mix that appears in good condition, although moss and lichen growth may disguise cracking. Previous heavy pointing to the chimney brickwork is showing no signs of decay despite having poor aesthetic quality.

Numerous satellite dishes and aerials are attached to the southern side of chimney stacks to both the front and back of the building. Despite unsecured cabling, these fixtures do not appear to have caused damage to the structure or weathering of the chimneys.

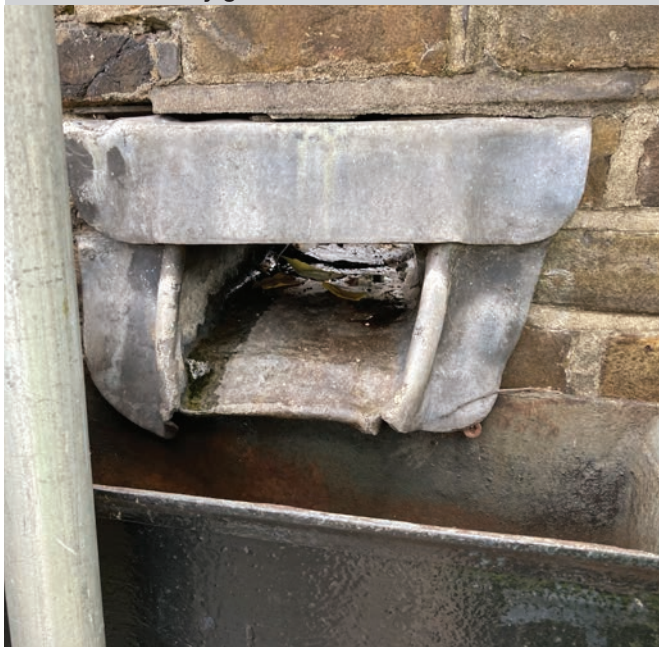
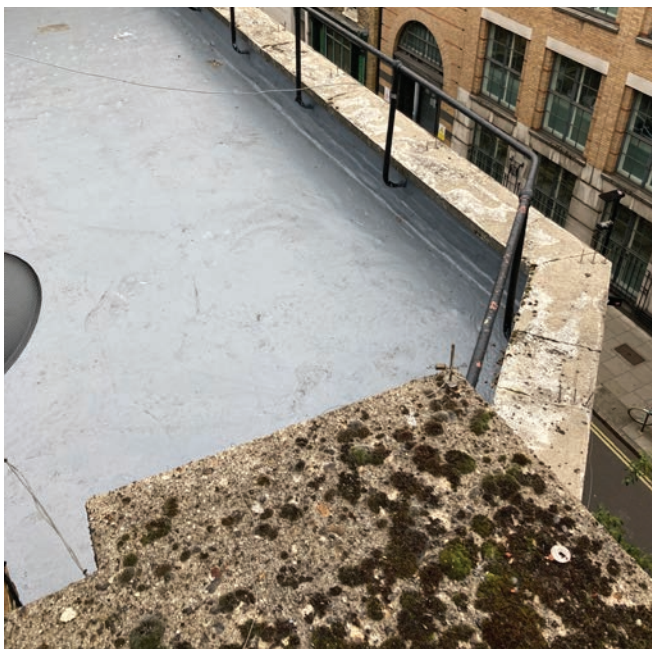
7. Lead Parapet Gutters and Hopper

Generally, the leadwork to guttering requires attention in the form of cleaning. The combination of water ponding and collection of vegetation has resulted the degraded state of some gutter areas.

In the case of the large cast iron hopper located to the rear between no.5 and no.6, the bed of the outlet requires replacement as the leaking cracked lead has resulted in deterioration of the timber substrate. Where the lead has been worked to provide flashings to the hopper outlets this is no longer tight to the brickwork and the surrounding pointing does not fully secure the lead.

In situations where lead has been folded to form details in susceptible locations the lead has begun to split on the folds with water tracking through the split and into the substrate of the valley gutters.

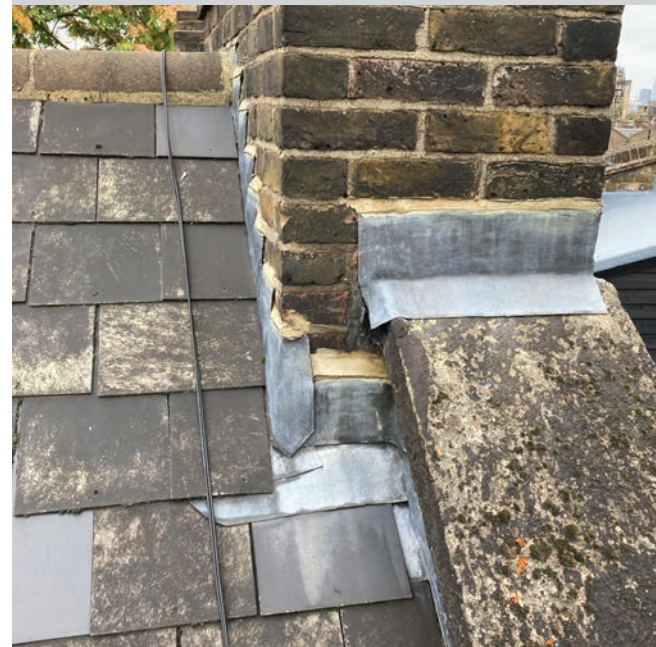
9. Lead Flashing to Brickwork and Copings

Pointing of the leadwork is of a reduced standard and, along with poor aesthetics, recent remedial leadwork is not in accordance with Lead Sheet Association details. Some areas of lead cover flashings are lifting from the brickwork face and may invite future water ingress.

Heavy pointing has been used as a weathering material in instances where a continuation of the leadwork detailing would have been considered the correct solution.

To address previous failings, bituminous black paint has been applied to some coping stone junctions, but this is now either cracking or has partially eroded over time.

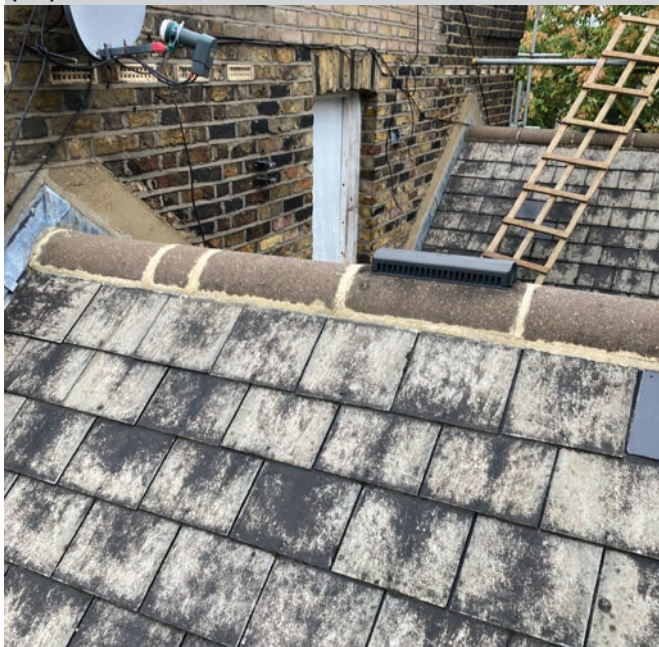
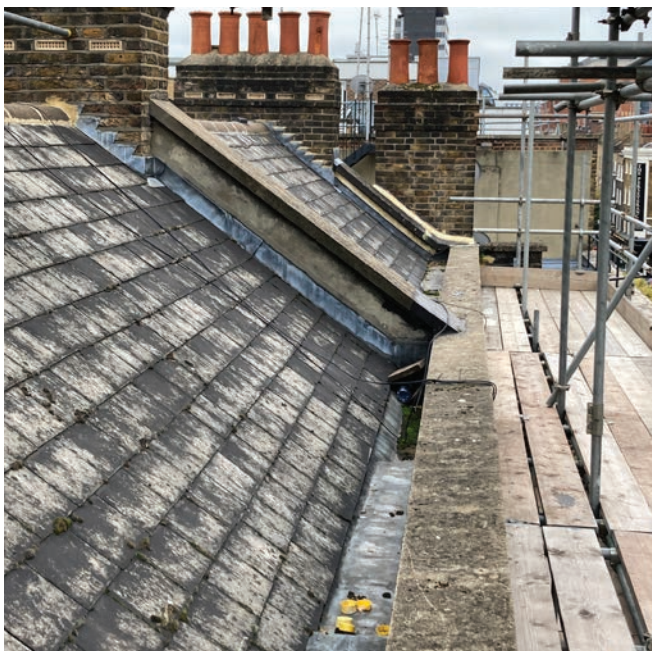
10. Synthetic Slates, Ridges Tiles and Roof Access

The pointing to the ridge tiles of No.5 Guilford Place is in a satisfactory condition but some of the synthetic slates beneath the ridge are broken and potentially unsecured where re-pointing has recently been undertaken. The pointing to the ridge of No.6 Guilford Place is considerably older but still in an adequate condition. There are two proprietary ridge tile ventilators per roof pitch (8no. in total) that all appear undamaged and in working condition.

Access to the valley guttering over No.5 (and No.6) Guilford Place is achieved via the reduced height timber door from the crown roof void over no.4 Guilford Place. The door is adequately secure and in a sound condition for the purpose of providing access to the roof area, although the frame is in need of redecoration. The door is to be retained for future maintenance access following completion of the proposed works.

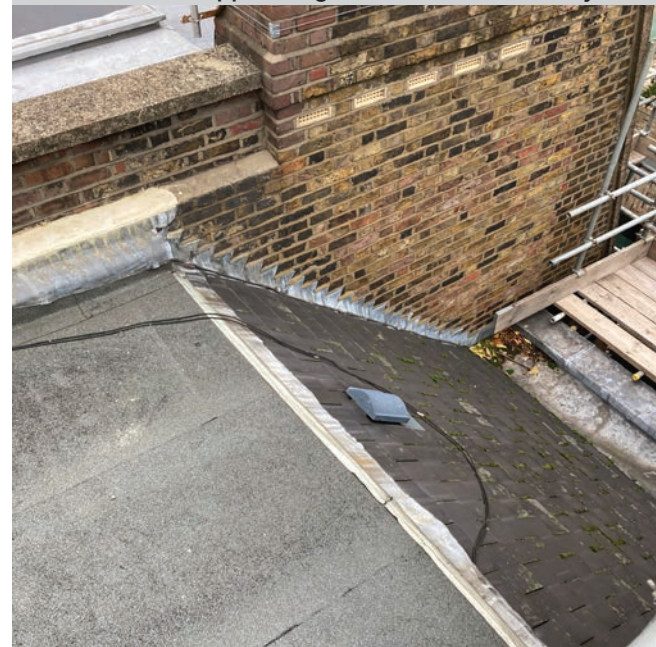
12. Felt Crown Roof, Abutment and Ventilation

The felt crown roof covering to No.4 Guilford Place is showing signs of wear at the joints, with the felt lifting across the seam from front to back of the roof. At the mansard ridge the horizontal felt has been flashed to the previous leadwork with an adhesive tape that is losing adhesion to the felt. This is evidently a temporary remediation to works that have failed and are now failing once again.

The stepped lead flashing to the party wall and chimney of No.3 Guilford Place is in good condition but the cover flashings over the felt roofing abutment is lifting in places.

Proprietary in-line ventilators in a contrasting synthetic colour have been installed within the pitch of the crown roof structure to provide cross ventilation to the roof void. Two are installed to the front roof pitch with a further two to the rear roof. All appear in good condition externally.

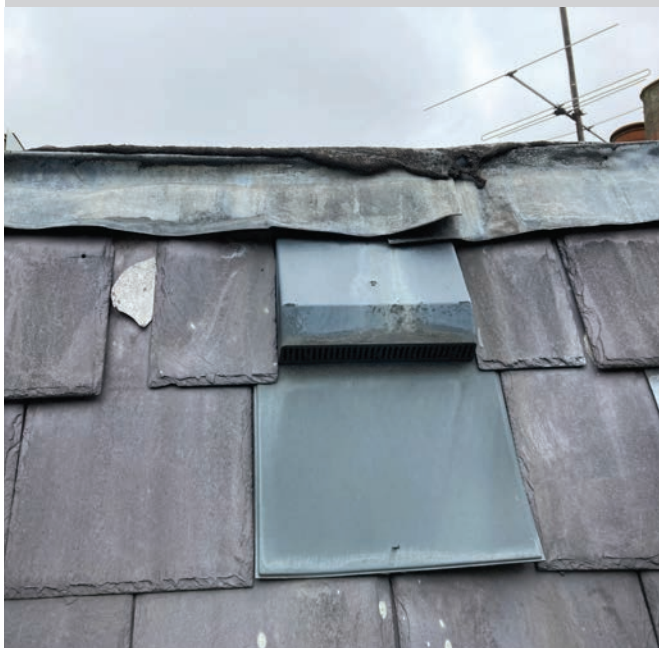
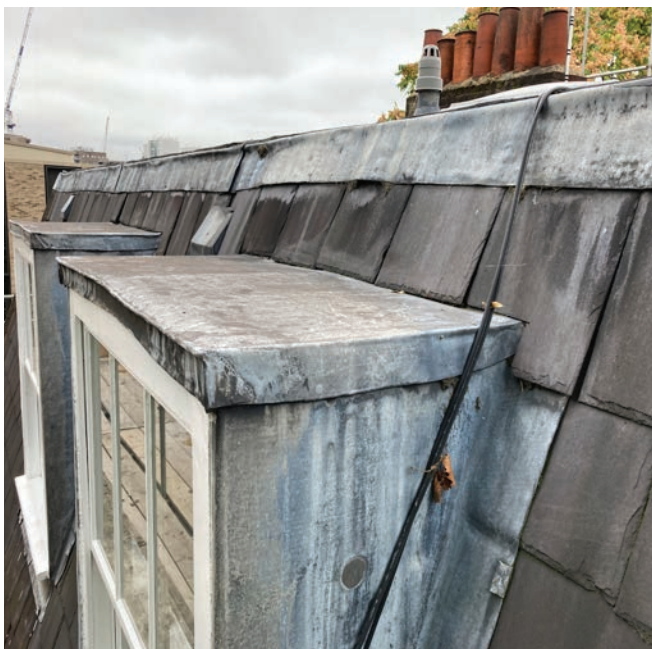
13. Ventilation and Flashing to Slate Roof

Four in-line ventilators have been introduced to the mansard roof of No.3 Guilford Place on the north and west facing pitches. The natural slates on the mansard are interrupted by the proprietary vents and their synthetic cover tile. These synthetic tiles have become warped over time and the plastic vented components are degrading at the air intake/outlet.

Where this cross ventilation has been installed the surrounding slates are often damaged and out of line from those below. Many of the cut slates are broken and are not securely fixed, with some smaller elements loose.

Leadwork flashings to the upper perimeter of the mansard have lifted around all three sides and the bituminous roof covering is untidily applied in places and spills over onto the visible elevation of the leadwork.

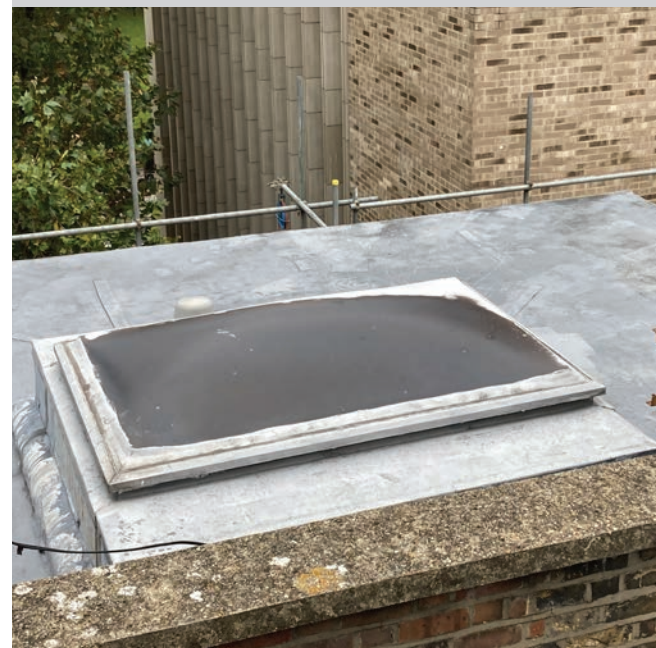
15. Rooflight and Kerb Detail

The rooflight located within the flat section of the mansard roof above no.3 Guilford Place is situated over a tank room that serves the block. As access into this space from within the communal stairwell is very compromised via a small hatch, the rooflight has been utilised to provide servicable access to the pipework and tanks.

Remedial works have been carried out surrounding the kerb detail using strip patching of an EPDM roofing membrane. The polycarbonate hood to the rooflight is discoloured and semi-obsured but the general weatherings to the kerb and it's flashings are in good condition.

Installation of a new water tank to this area will require a fully-functioning openable access hatch to enable improved maintenance access in the future.

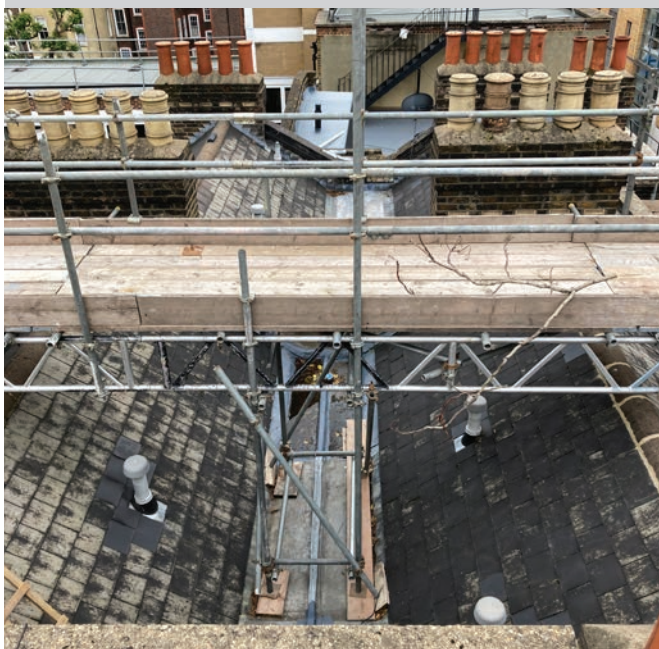
16. Valley Guttering

The 1 metre wide valley gutters that span between the pitched roofs of No.5 and 6 Guilford Place are in disrepair following previous attempts to address necessary remedial works. The liquid applied membrane which has been overlaid on the failed lead guttering beneath has begun to crack in corner folds creating water ingress opportunities.

Pockets of swelling to the membrane and substrate in these locations serves as evidence of moisture in the roof build-up. Damage to the substrate is unknown but the quantity of tears to the fabric suggests that water will have been penetrating the plywood deck below for a considerable time.

There is a single rainwater outlet to each stepped valley gutter which drains through the plywood (on either side of the dividing parapet wall) and out to the rear parapet of the building via the roof void.

Both outlets are heavily submerged in debris from the neighbouring tree. The grilles to the outlets are blocked and there is no protection to prevent debris build-up recurring. As the large tree is in such close proximity to the building the problem escalates with the autumnal season. Once leaves and small branches enter the valley gutter there is no means of it being removed without human intervention.
