## Report on Mayor's Parlour Balcony drainage

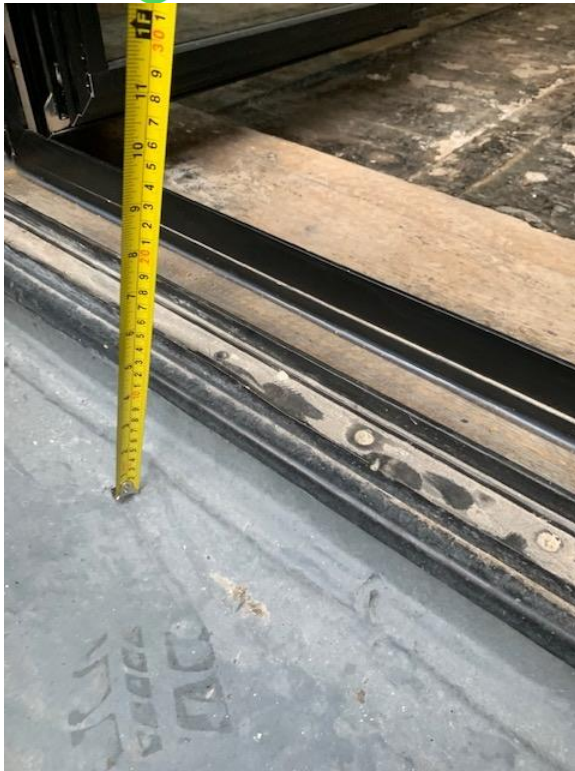
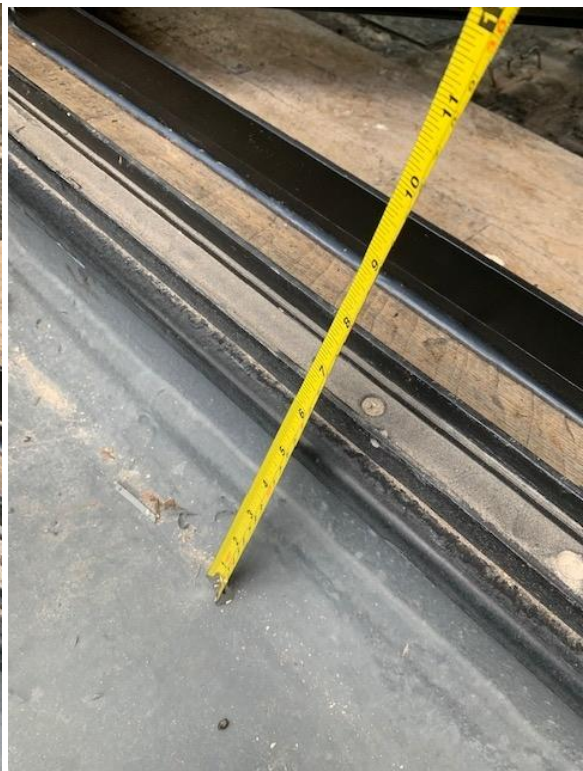
Balcony depth measurement

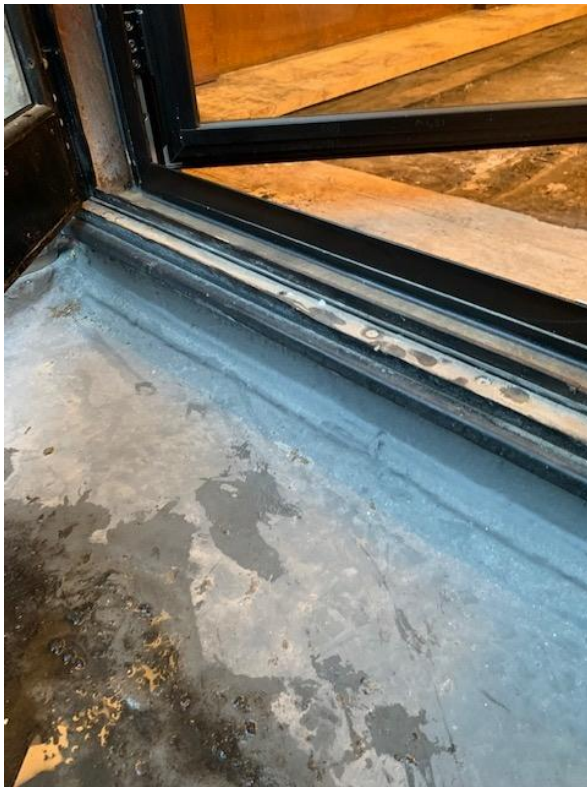
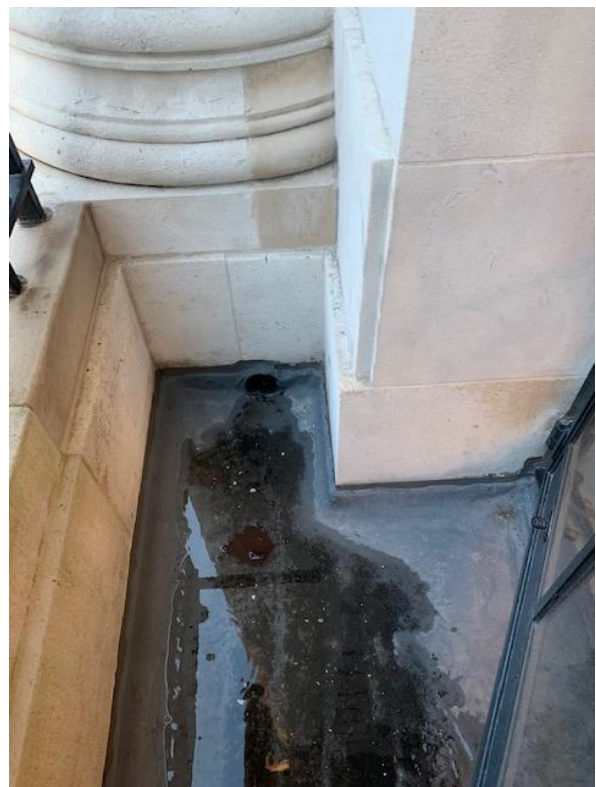
Existing condition of balcony

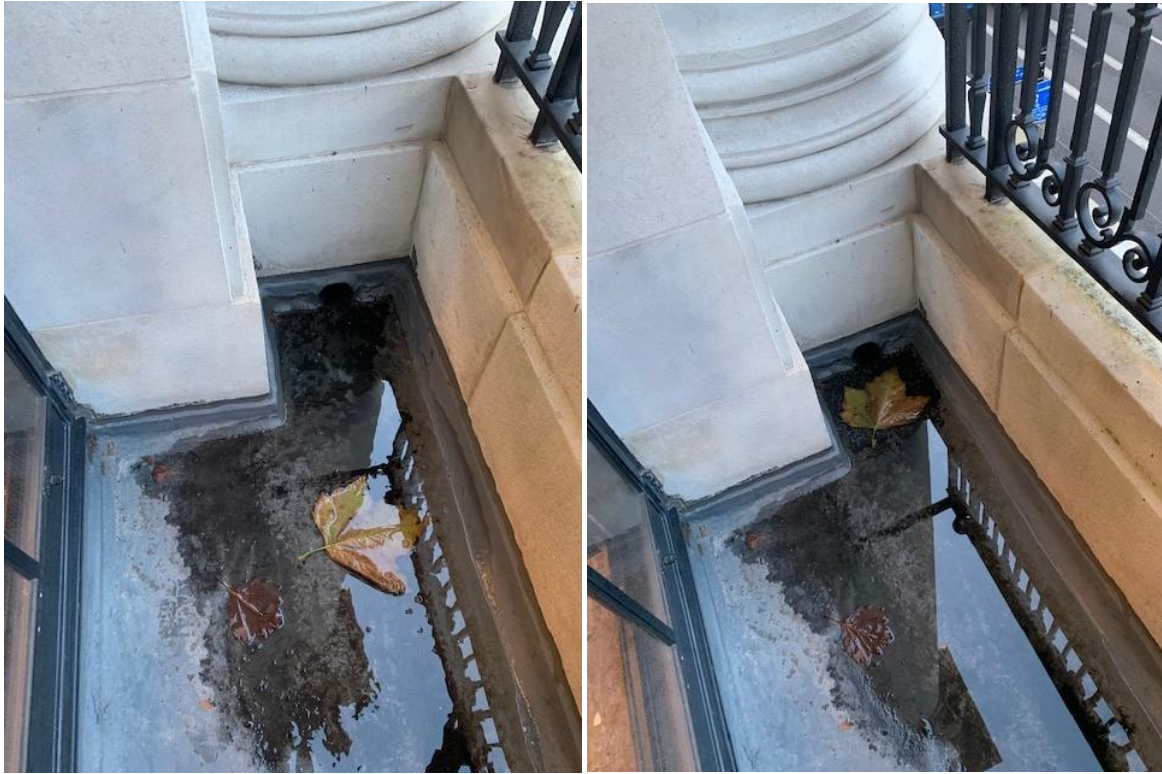
Balcony condition after rainfall

Due to the shallow depth of the balcony, to mitigate against water ingress from future blockage or adverse weather condition, it is recommended that overflow weep holes are installed going through the façade on Euston Road. These will have lined lead shoot to avoid staining of the stone façade. These weep holes will only ever be used in the case of an adverse weather condition.

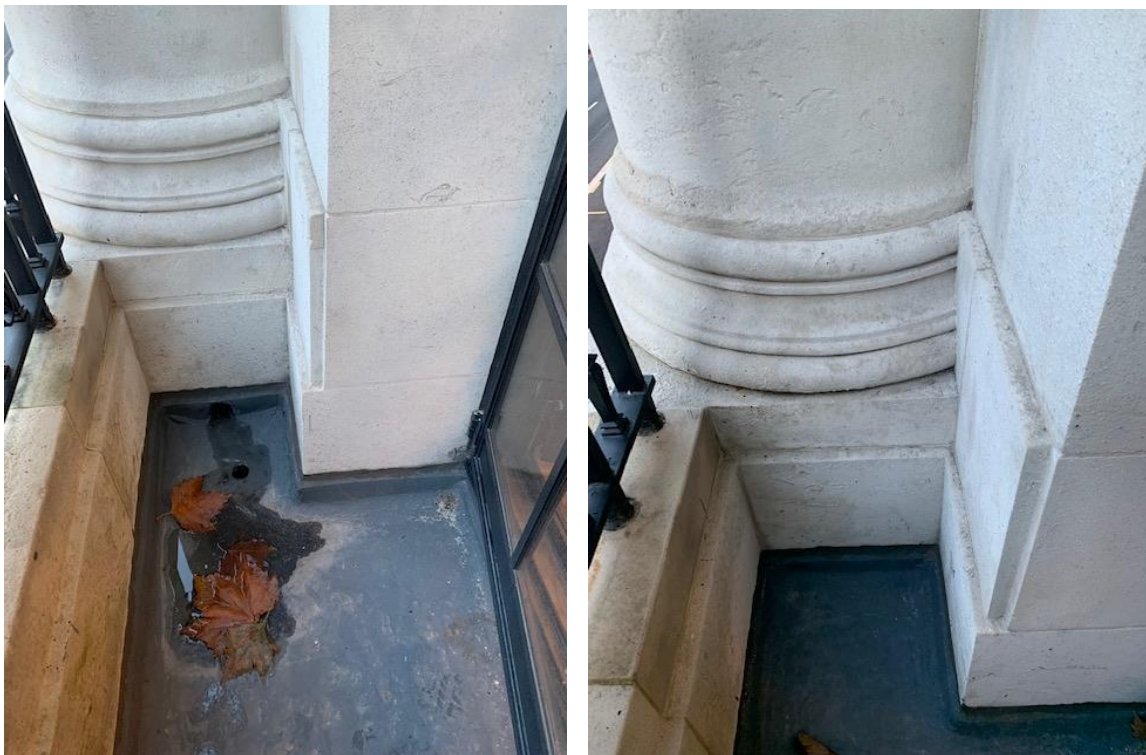
Existing Shallow balcony

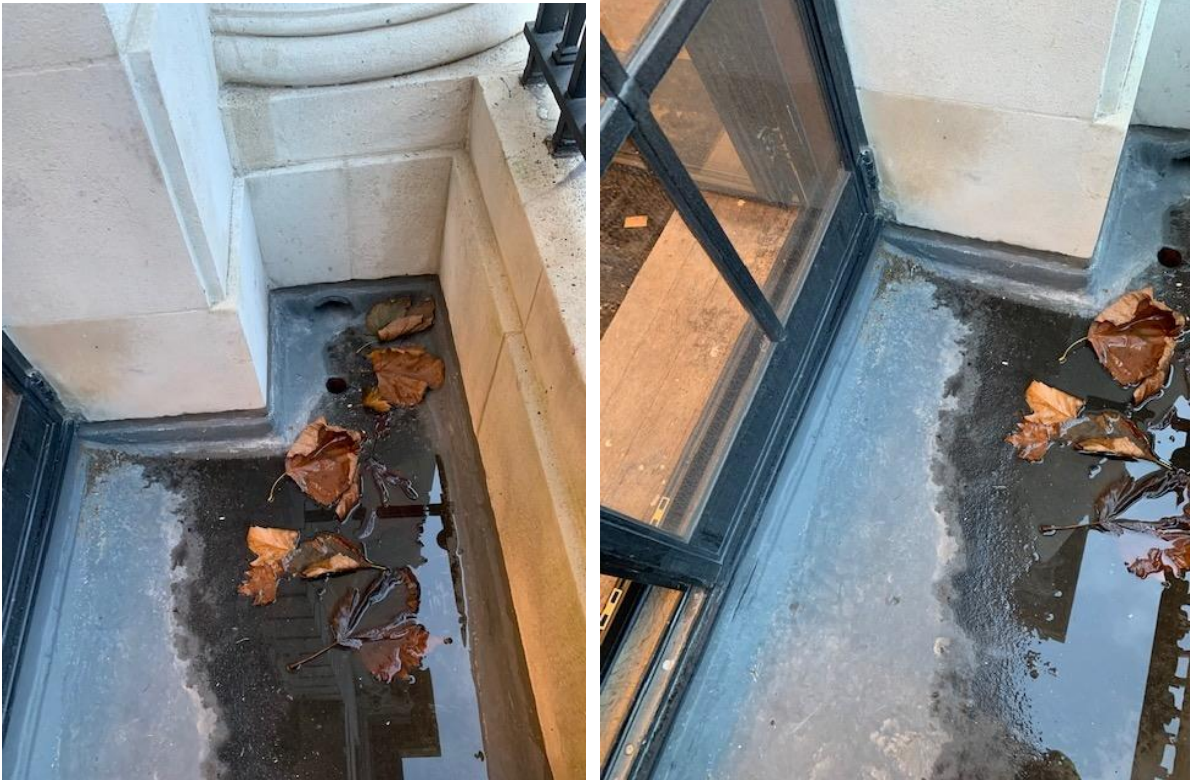
Balcony prone to foliage
