## **4 Murray Mews – Site Contamination Assessment**

## **Phase II ENVIRONMENTAL REPORT**

**Site at  
4 Murray Mews &  
3 Augustines Road  
London  
NW1**

**March 2007  
Report No. 7769**

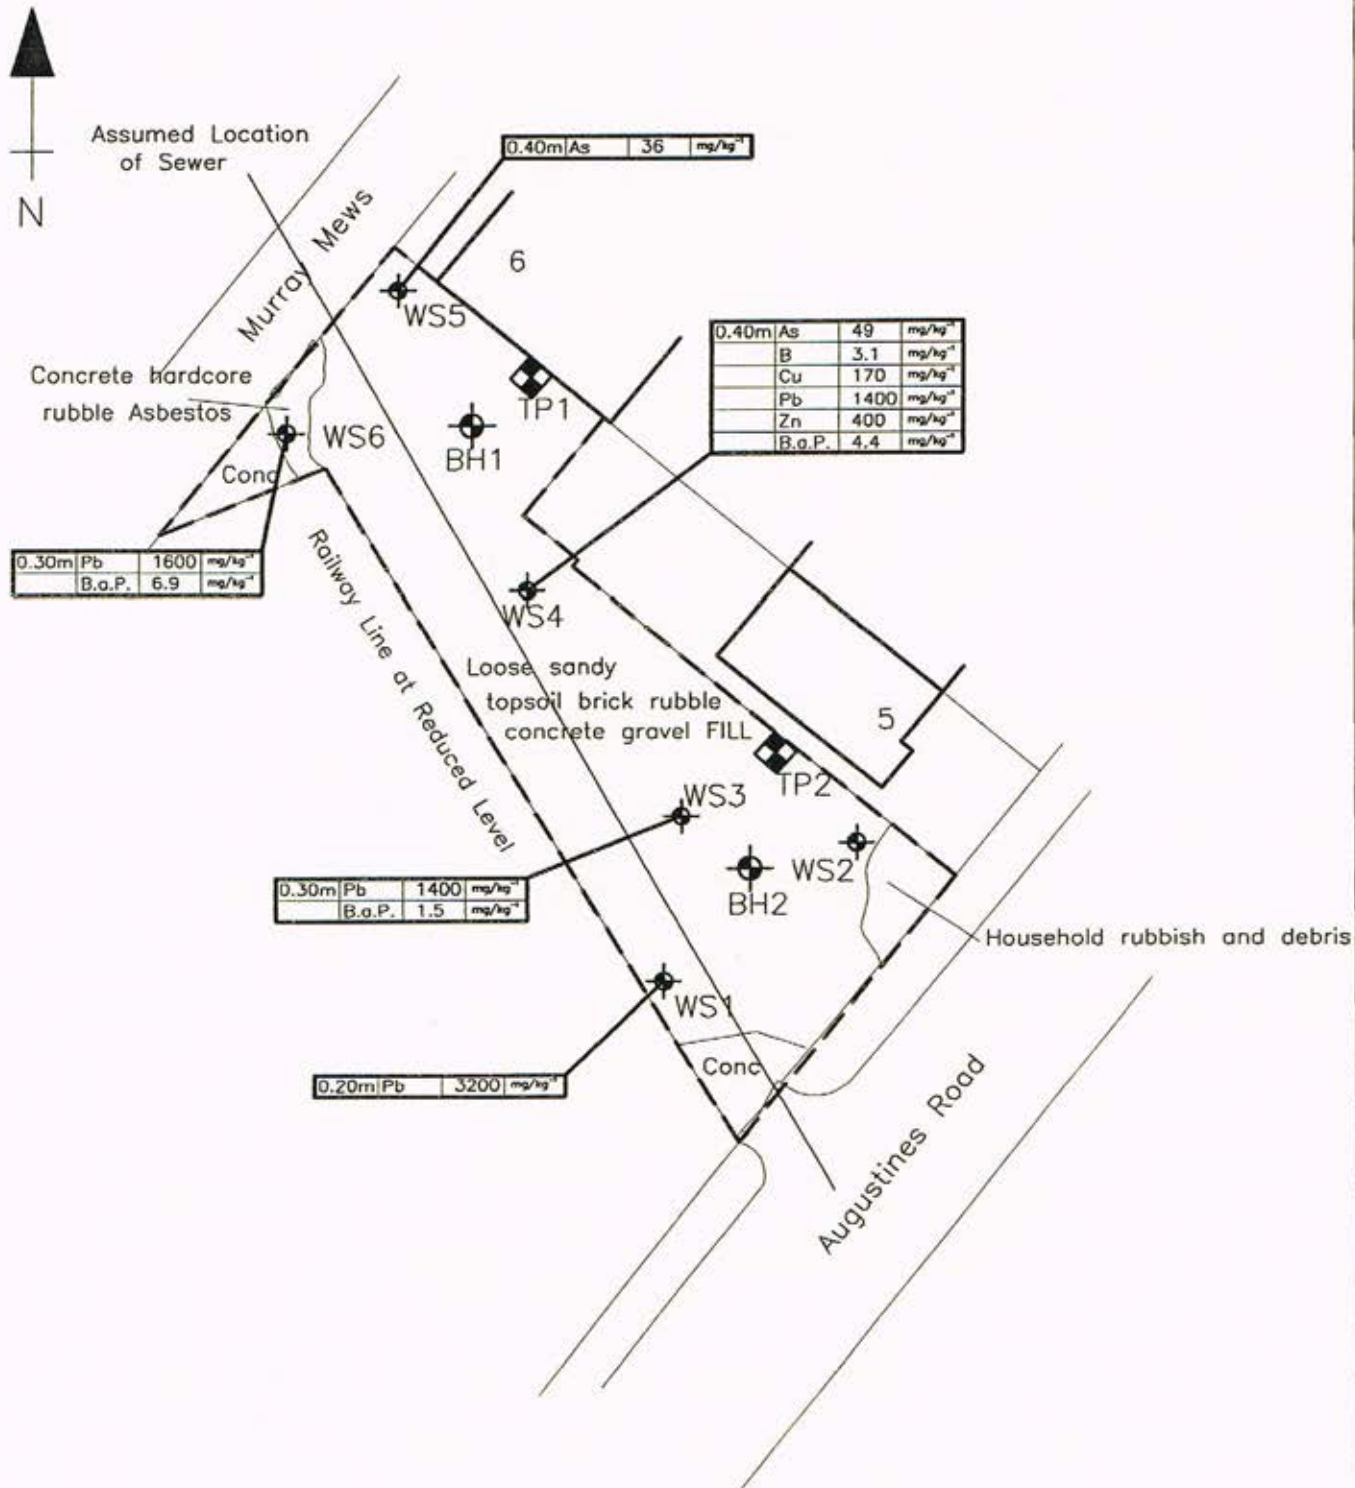
Existing Site Plan with Contamination Location

Within the assessment of zoning which has been undertaken in order derive areas of contamination we would suggest that no specific on site features would cause the site to contain specific levels of contamination. As such, we can only surmise that the risk from Benzo(a)pyrene and metal contamination is present resulting from depositional placement. As such, we consider this as one zone with the remaining site forming a further zone.

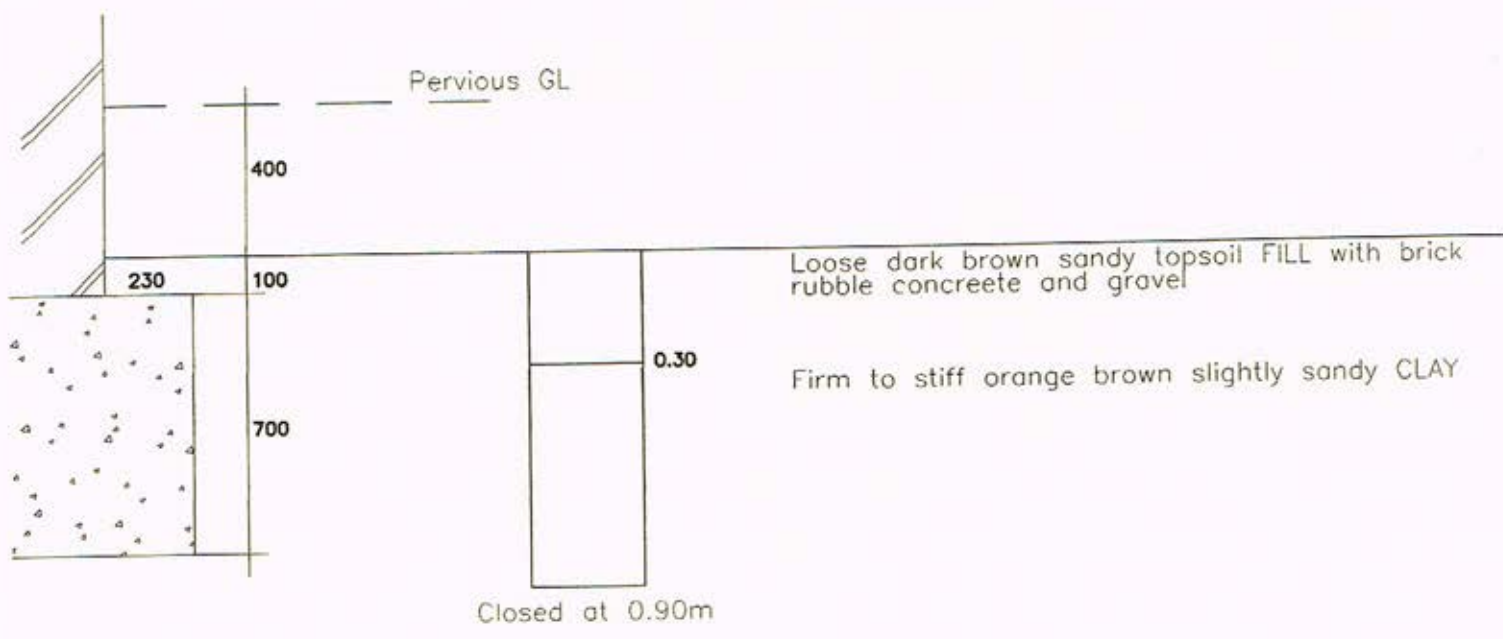
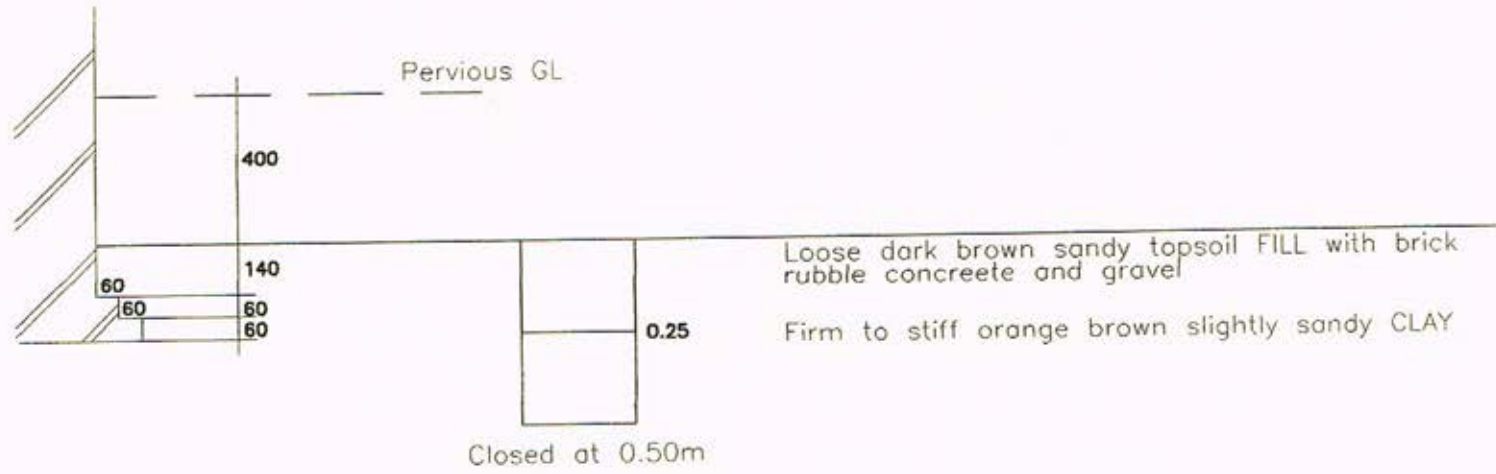
Trial Pit One

Existing Footing Detail
