METHOD STATEMENT

Christ Church, Albany Street NW1

Netting Removal and Tower and Cornice Repairs

Rev 01 · April 2023

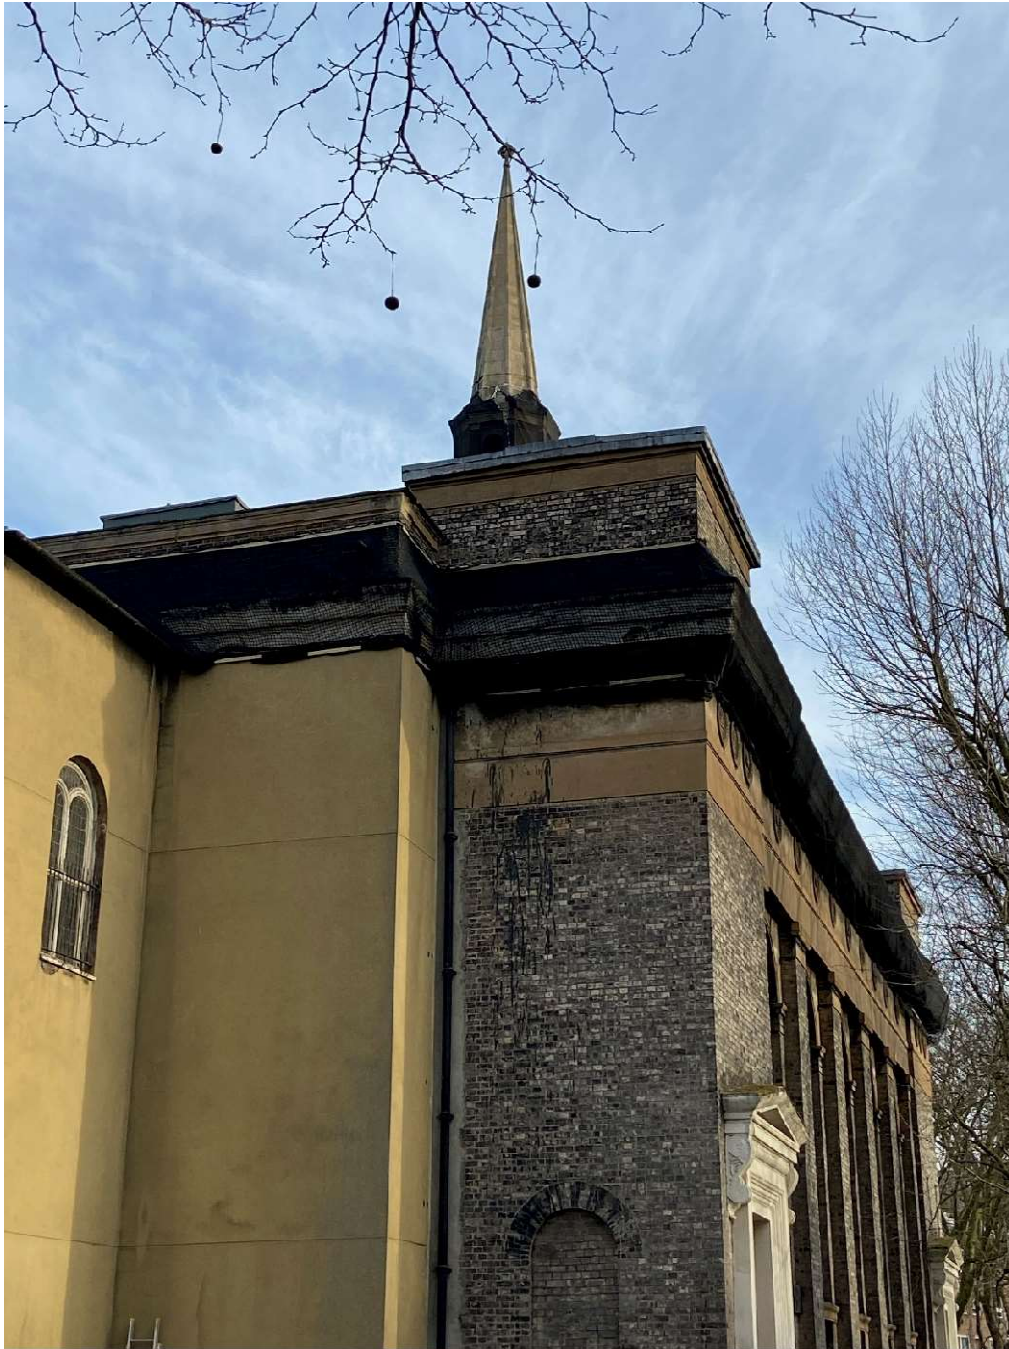
Img. 1; Netting installed to the cornice

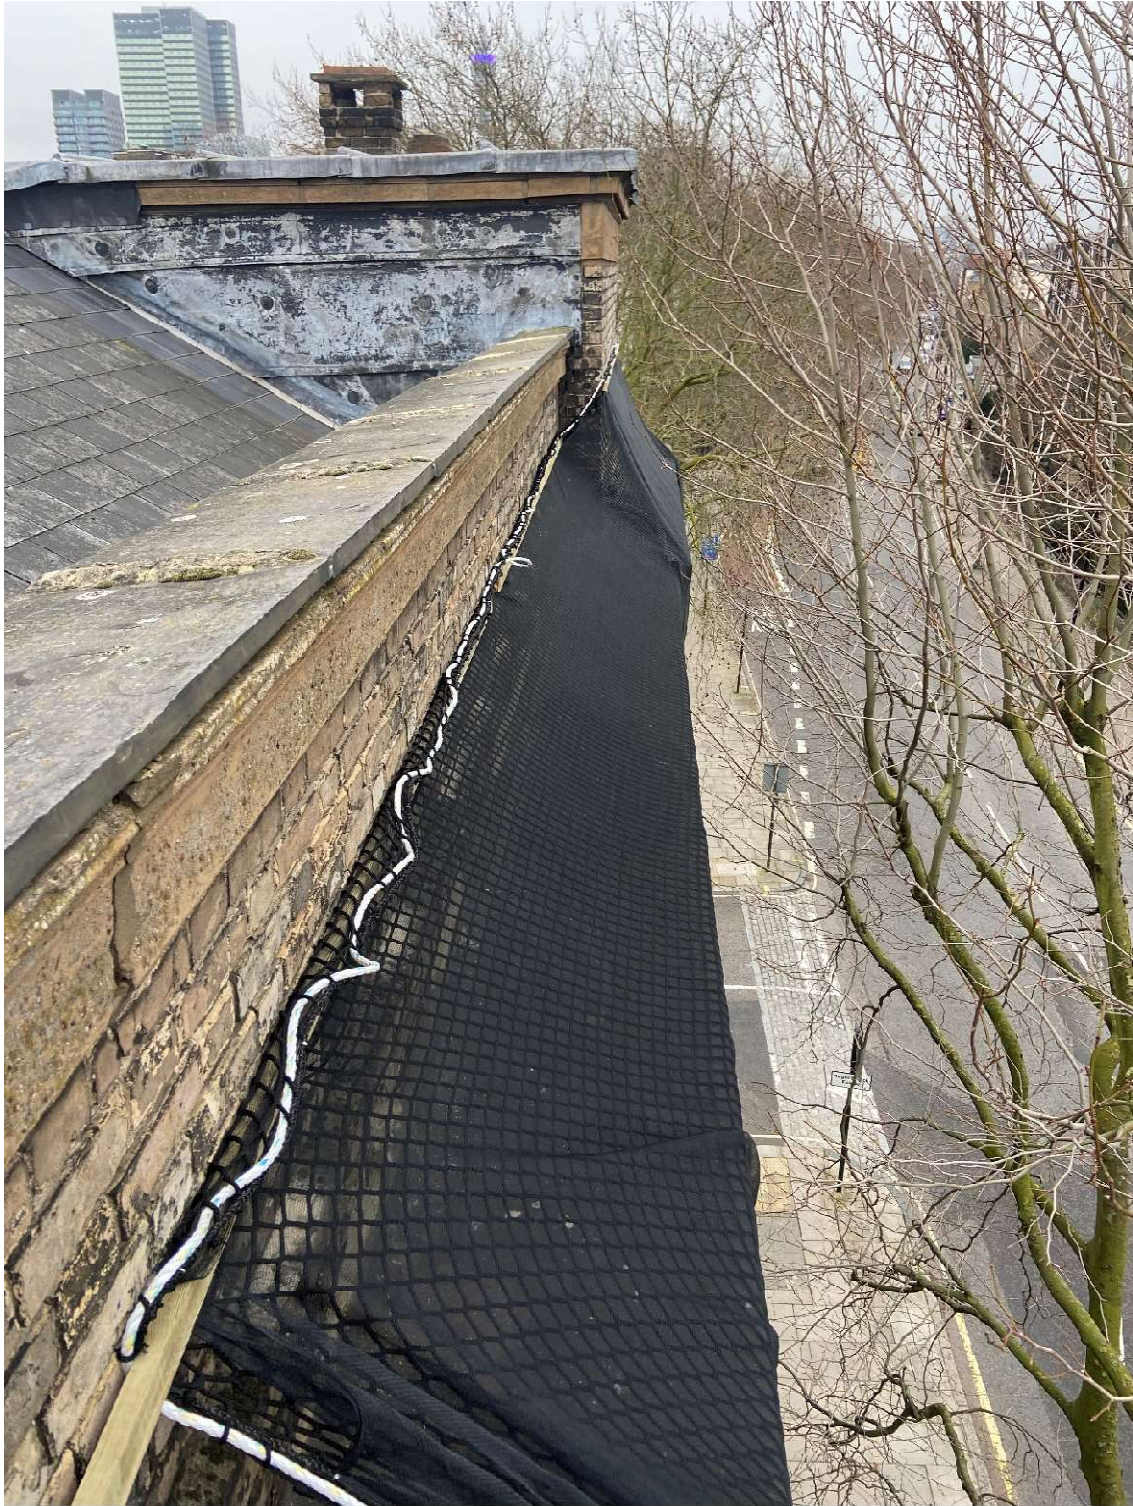
Img. 2; Close-up view of black netting installed to sky-facing edge of cornice

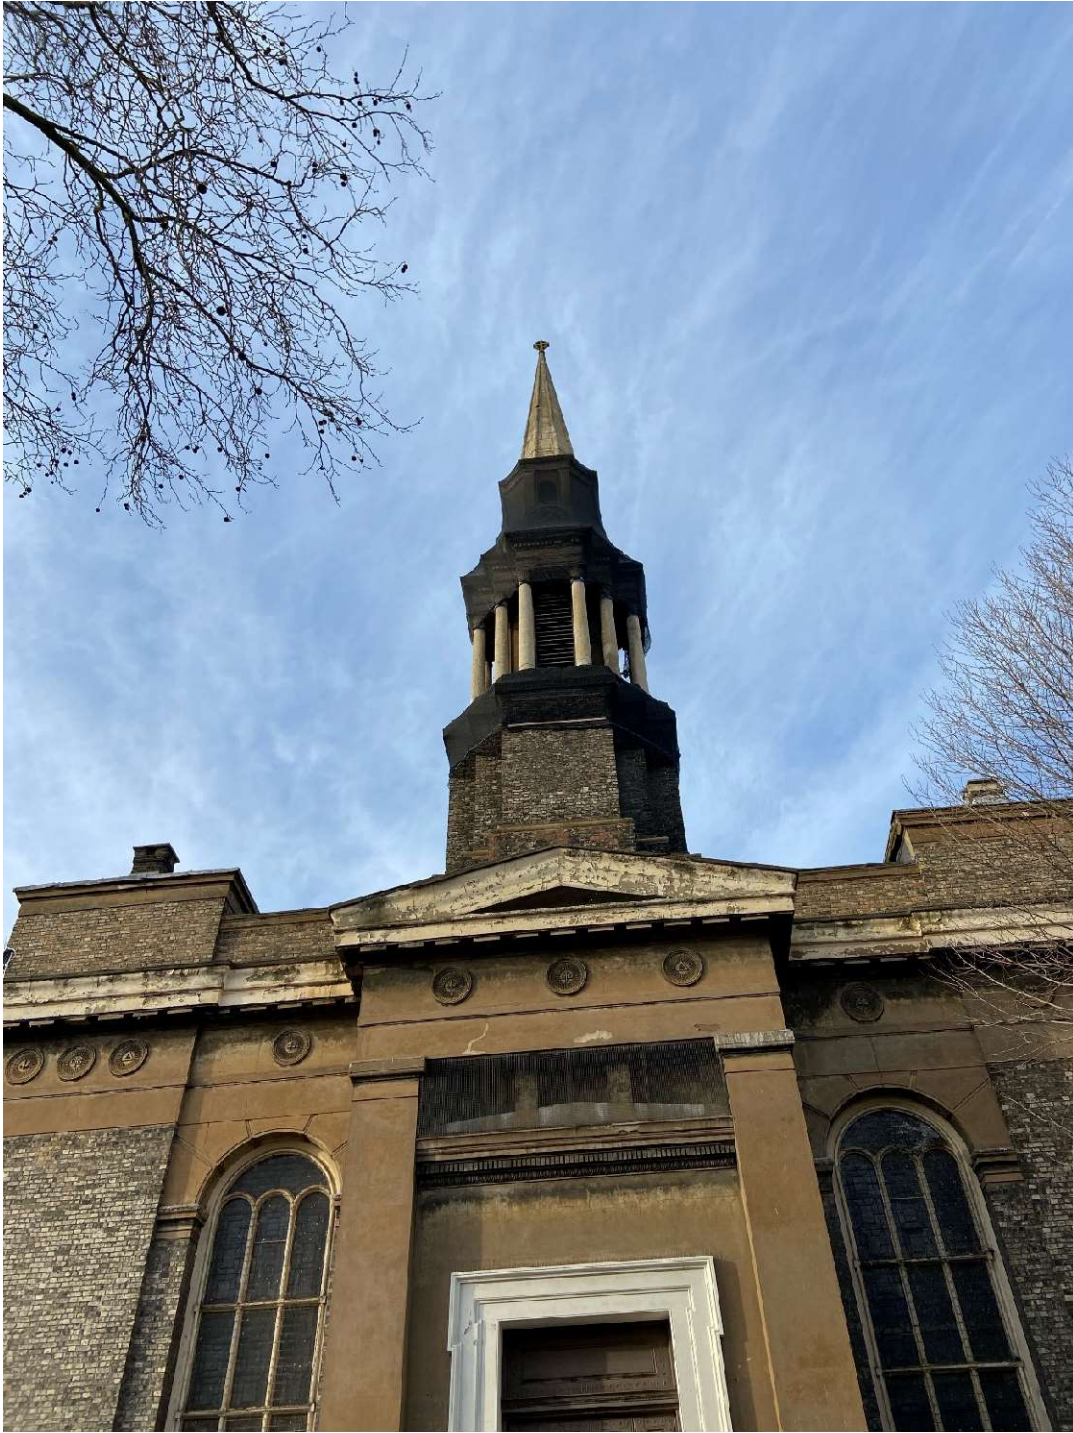
Img. 3; Black netting installed to tower
