SJ Stephens Associates

Tree Condition Survey

Gainsborough Gardens
London
NW3 1BJ

Survey Date: 7th February 2023
Report Date: 15th February 2023
Project no: 1540

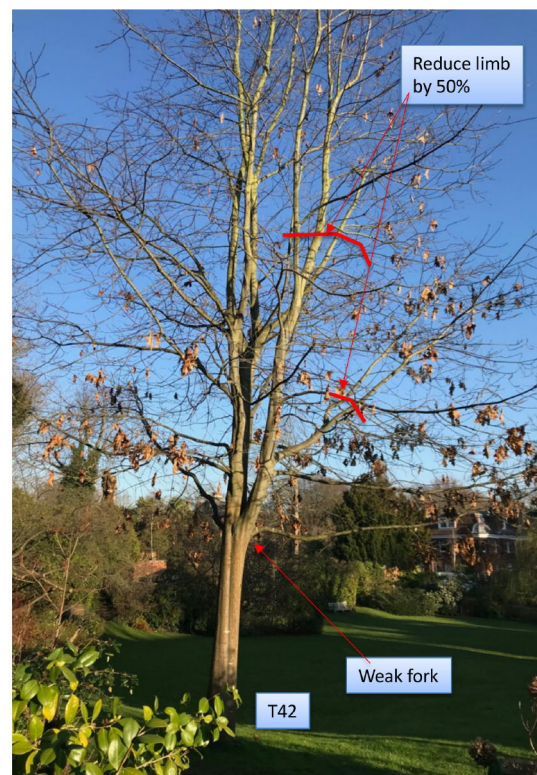
Appendix Eii)

T40	Turkey oak	17.5	610	6	6	6	6	0	Early mature	Good vigour.		>40	A		
T41	Horse chestnut	10.5	300	4	4	4	4	1.7	Semi- mature	Surface roots exposed, but showing good vigour.		>40	B		
T42	Red oak	11	280	4	5	4.5	3.5	1.7	Semi- mature	Included bark to major limb to south. Good vigour.	Reduce limb to south by 50% to encourage remainder of tree to dominate and avoid future problems, as shown in photo in Appendix Eii).	>40	B	0.5	Medium
