# Bartlett Consulting

## TREE HEALTH & STRUCTURAL INTEGRITY REPORT

**Date:** 7<sup>th</sup> January 2019

257 Goldhurst Terrace,  
London  
NW6 3EP

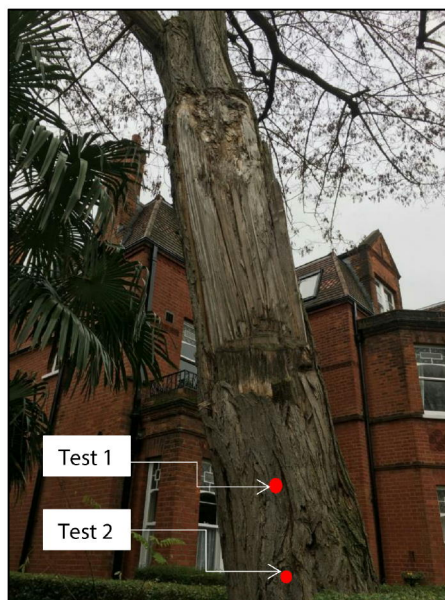
Figure 2: Image Showing Resistance Micro-drill Testing Locations on False Acacia within the eastern quadrant

A total of 2 tests were conducted within the eastern quadrant of the main stem of the False Acacia at 1.3m & 2.0m height above ground level. The aim of the testing was to establish the extent of the tear below that visually identifiable. Both drill test locations are highlighted by a red dot within figure 2 below.

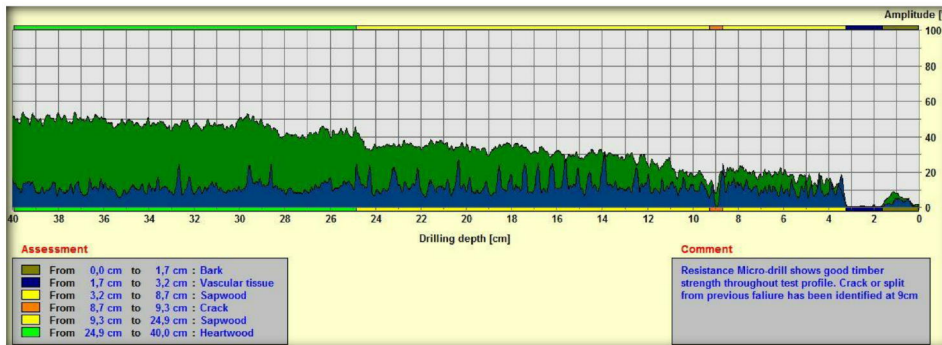
Test 1 Eastern Quadrant at 2.0m above ground level

Test 1 located within the eastern quadrant directly below the wound (2.0m height above ground level) clearly identifies the presence of a small internal crack / split at 9cm resulting from the previous failure of the northern co-dominant leader.

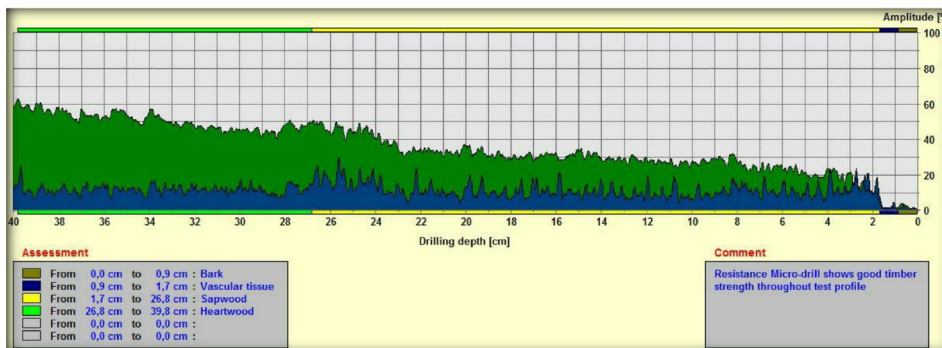
Test 2 Eastern Quadrant at 1.3m above ground level

Test 2 located directly below test 1 at a height of 1.3m above ground level did not identify the continuation of the crack or split at this level and shows good structural integrity of the main stem with no decay or dysfunction continuing vertically down the stem from the wound.

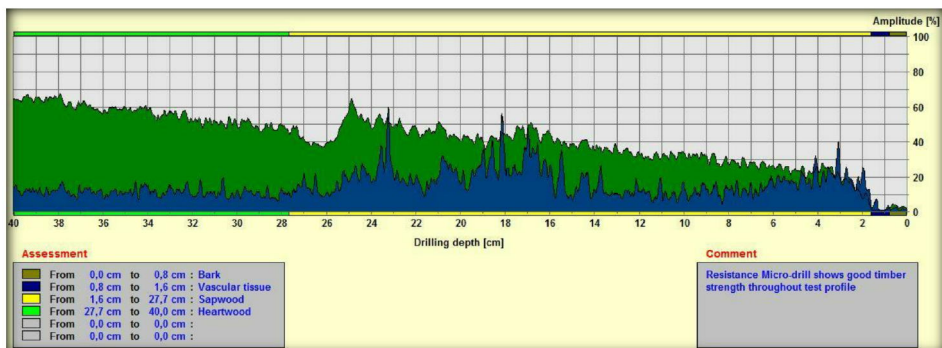
Test 3: Control test northern quadrant at 1.0m above ground level

Whilst comparing the three test results, the Resistance Micro-drill (IML Resi PD400) shows that the general resistance through the zones of vascular tissue and sapwood is good and consistent, when compared to the control test, as shown with the green graph (drilling curve). The amplitude is found to be ranging between 20% and 40%, where the differences in wood resistance are better distinguished.

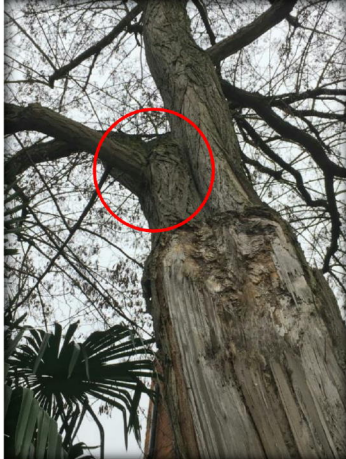
*Image 3: as viewed from a northern aspect showing the extent of the wound and partially included union of the subordinate leader at 7.0m highlighted above*

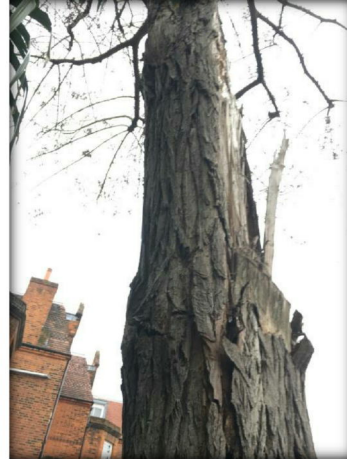
*Image 4: as viewed from an eastern aspect showing approximately 35% loss of main stem at 2.5m*

Failure and subsequent loss of the northern co-dominant leader in 2016 has resulted in a significant wound and exposed heartwood leaving the tree vulnerable to the spread of decay and fungal pathogens. Furthermore, we consider that the failure has structurally compromised the main stem with an estimated 35% loss of timber representing over 1/3 of the stem circumference. The tree has responded to the failure through the development of wound-wood (a barrier zone) around the edges of the wound; however, this new growth is unlikely to ever fully compensate for the loss in timber strength or ever fully occlude the wound.

Taking into account all the above mentioned factors, we must regrettably conclude the removal of this tree is deemed the most appropriate course of action. The replacement planting of a more appropriate tree for the location will go some way into mitigating for the loss.

Tree Reference	Specification of Works
False Acacia	<ul style="list-style-type: none"> <li>•Fell &amp; Remove</li> <li>•Replant with appropriate specimen tree</li> </ul>

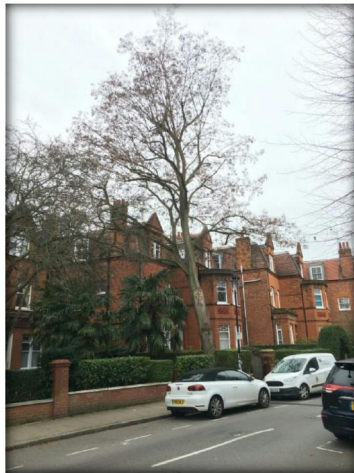
*Image 5: View of tree from an eastern aspect highlighting the lean on stem and its asymmetrical crown*

The loss of the northern co-dominant leader has also resulted in an unbalanced crown with a bias to the south in the direction of the residential properties, which has resulted in excessive static loading on the tension aspect of the main stem and area of failure and wounding. If failure of the main stem was to occur it would most likely fall in the direction of the two properties.

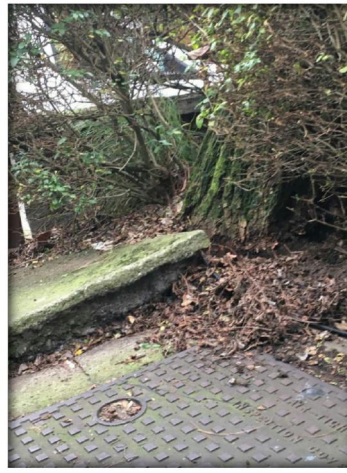
*Image 6: Direct damage caused by tree to the private path in proximity to drain*

Direct damage caused by the trees incremental growth has been observed to both the boundary wall and private path causing significant amounts of movement as shown in image 6.
