Geotechnical Survey Report

FSI Ref: [REDACTED]
Issue Date: January 2023
Risk Address: 14 Eton Avenue
London
NW3 3EH

Property Address: 14 Eton Avenue, London, NW3 3EH

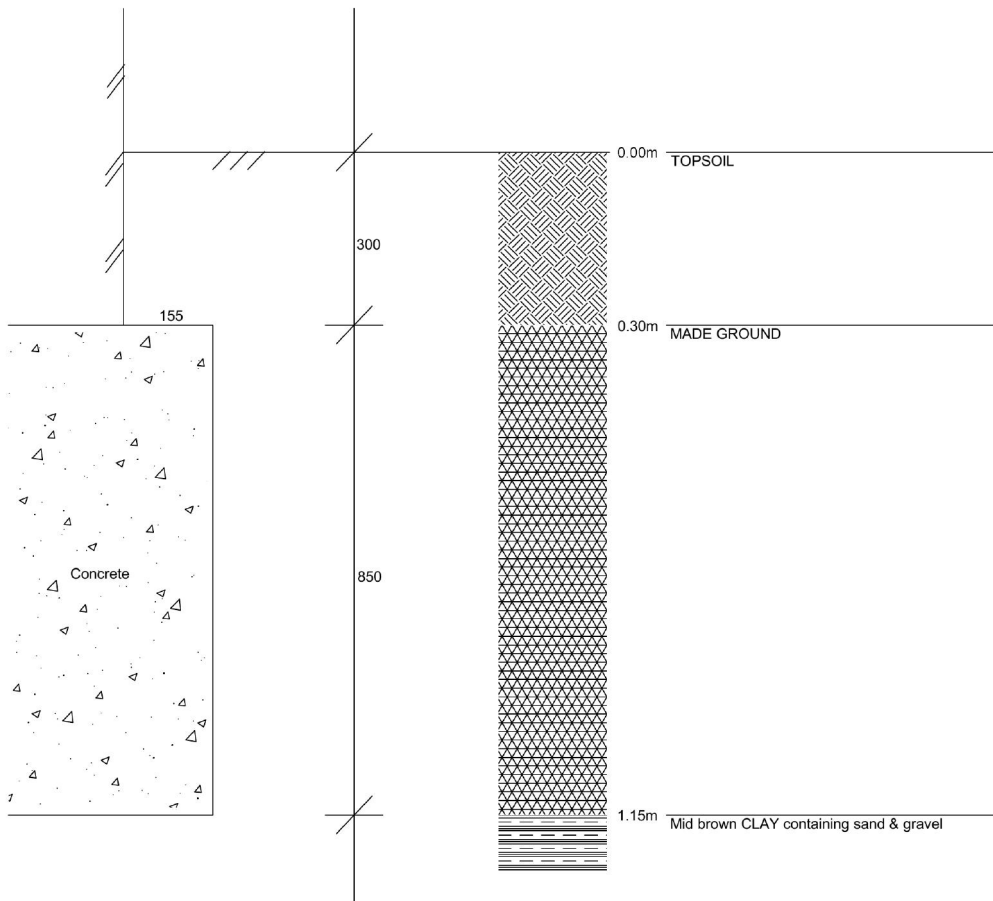
TRIAL PIT 1

D1 @ F.L. (1.15m)
V = 57-62kPa
Founding strata: Mid brown CLAY containing sand & gravel
