Arboricultural Appraisal Report

Subsidence Damage Investigation at:

14 Eton Avenue
London
NW3 3EH

CLIENT:	Crawford & Company
CLIENT REF:	[REDACTED]
MWA REF:	[REDACTED]
MWA CONSULTANT:	Giles Mercer B.SC Hons
REPORT DATE:	10/04/2023

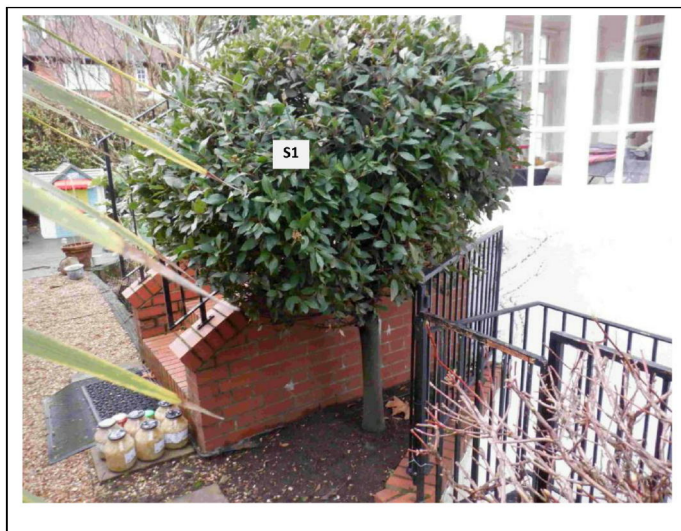
View of S1

Irrespective of the identification of recovered root samples, the roots of the Bay Laurel (S1) and the Fatsia (S3) are also likely to be present below foundation level in proximity to the area of movement/damage and influencing soil moisture and volumes.

If an arboricultural solution is to be implemented to mitigate the influence of the implicated trees/vegetation we recommend that the Magnolia (S2), the Bay Laurel (S1), the Fatsia (S3) and the Palm (T1) are removed. Other vegetation recorded presents a potential future risk to building stability and management is therefore recommended.

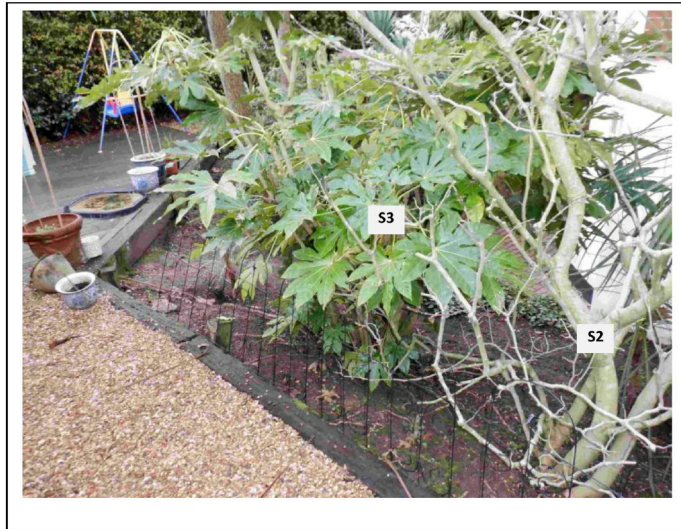
View of S2 & S3

Roots were observed to a depth of 2.0m bgl in TP/BH1 and recovered samples have been positively identified (using anatomical analysis) as Magnolia spp., Monocotyledon spp. and probably Sambucus spp. Our survey has identified the Magnolia (S2) and the Palm (T1), we are confident that these are the source of the Magnolia spp. and Monocotyledon spp. roots. No significant source was identified for the Sambucus root. We believe that this root emanates from either very small or historically removed vegetation and we do not consider that it represents a material influence in the current subsidence event.

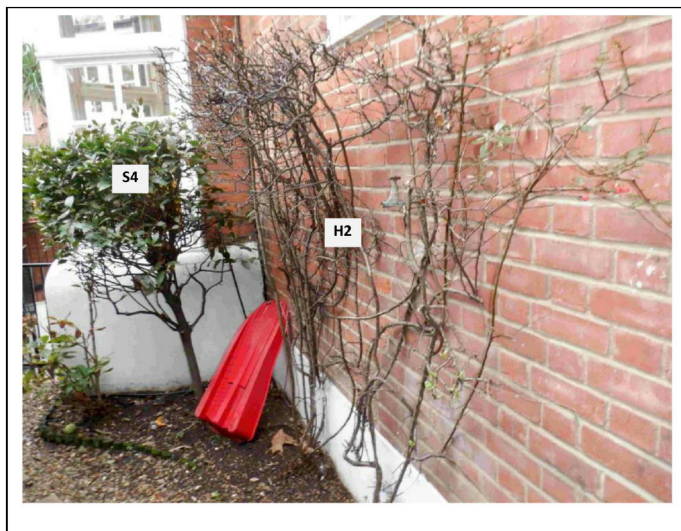
View of S4 & H2

S4	Laurel (Bay)	1.8	10 *	1	0.46	Younger than Property	Policy Holder
Management history		No significant recent management noted.					
Recommendation		Remove (fell) to near ground level and treat stump to inhibit regrowth.

Recommendation		Do not allow to exceed current dimensions.

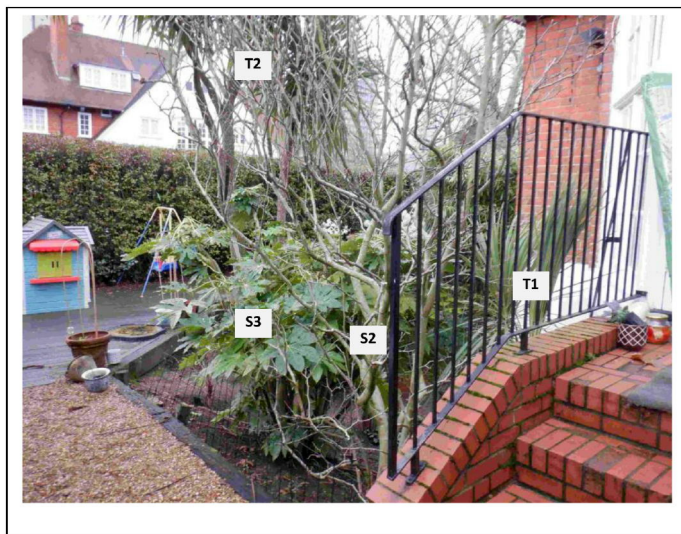
View of T1, T2, S2 & S3

Based on the technical reports currently available, engineering opinion and our own site assessment we conclude the damage is consistent with shrinkage of the clay subsoil related to moisture abstraction by vegetation. Having considered the information currently available, it is our opinion that the Magnolia (S2), the Bay Laurel (S1), the Fatsia (S3) and the Palm (T1) are the principal cause of or are materially contributing to the current subsidence damage.
