## SITE INVESTIGATION FACTUAL REPORT

Report No: [REDACTED]  
Client: Crawford Claims Management  
Site: Flat 2, 34 Frognall  
Client Ref: [REDACTED]  
Date of Visit: 16/01/2020

# Drainage Layout Plan

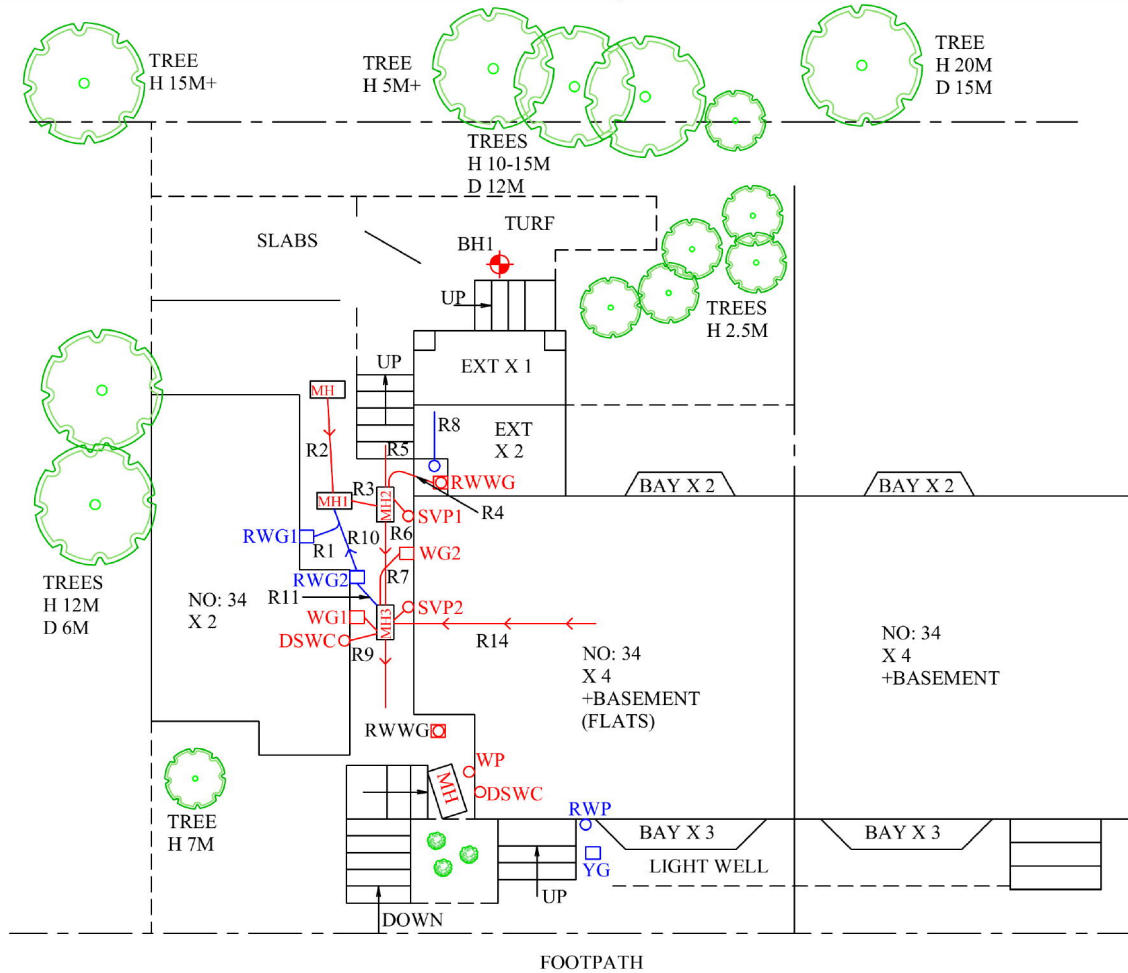
| 0.10 | LR | | | | | | slight | slabs | 1 | |
| 0.60 | JDM | | | | | | Joint displaced medium | | | |
| 0.90 | JDL | | | | | | Joint displaced large | | | |

Remarks: MH3 upstream to WG 2 - Run 12. Excavate and replace gully plus pipe work downstream to manhole 3.

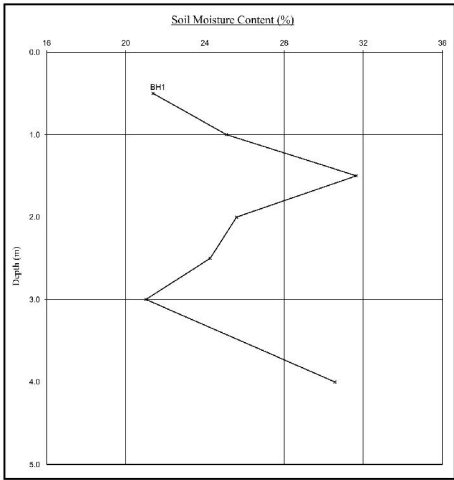
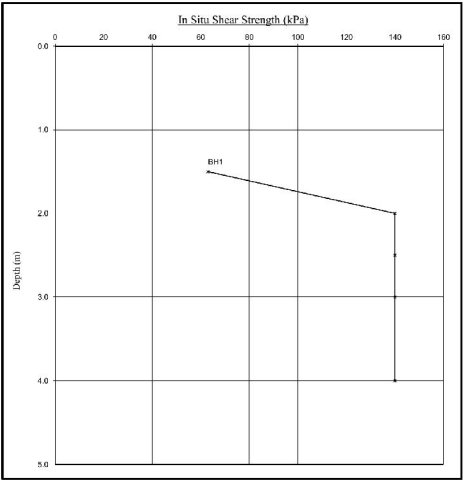
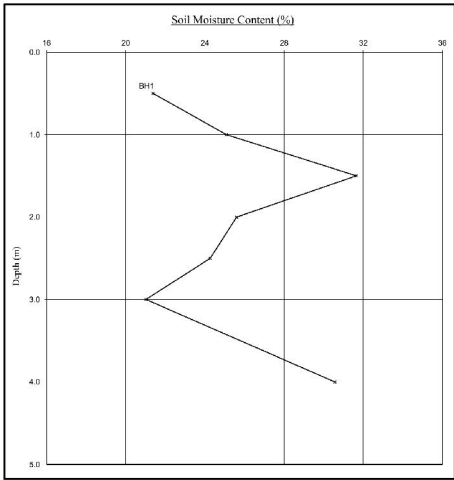
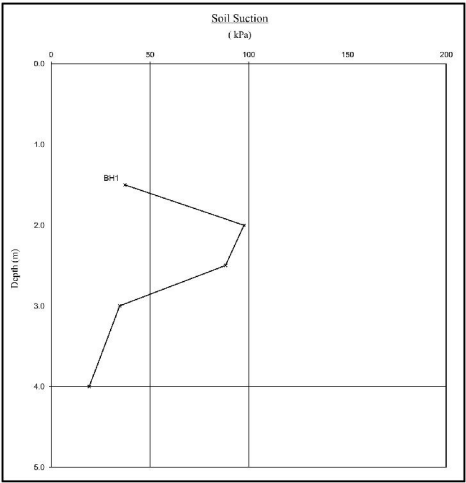
| Remarks:<br>BH ends at 4.0m. Water seepage at 3.0m. BH open with standing water level at 3.7m on completion. No roots observed below 3.0m. | | | | | Key:<br>D - Disturbed Sample<br>B - Bulk Sample<br>W - Water Sample<br>J - Jar Sample<br>V - Pilon Shear Vane (kPa)<br>M - Mackintosh Probe<br>TD - Too Dense To Drive |
