TECHNICAL REPORT ON A SUBSIDENCE CLAIM

**Flat 2, 34 Frognall
London
NW3 6AG**

SUBSIDENCE CLAIM

22nd November 2019

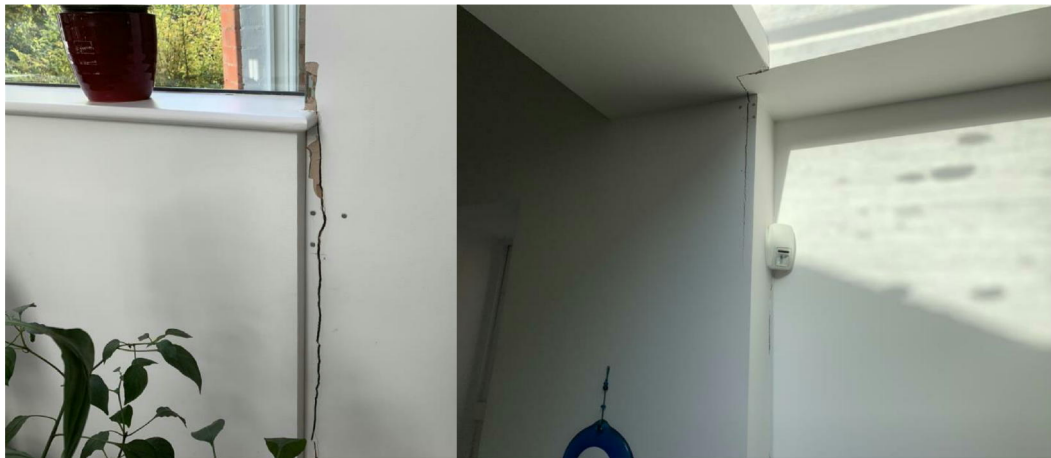
Rear Lounge Extension (Conservatory)

Right junction

Left junction

Tapering vertical crack at left junction with rear wall of main house, extending into roof light area.

Tapering vertical crack at right junction. Additional fine hairline vertical crack.

Tapering vertical crack on right wall at mid-point.

Slight displacement/pulling of window units in roof light at junction with rear wall of main house.

Rear door frame slightly out of square rendering door catching.

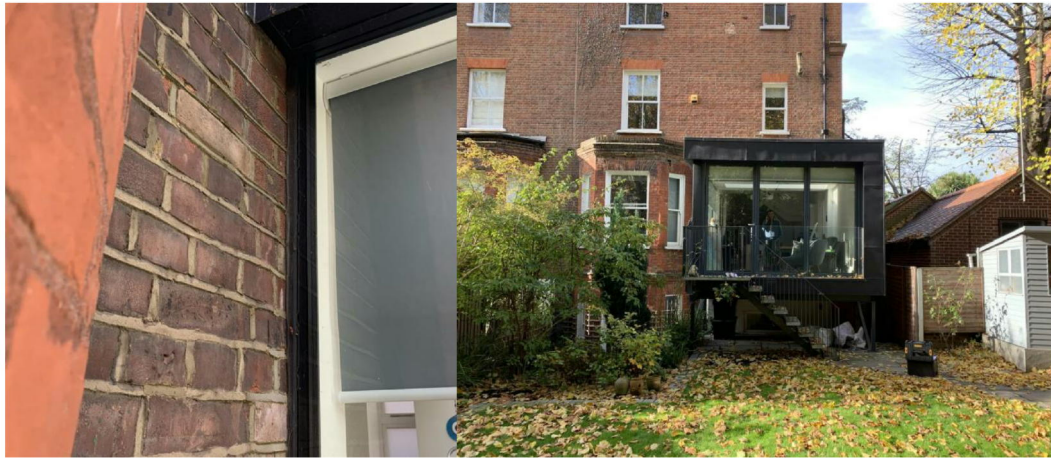
View from rear

Right junction

Left Elevation

Tapering vertical crack at junction of original projection with rear wall of house, extending partly as a stress crack on the rear of the original house.

Diagonal and vertical crack on left flank wall above door to kitchen on lower ground floor flat.

Right Elevation

Slight displacement between conservatory structure and rear wall of house.

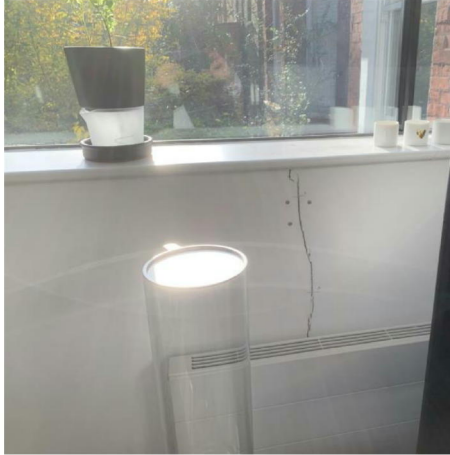
Right mid-point

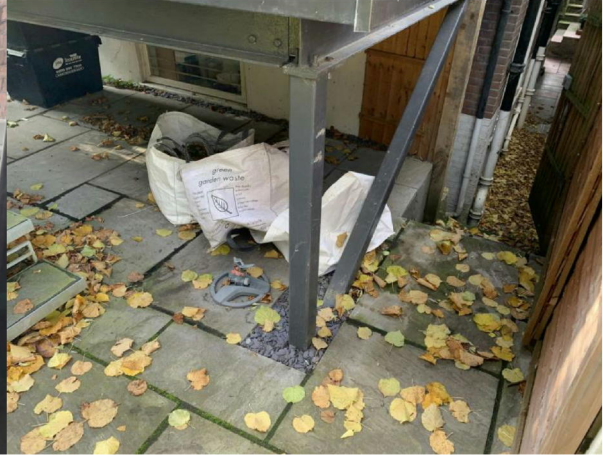
Steel supports, reportedly on pad footings
2.5m-3m deep

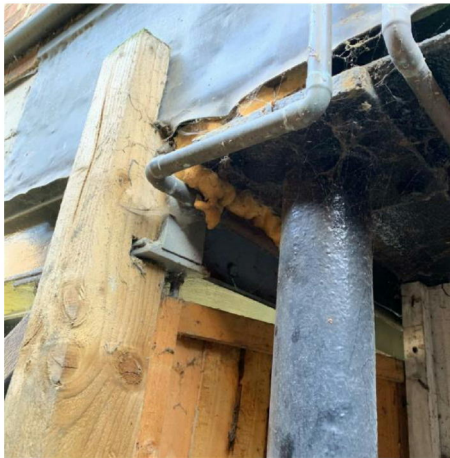
Supporting columns to original projection

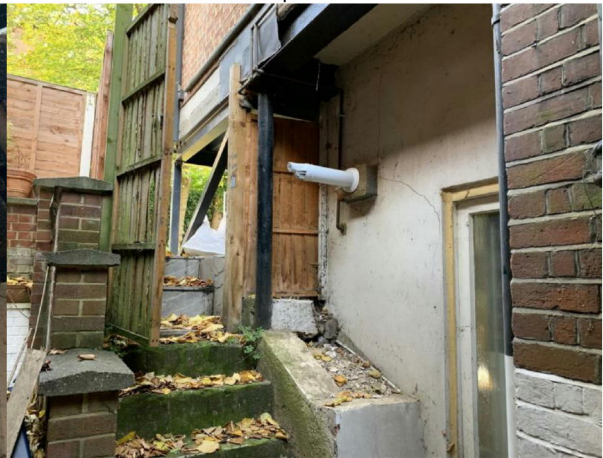
Supporting column to original projection
and diagonal crack on lower ground flat
wall

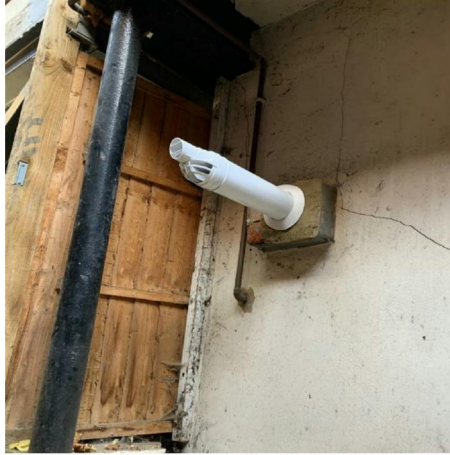
Lower ground falt - cracking above door at rear junction

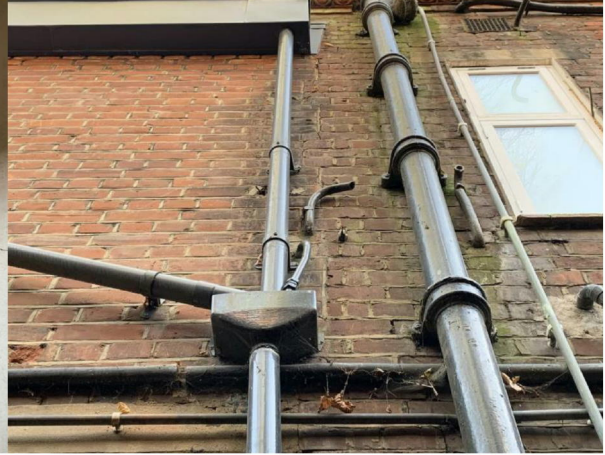
Cracking at junction on left flank wall

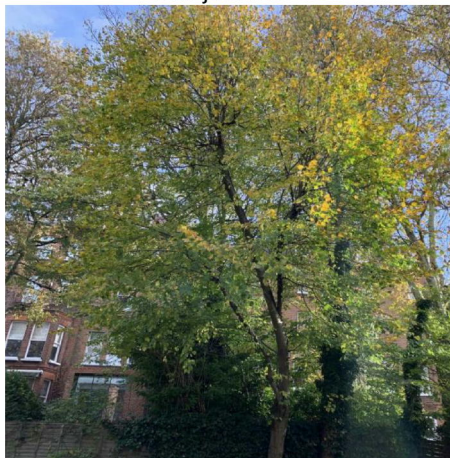
Protected Lime trees at rear

Although the cause of the movement needs to be dealt with, we note the vegetation is subject to a Preservation Order. Unfortunately, current legislation requires certain investigations to be carried out to support an application for the tree works.

It will also be necessary to obtain a specialist Arboricultural Report.

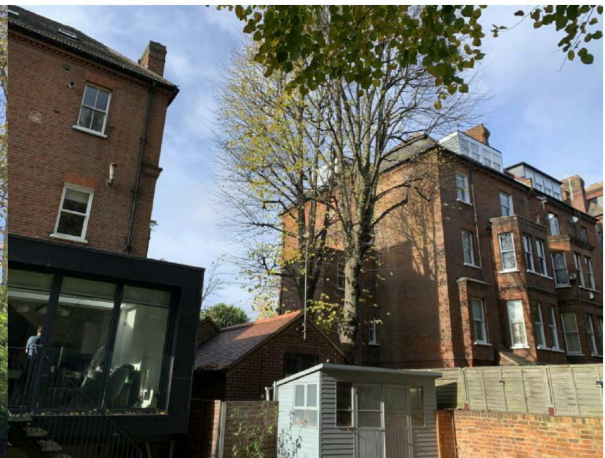
Lime trees to side, behind neighbouring property built on original drive for house
