## Revised Arboricultural Appraisal Report

### Subsidence Damage Investigation at:

Flat 2, 34 Frognal  
London  
NW3 6AG

| REPORT DATE: | 04/05/2020 |

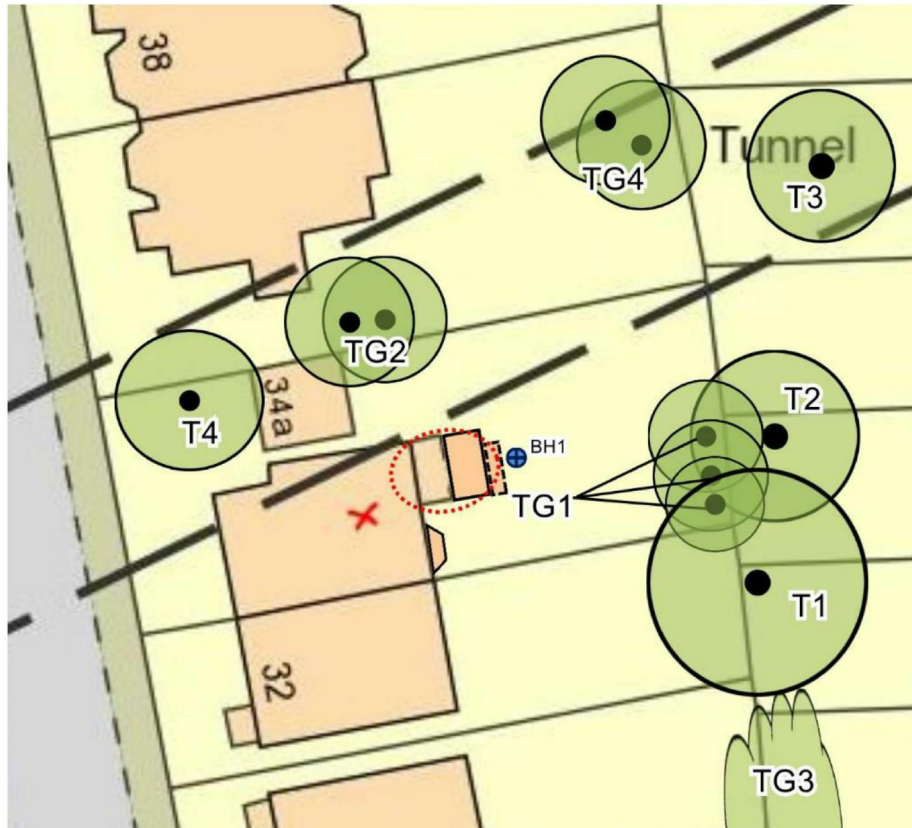
Site Plan

Approximate areas of damage

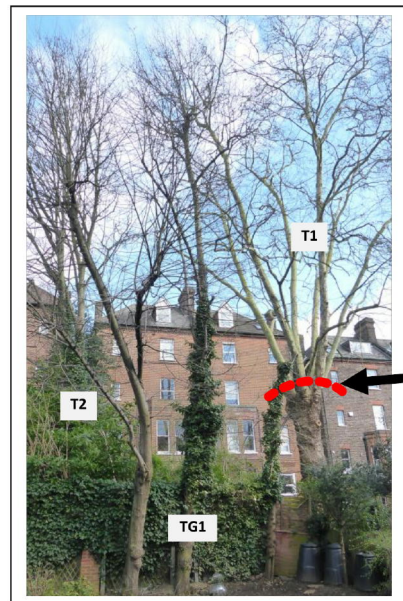
Roots were observed to a depth of 3.0m bgl in BH1, and recovered samples have been positively identified (using anatomical analysis) as *Platanus* spp. and *Tilia* spp.; the origins of which will be T1 London Plane and most likely the TG1 Lime group, however the TG2 Lime group is also within influencing distance and may account for retrieved samples.

Irrespective of the identification of recovered root samples, the roots of T2 Sycamore are also likely to be present below foundation level in proximity to the area of movement/damage and contributing to the influence of soil moisture and volumes.

Based on the technical reports currently available, engineering opinion and our own site assessment we conclude the damage is consistent with shrinkage of the clay subsoil related to moisture abstraction by vegetation. Having considered the information currently available, it is our opinion that T1 London Plane, T2 Sycamore and TG1 Lime group are the combined cause of the current subsidence damage. TG2 Lime group has recently been pollarded, and so any current involvement is at present equivocal.

View of T1 London Plane, TG1 Lime group and T2 Sycamore

If an arboricultural solution is to be implemented to mitigate the influence of the implicated trees/vegetation we recommend that T1 London Plane is pollarded, T2 Sycamore and TG1 Lime group are removed. Other vegetation recorded presents a potential future risk to building stability and management is therefore recommended.

| Tree No. | Species | Ht (m) | Dia (mm) | Crown Spread (m) | Dist. to building (m) | Age Classification | Ownership |
|---|---|---|---|---|---|---|---|
| Recommendation | | Pollard at previous reduction @ approx. 6m. See photos below. Pollard on a triennial cycle. | | | | | |
| Recommendation | | Remove (fell) to near ground level and treat stump to inhibit regrowth. | | | | | |

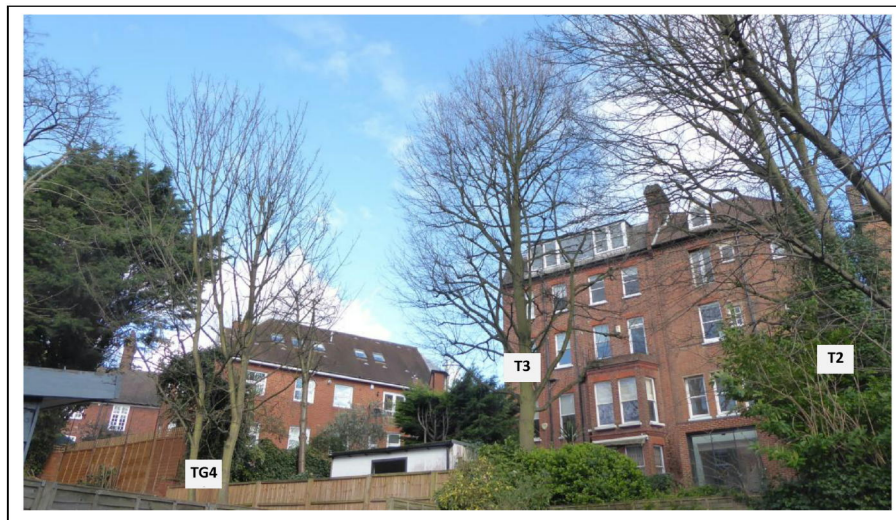
View of T3 Lime and TG4 Sycamore group with T2 Sycamore visible to right of frame

| Tree No. | Species | Ht (m) | Dia (mm) | Crown Spread (m) | Dist. to building (m) | Age Classification | Ownership |
|---|---|---|---|---|---|---|---|
| Recommendation | | Maintain broadly at no more than current dimensions by periodic pruning. | | | | | |

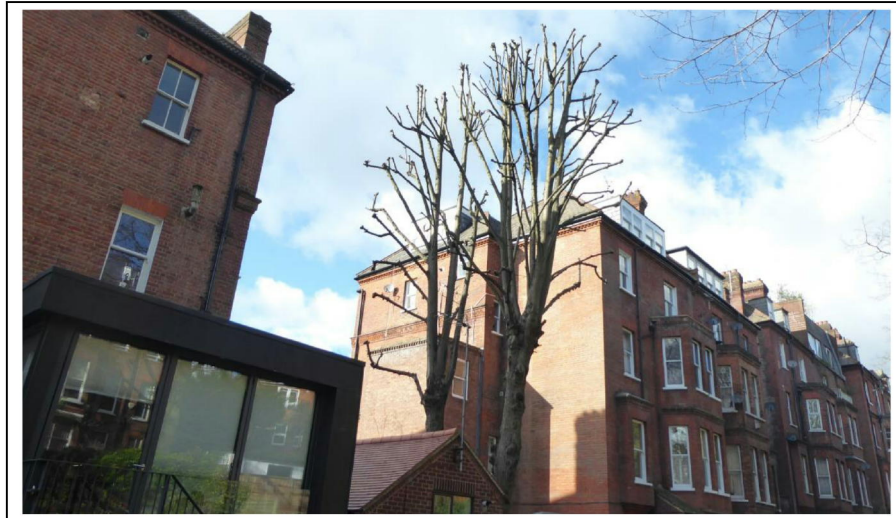
| Tree No. | Species | Ht (m) | Dia (mm) | Crown Spread (m) | Dist. to building (m) | Age Classification | Ownership |
|---|---|---|---|---|---|---|---|
| Management history | | Subject to past management/pruning – recently pollarded at current dimensions and historically pollarded at approx. 6.5m. | | | | | |

View of TG2 Lime group

| Tree No. | Species | Ht (m) | Dia (mm) | Crown Spread (m) | Dist. to building (m) | Age Classification | Ownership |
|---|---|---|---|---|---|---|---|
| Recommendation | | Maintain broadly at no more than current dimensions by periodic [triennial] re-pollarding. | | | | | |

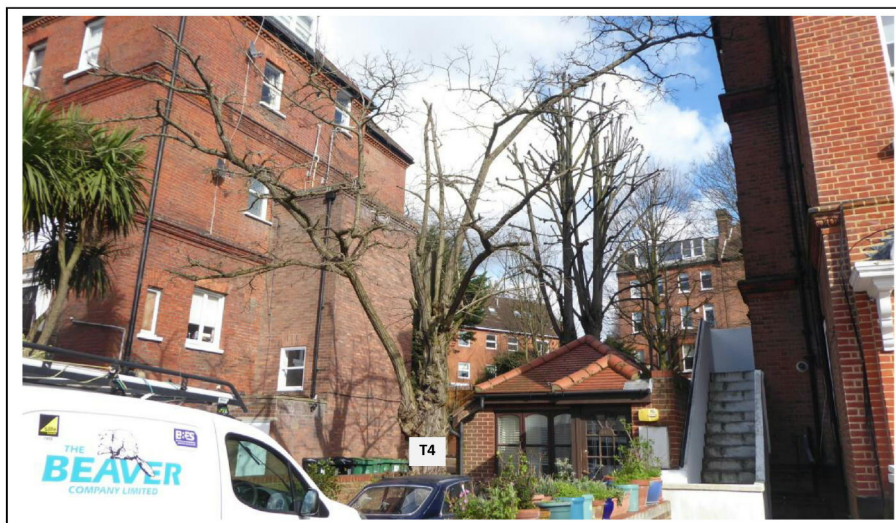
View of T4 False Acacia

| Tree No. | Species | Ht (m) | Dia (mm) | Crown Spread (m) | Dist. to building (m) | Age Classification | Ownership |
|---|---|---|---|---|---|---|---|
| Recommendation | | Maintain broadly at no more than current dimensions by periodic pruning. | | | | | |
