10-11 Doughty Street, London WC1N 2PL

Structural engineer's report and feasibility

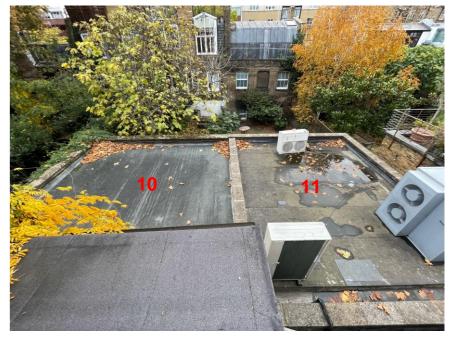
CHARTERED STRUCTURAL ENGINEERS | SUSTAINABLE DRAINAGE DESIGN | PARTY WALL DESIGN-FOCUSED SUSTAINABILITY-DRIVEN ENGINEERING Figure 2: View of rear extension roofs to no.10 & no.11

No significant structural defects were observed to the single-storey rear extension.

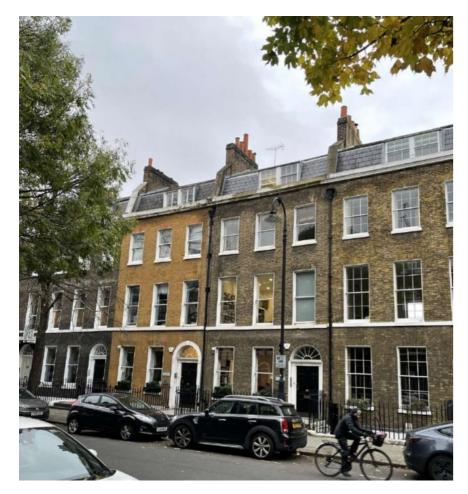
Figure 3: Front Elevation 10-11

The front elevation appears to be in reasonable condition and comprises of rendered up to ground floor with exposed brickwork above and a tiled mansard roof at fourth floor level.

Some slight staining to the brickwork below was observed and some spalling to the brickwork seen but no significant structural defects were observed.

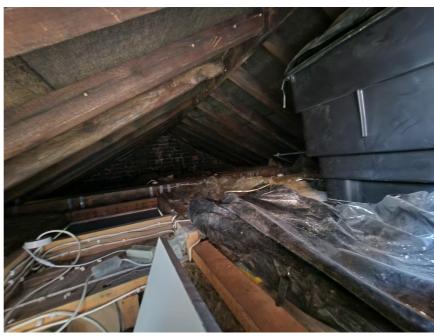
Figure 4: Existing Roof Construction no11

The main roof rafters are 95x65 timbers at c.440mm centres with central ridge board.

There are signs of historic water ingress, and some local areas of damp however no significant structural defects were observed in the areas that were accessible.

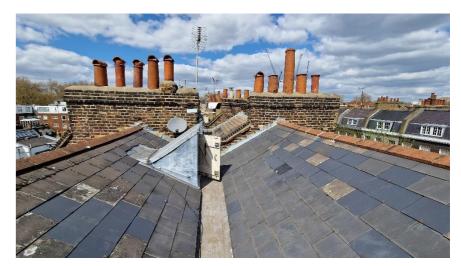
Figure 5: Existing Roof Construction no.10

Strengthening works have been carried out to support the water tanks within the roof space. These works include the addition doubled up timber joists positioned above the existing loft floor construction.
