# ARBORICULTURAL ASSESSMENT REPORT

18 Bartholomew Villas, London, NW5 2LL

Survey Date: 27/02/2023

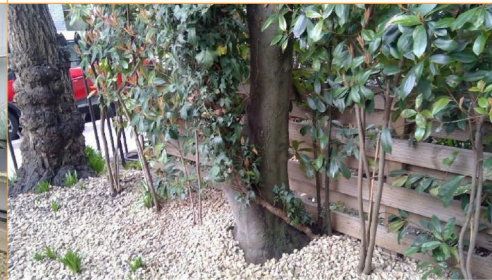
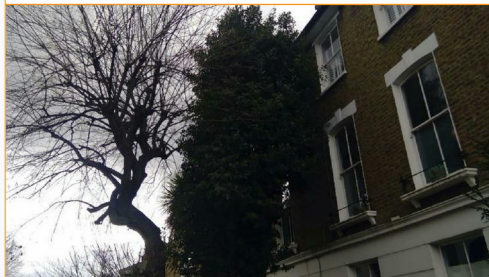
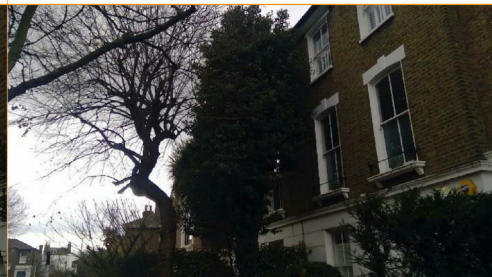
T2 - Laurel (Bay)

Tree No:	Species	Works Required
T2	Laurel (Bay)	Fell and treat stump with eco plugs (broadleaved)
T3	False Acacia	Fell and treat stump with eco plugs (broadleaved)

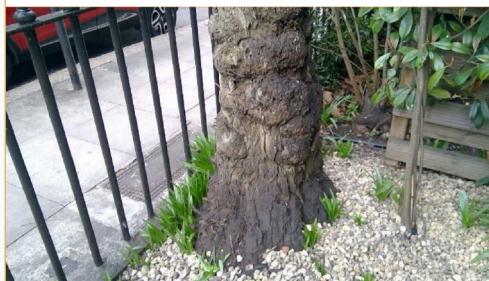
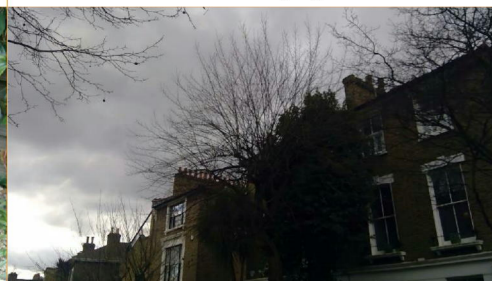
T3 - False Acacia
