Property Risk Inspection
LIMITED

ARBORICULTURAL ASSESSMENT REPORT

80 Camden Road, London, NW1 9DU

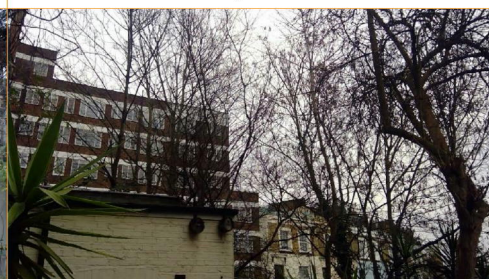
TG1 - Sycamore

TG1	Sycamore	Early Mature	Good	15*	4	450*	14*	N	No significant past tree works.	No work required.	Restricted access.	Large group of sycamore tree along River bank	London Borough of Camden	LA
SG1	Rose	Early Mature	Good	1.5	1.0	30	4.5	N	Subject to past management.	No work required.	Access through building.		80 Camden Road, London, NW1 9DU	PH
T9	Plum	Mature	Fair	10*	3.0*	250*	9*	N	Pollarded with approximately 3 years regrowth.	No work required.	Restricted access.		78 Camden Road, London, NW1 9DU	P3P
