Planning and Listed Building Consent

These additional photographs are submitted in support of the application **2023/0956/L** for the replacement of non-original glazed timber doors and windows to the rear second floor of 5 The Grove N6 6JU.

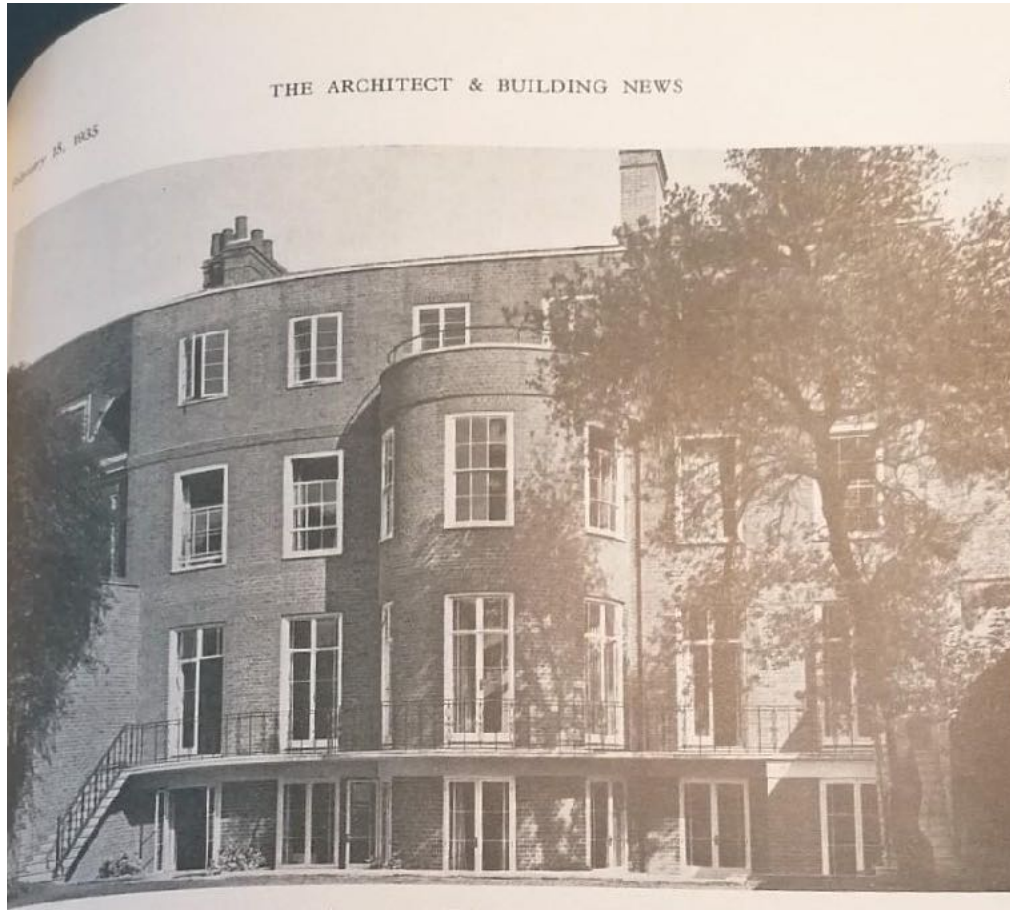
Right above:

Photograph of the original rear elevation of no. 5 The Grove.

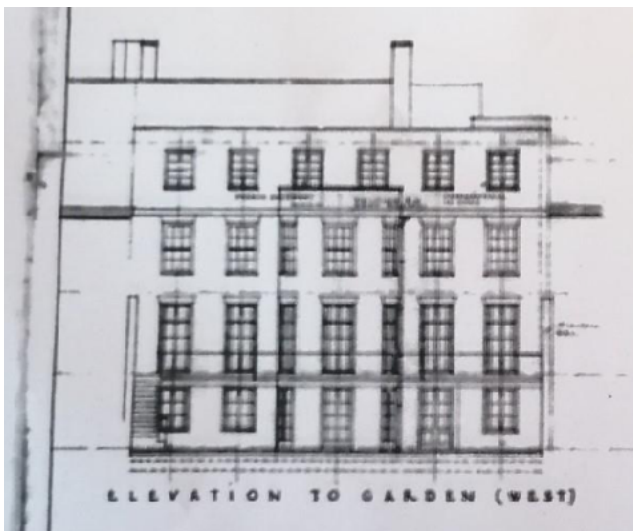
Right below:

Elevation drawing showing the original elevation of no.5 The Grove

These show the fenestration pattern at second floor level, which were original casements of 1930s character.

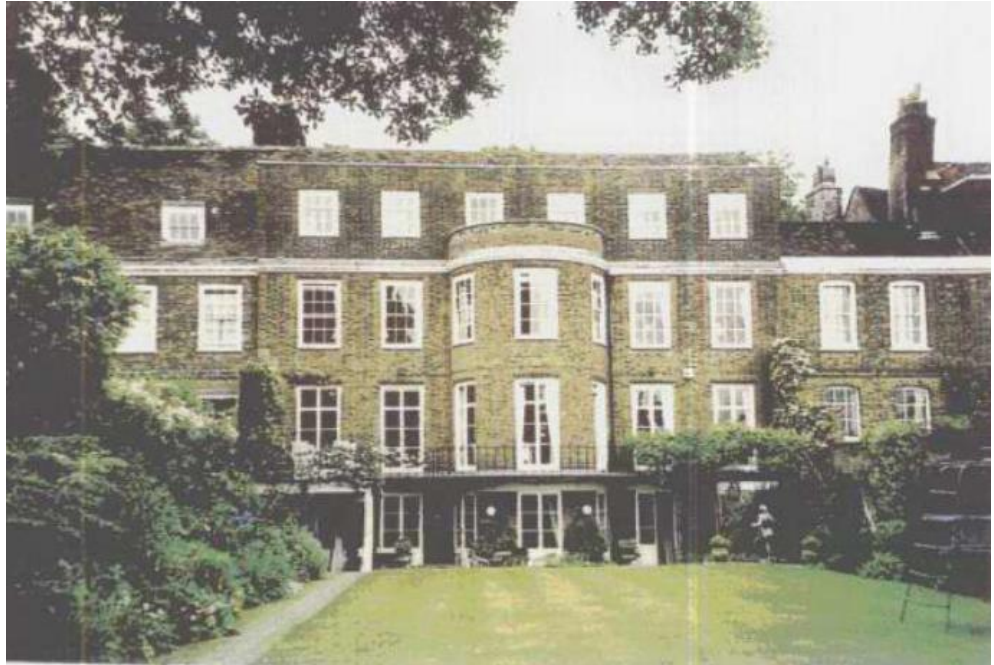
Right above:

Photograph of the rear elevation of no. 5 The Grove circa. 1980

These show that the second floor rear windows had been replaced at some point before the new chimney stack was constructed, which was undertaken during the early 2000s between 2002 and 2004 (LEX0201027).

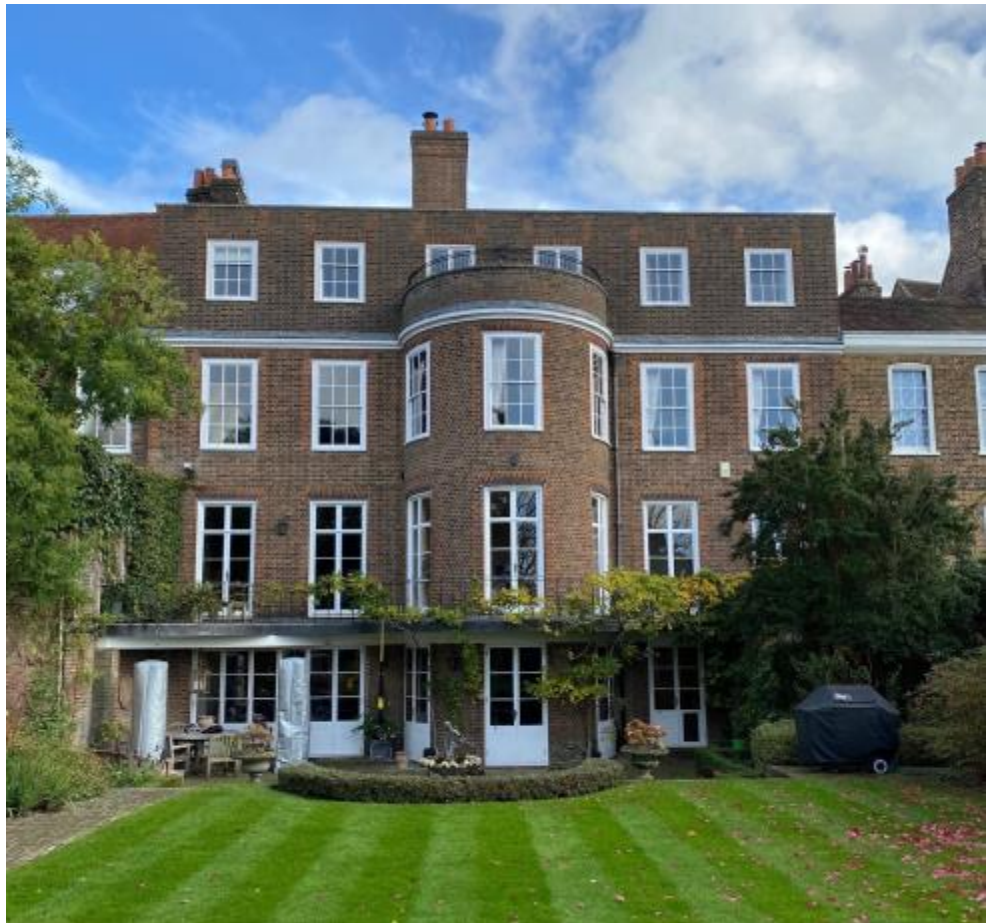
Right below:

Photograph of the rear elevation of no. 5 The Grove 2020.

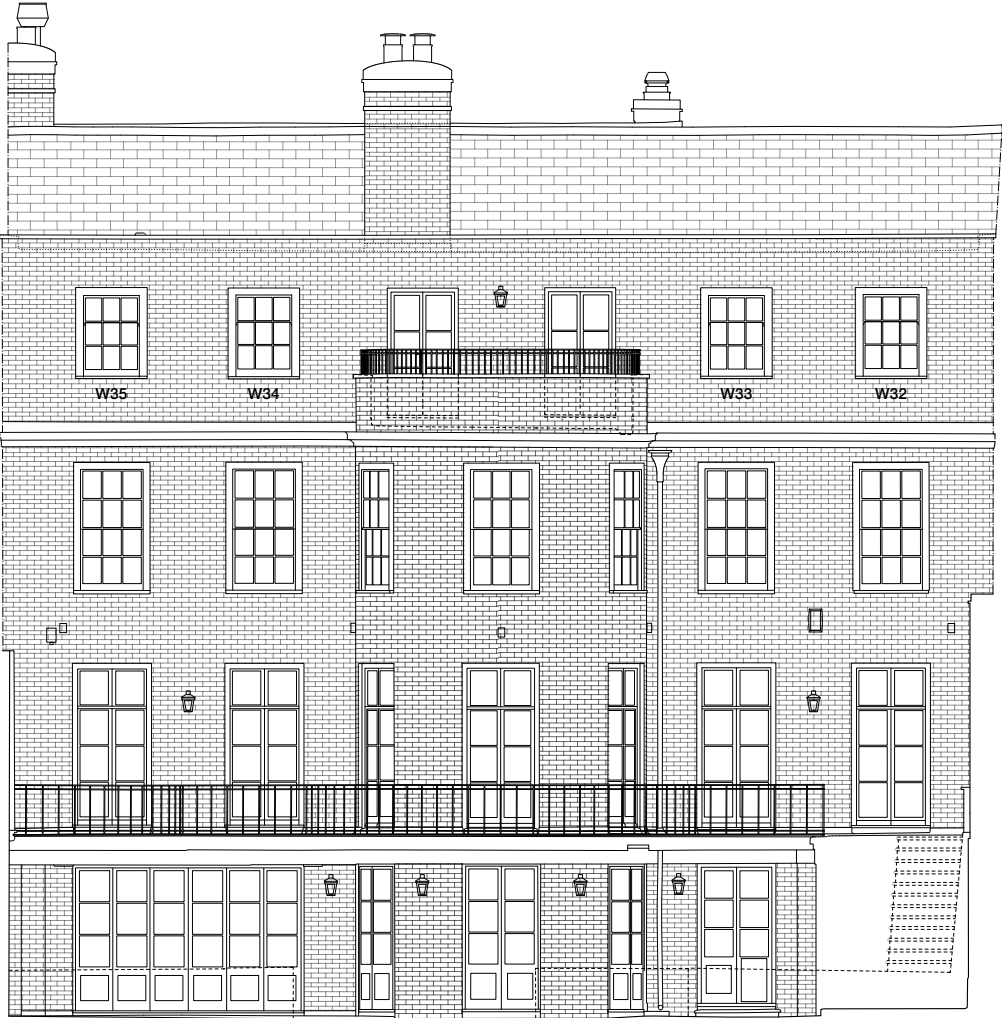
Right:
Rear elevation with window numbers shown. Please refer to additional photographs on following page.

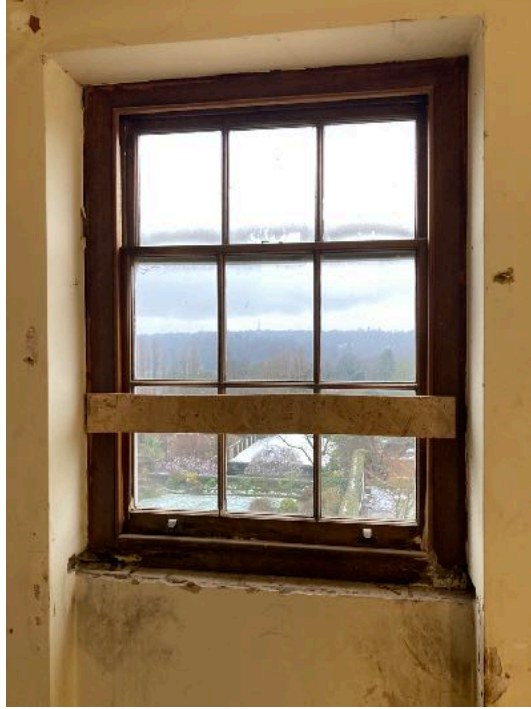
Above left: W32

Non-1930s original.

Required repair works:

Replace 1 cill; Resin repair to inner jamb at right frame jamb middle section; Replace exposed outer jamb at right frame jamb bottom section; Resin repair to outer jamb at left frame jamb middle section; Replace half pulley stile at left frame jamb bottom section; Splice repair at right sash stile bottom section of sash A2; Splice repair at left sash stile bottom section of sash A2

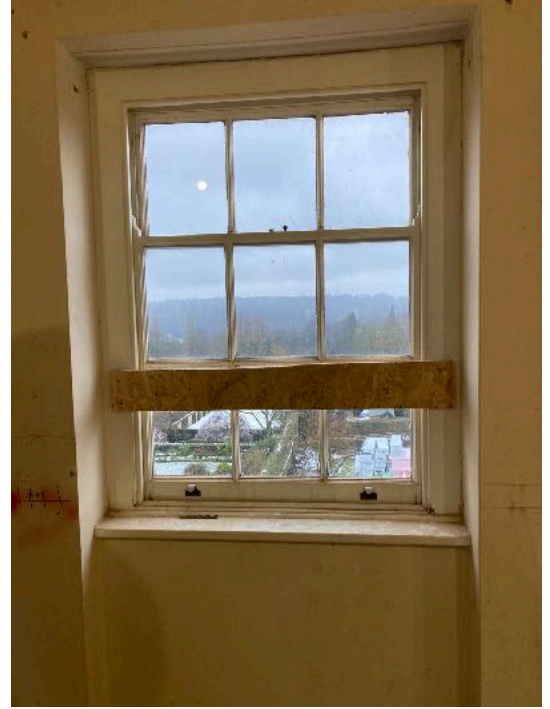
Above right: W33

Non-1930s original.

Required repair works:

Replace 1 cill; Resin repair to inner jamb at right frame jamb middle section; Replace exposed outer jamb at right frame jamb bottom section; Resin repair to outer jamb at left frame jamb middle section; Replace half pulley stile at left frame jamb bottom section; Splice repair at right sash stile bottom section of sash A2; Splice repair at left sash stile bottom section of sash A2

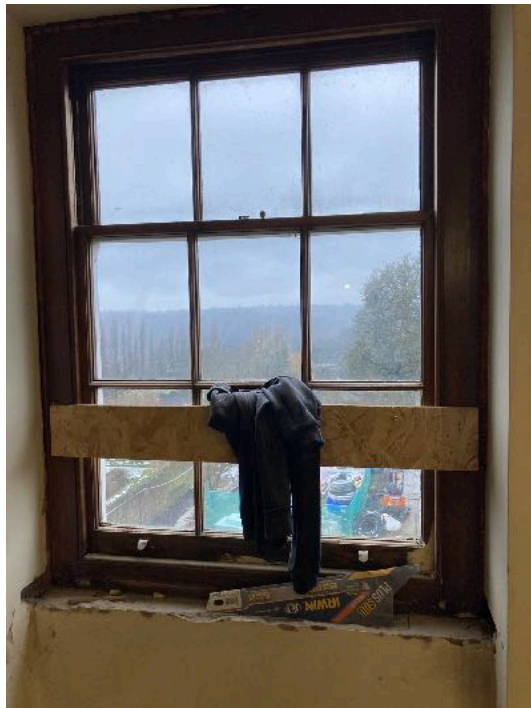
Below left: W34

Non-1930s original.

Required repair works:

Replace 1 cill; Splice repair to outer jamb at right frame jamb middle section; Replace half pulley stile at right frame jamb bottom section; Splice repair to outer jamb at left frame jamb middle section; Replace half pulley stile at left frame jamb bottom section; Splice repair at left of sash bottom rail of sash A2; Splice repair at right of sash bottom rail of sash A2

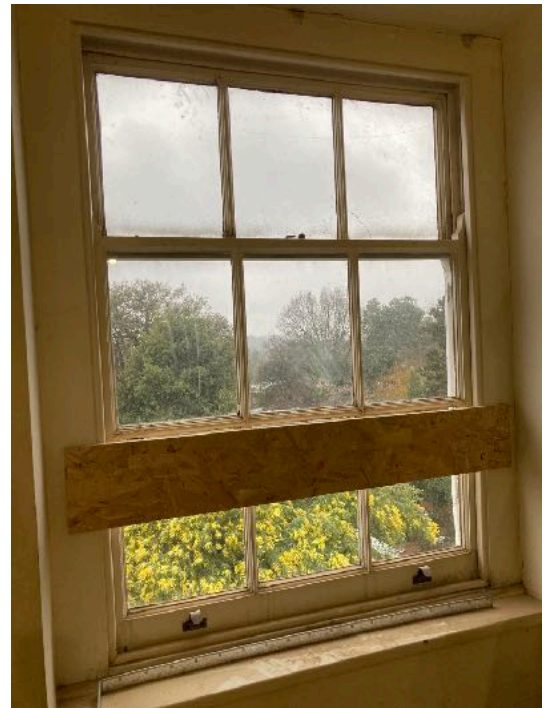
Below right: W35

Non-1930s original.

Required repair works:

Replace 1 cill; Splice repair to outer jamb at right frame jamb bottom section; Replace half pulley stile at left frame jamb bottom section.
