## Arboricultural Appraisal Report

### Subsidence Damage Investigation at:

10 Park Village East  
London  
NW1 7PX

| REPORT DATE: | 17/03/2023 |

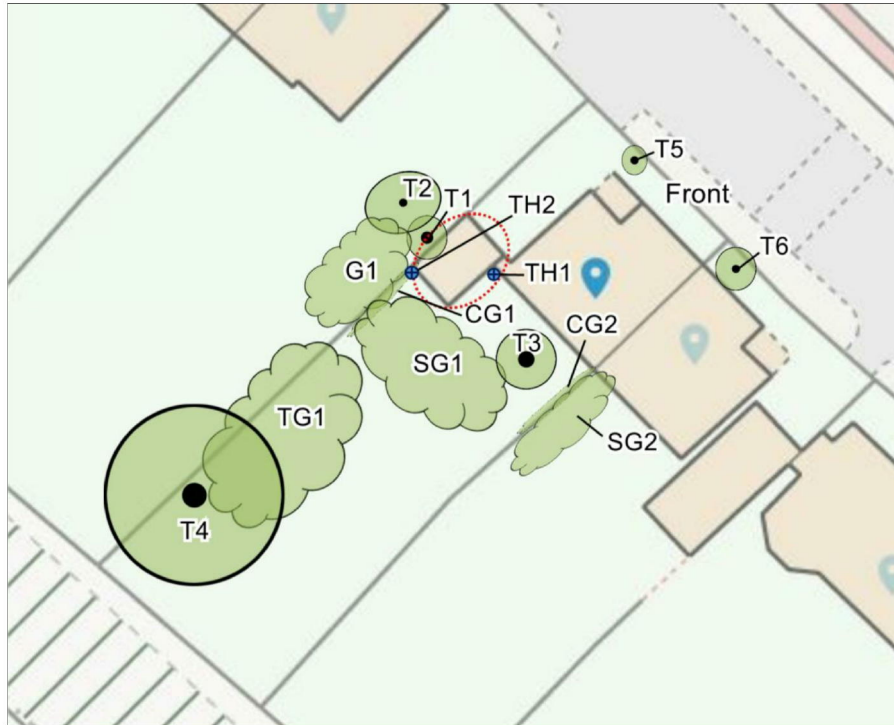
Site Plan

Approximate areas of damage
