Arboricultural Appraisal Report

Subsidence Damage Investigation at:

10 Park Village East
London
NW1 7PX

CLIENT:	Crawford & Company
CLIENT REF:	[REDACTED]
MWA REF:	[REDACTED]
MWA CONSULTANT:	Richard Percival (TechArborA)
REPORT DATE:	17/03/2023

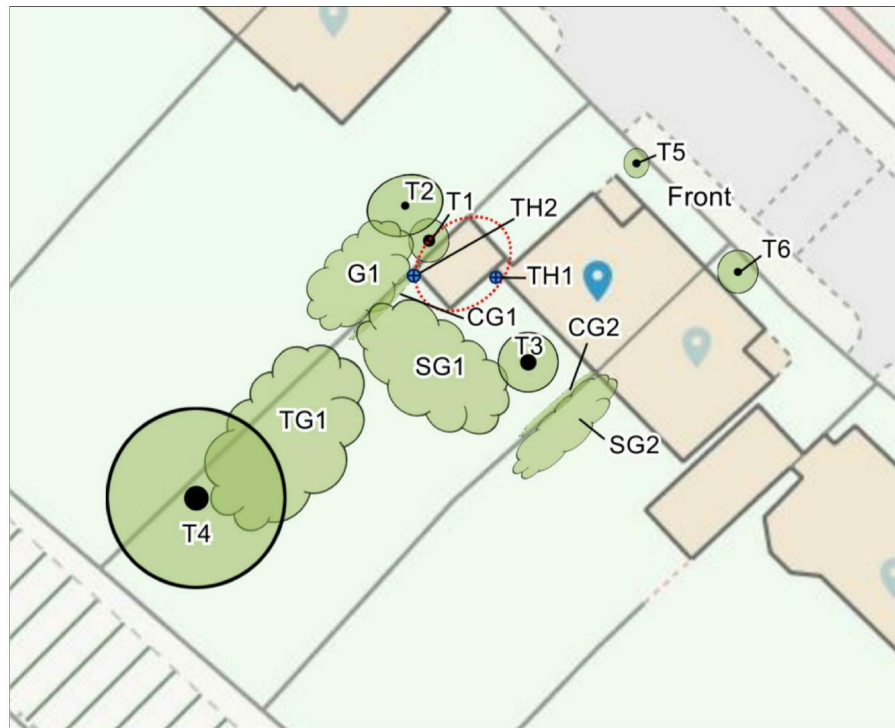
Site Plan

Approximate areas of damage
