TECHNICAL REPORT ON A SUBSIDENCE CLAIM

**10 Park Village East
London
NW1 7PX**

SUBSIDENCE CLAIM

DATE 24 May 2023

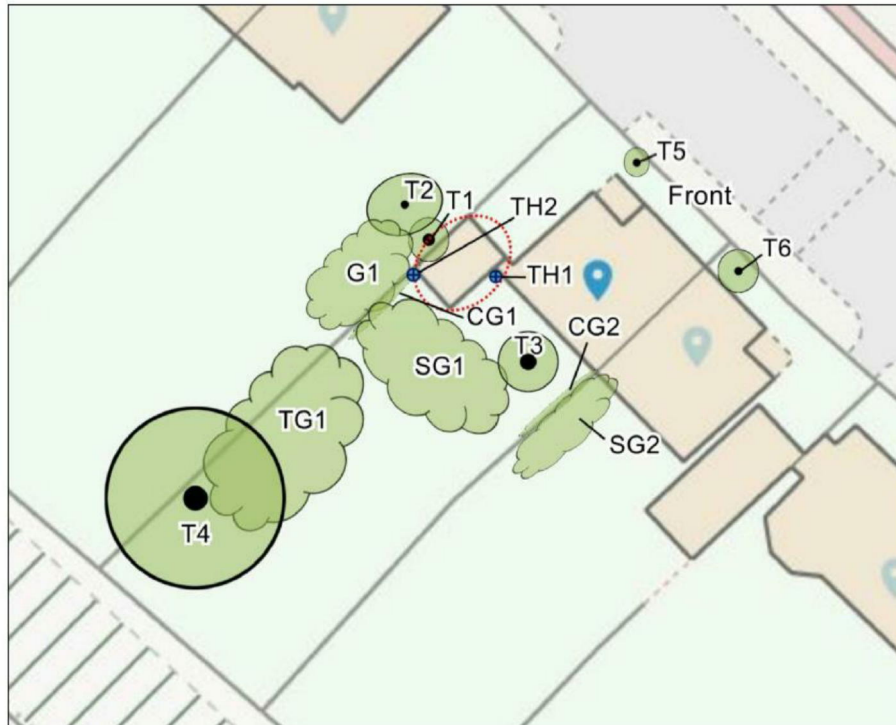
Site Plan

See sketch. Tree roots can be troublesome in cohesive (clay) soils because they can induce volumetric change. They are rarely troublesome in non-cohesive soils (sands and gravels etc.) other than when they enter drains, in which case blockages can ensue.
