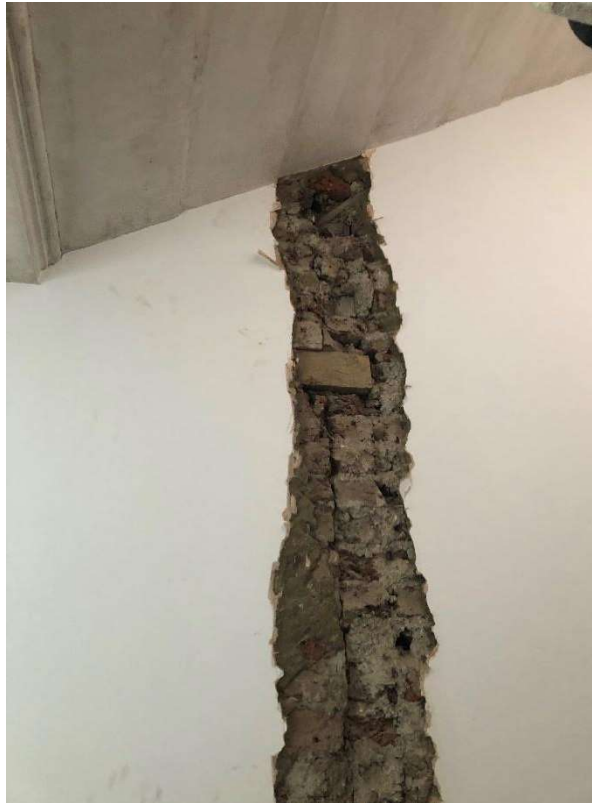
Opening up on site has shown a straight divide between two panels of masonry, the most likely reason is that the rear section was constructed at a later date to the original house and was not adequately toothed in during construction. The crack is likely as a result of natural movements of the two structures and as such to prevent the further cracking reinforcing bars should be installed as shown in figure 3, in the area of the first floor landing..

Figure 4 - Opening up has shown a straight crack between two panels of masonry, image 1 of 2

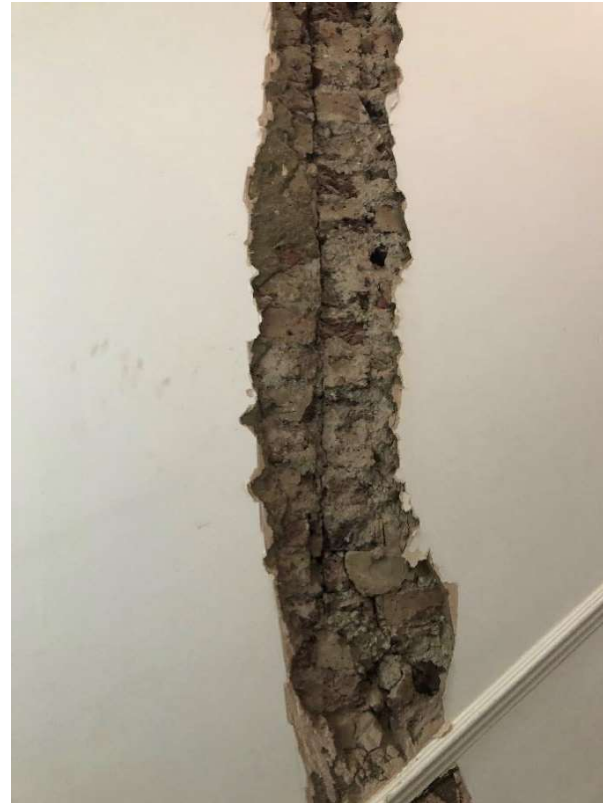
Figure 5 - Opening up has shown a straight crack between two panels of masonry, image 2 of 2

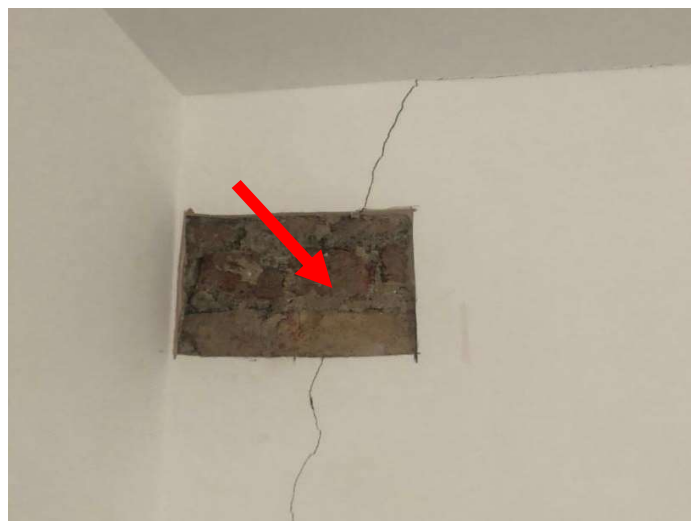
The finishes in front of the crack in the 3rd floor bedroom over the crack have been removed and it can be observed that the crack does not follow through the into the masonry, which suggests that the crack is not structural in this case. There is no requirement for structural intervention here.

Figure 6 - Removal of the finishes over the crack in the 3rd floor bedroom wall shows no sign of affecting the masonry structure

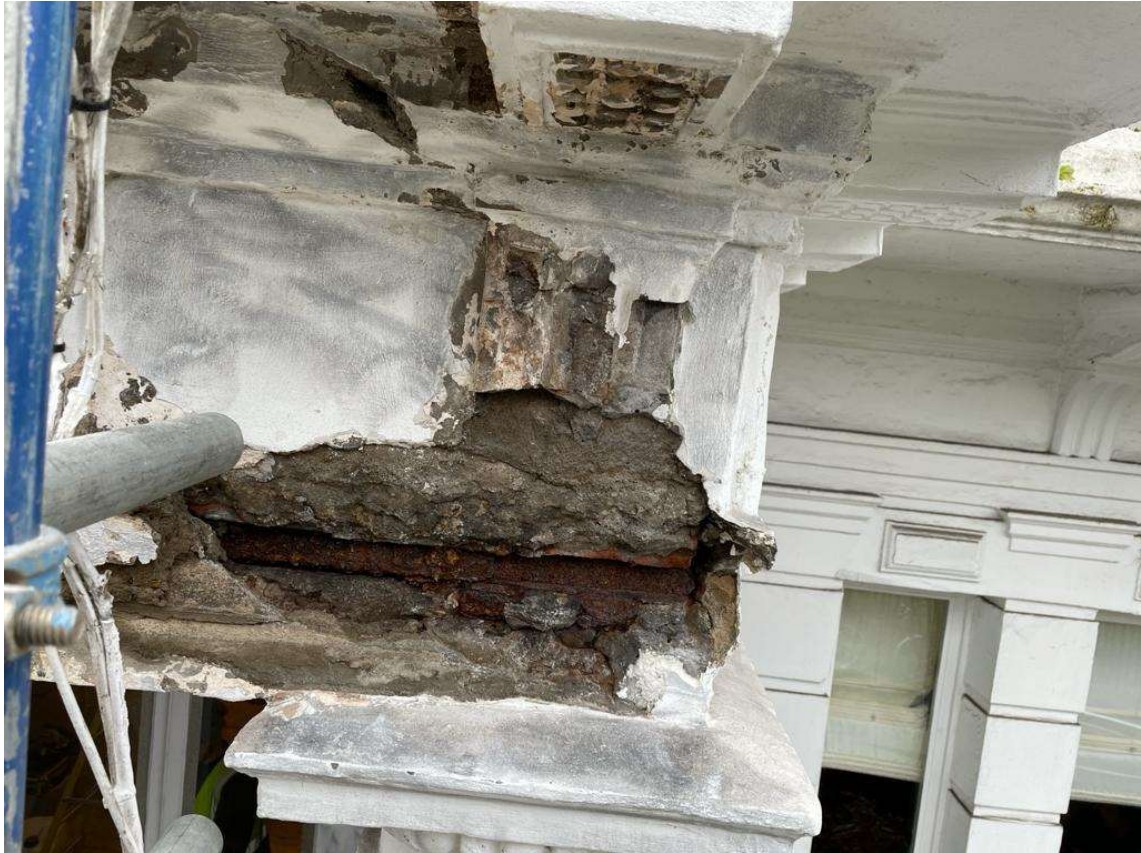
Various cracking was noted on the front portico which was opened on site by the builder which revealed that the portico was not of stone construction but is a plastered finish around concreted beams with steel plates to the underside. The cracking appears to have been caused by water ingress resulting in the steel plates corroding and spalling the concrete.

Figure 19 - Opened up Portico at the end column

Having consulted with a concrete repair specialist (Fosroc) it was decided that the areas which have been opened up should be repaired as this is where the cracking/spalling is at it's worst. This would involve removing all the defective concrete, expose the corroded steel and grit blast, apply an anti-corrosion primer, apply the repair mortar and then reinstate the decorative plaster. In areas where the cracking is minor the cracks should be repaired with the repair mortar to ensure no further water ingress. It is also noted that the water proofing to the slab above the portico was also to be repaired.

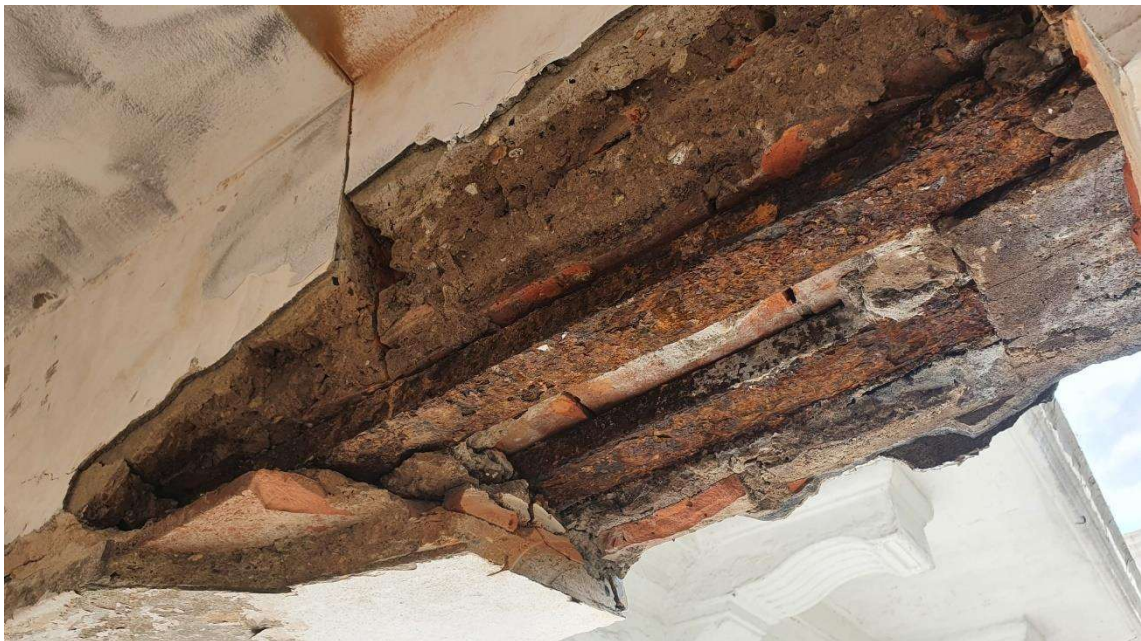
Figure 20 - Opened up Portico to the underside of a beam
