Project name :  
**11455 - ST PANCRAS WAY**

Date :  
**30/01/2019**

## Inspection report

## Inspection pictures

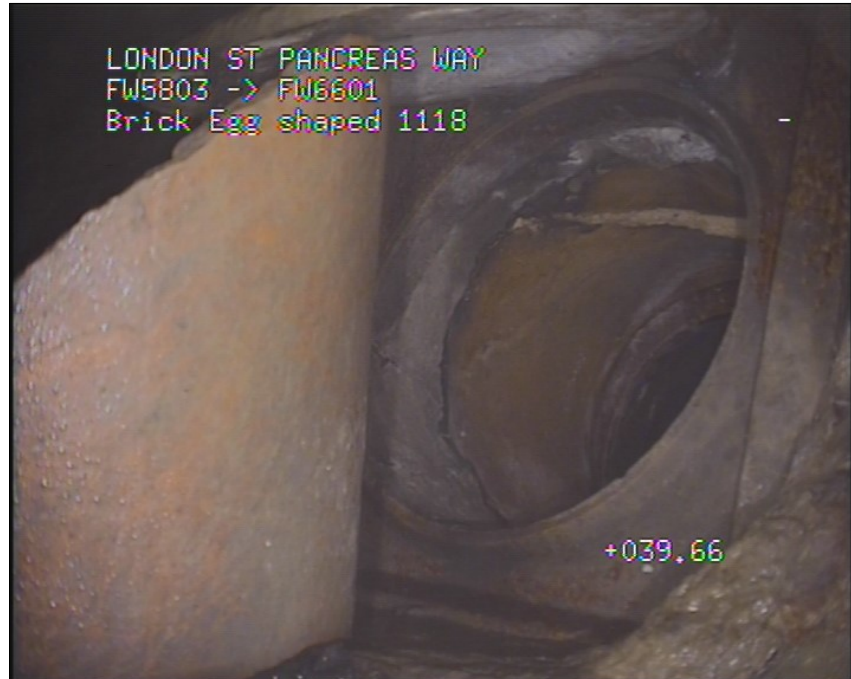
Photo: 1\_1\_15\_A.JPG

| 1:342<br>Depth: 0 | Position | Code | Observation | Grade | |
|---|---|---|---|---|---|
| | 39.66 | CN | Connection other than junction, at 2 o'clock, diameter 150mm Remarks: PIECE OF CLAY PIPE WEDGING OPEN NRV | (Constr) 0 | |

39.66m, Connection other than junction, at 2 o'clock, diameter 150mm

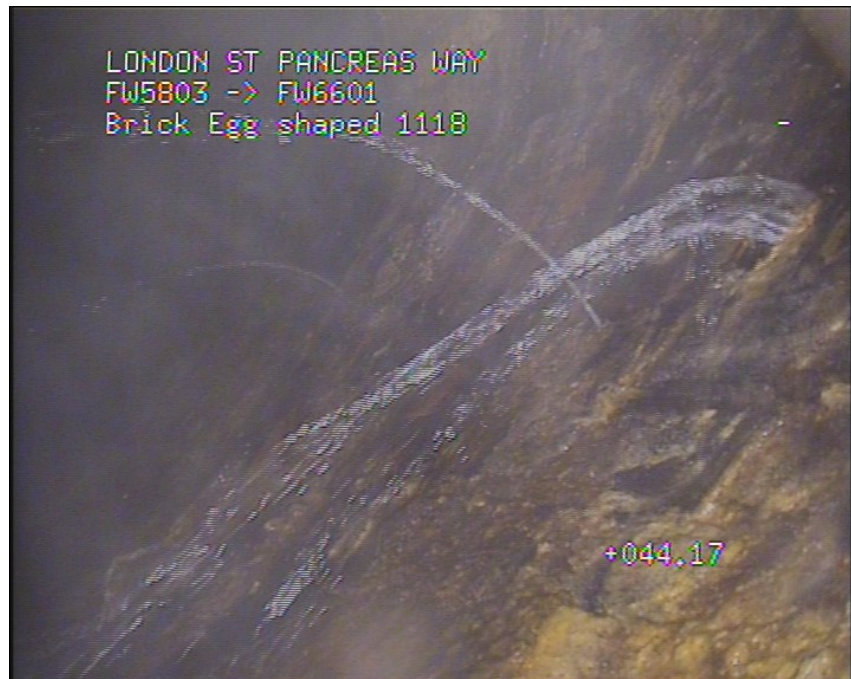
Photo: 1\_1\_18\_A.JPG

44.17m, Infiltration, running, at 3 o'clock

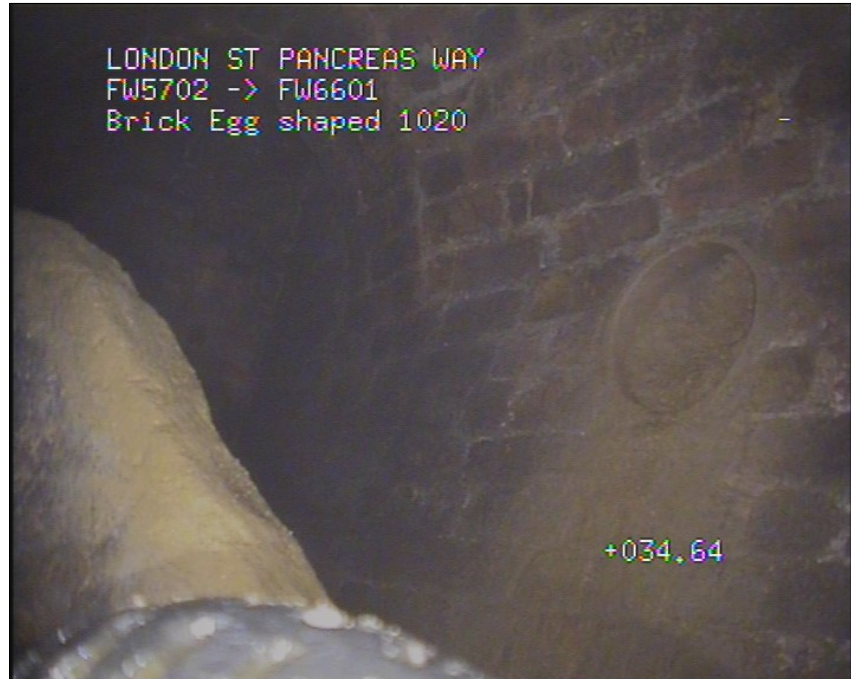
Photo: 4\_4\_41\_A.JPG  
34.64m, General remark

| 1:666<br>Depth: 0 | Position | Code | Observation | Grade | |
|---|---|---|---|---|---|
| | 34.64 | REM | General remark Remarks: SEWER CONNECTION | (Misc) 0 | <br>LONDON ST PANCRAS WAY<br>FW5702 -> FW6601<br>Brick Egg shaped 1020<br>+062.54<br>62.54 m |

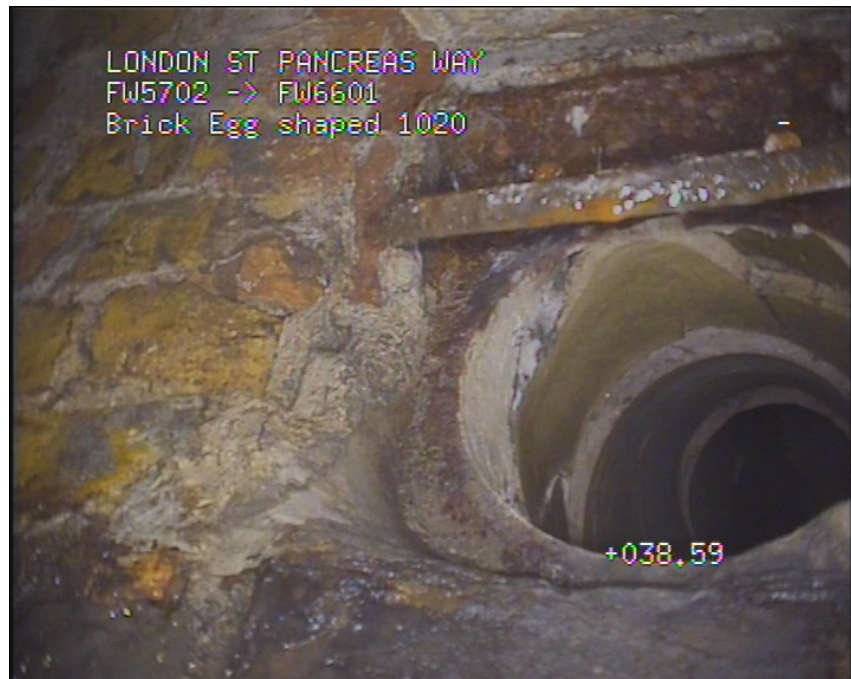
| 1:666<br>Depth: 0 | Position | Code | Observation | Grade | |
|---|---|---|---|---|---|
| | 38.49 | CXD | Connection defective, connecting pipe is damaged, at 3 o'clock, diameter 150mm Remarks: NRV OPEN | (Constr) 0 | |

Photo: 4\_4\_42\_A.JPG  
38.49m, Connection defective, connecting pipe is damaged, at 3 o'clock, diameter 150mm

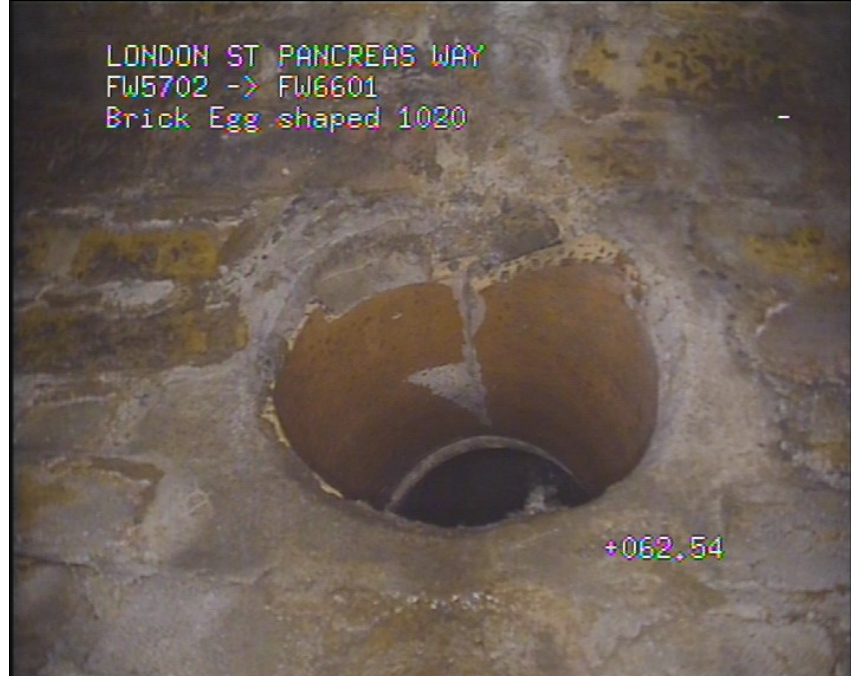
Photo: 4\_4\_48\_A.JPG

| 1:666<br>Depth: 0 | Position | Code | Observation | Grade | |
|---|---|---|---|---|---|
| | 62.54 | CXD | Connection defective, connecting pipe is damaged, at 10 o'clock, diameter 150mm | (Constr) 0 | |

62.54m, Connection defective, connecting pipe is damaged, at 10 o'clock, diameter 150mm

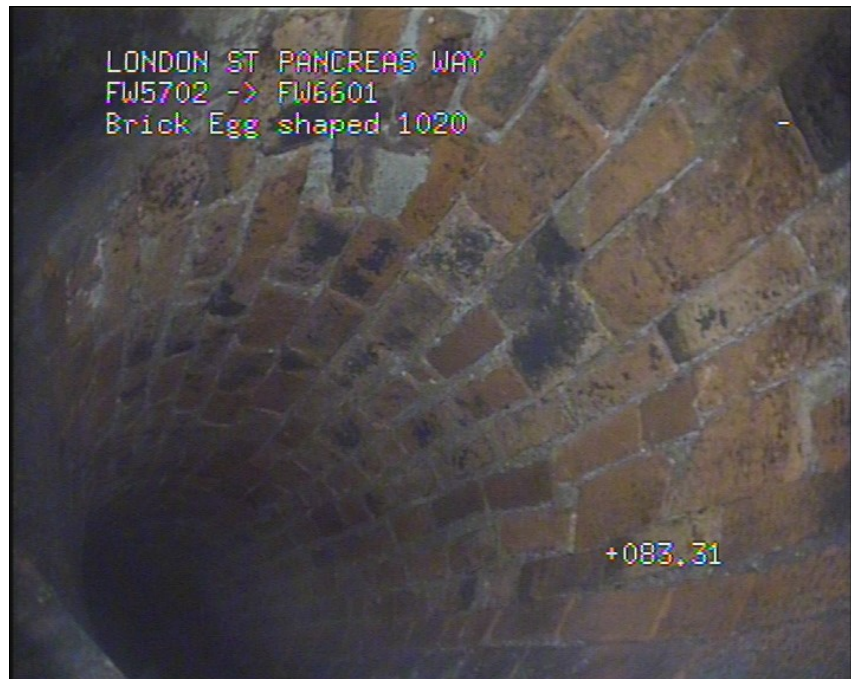
Photo: 4\_4\_50\_A.JPG

| 1:666<br>Depth: 0 | Position | Code | Observation | Grade | |
|---|---|---|---|---|---|
| | 83.31 | JN | Junction, at 10 o'clock, diameter 600mm Remarks: PIPE SIZE UNKNOWN | (Constr) 0 | |

83.31m, Junction, at 10 o'clock, diameter 600mm

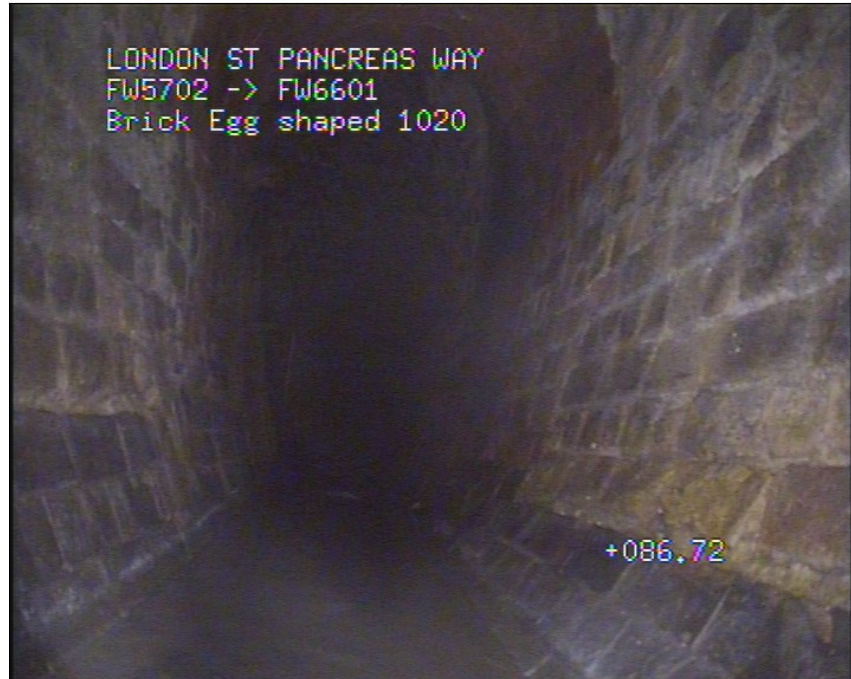
Photo: 4\_4\_54\_A.JPG

| 1:666 | Position | Code | Observation | Grade |
|---|---|---|---|---|
| | 86.72 | REM | General remark Remarks: DEBRIS UNDER WL | (Misc) 0 |
| | 86.72 | F01 DEE | Attached deposits, encrustation, from 7 to 5 o'clock, 5% cross-sectional area loss, End Remarks: PATCHY | (Serv) 3 |

86.72m, Finish node type, manhole reference number: FW6601

| | Upstream MH | Downstream MH | Remarks regarding the inspection | No. |
|---|---|---|---|---|
| 3 | FW5702 | FW6601 | SCALE CUTTING REQUIRED | 3 |
