Refurbishing the existing 16 apartments, internal communal areas, replacement windows and roof with associated structural and drainage works

10 Canfield Gardens,

**Ref No:** 502198

**Site Address:** 10 Canfield Gardens,  
London

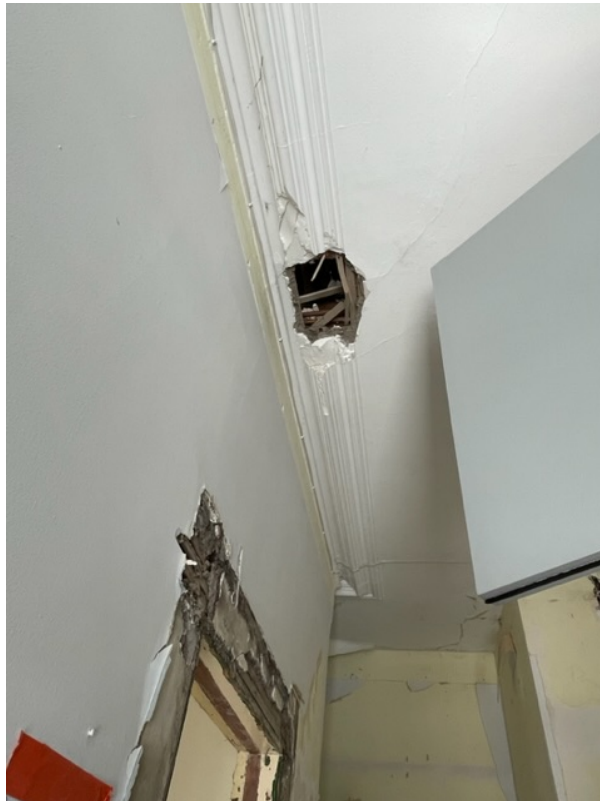
**Evidence of lath and plaster walls/ceilings**

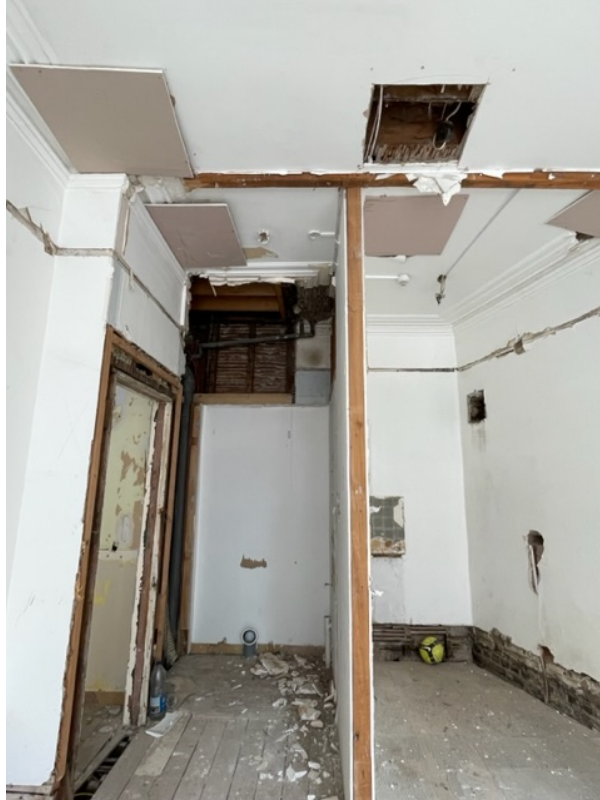
**UGF flat to the right stripped with large and plaster construction exposed in areas**

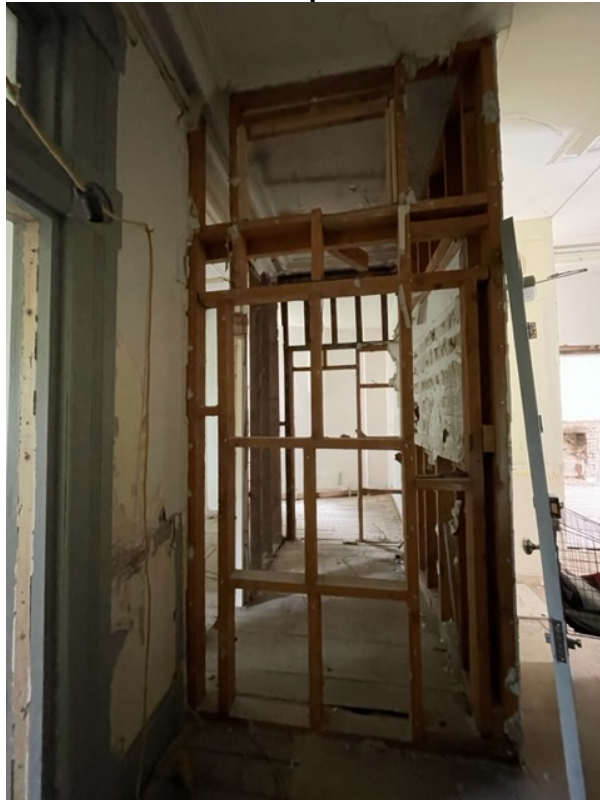
**Separating wall between flat and communal area stripped back to the studs**

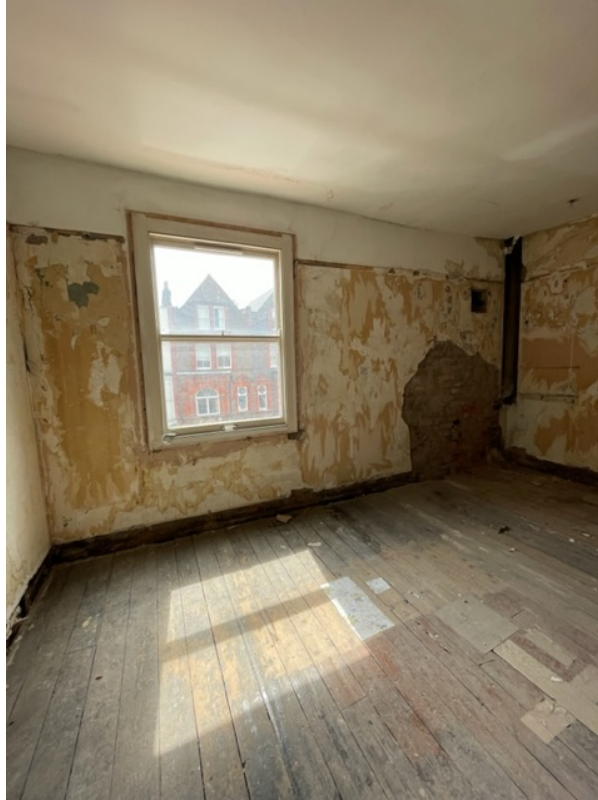
**Example of removed plaster in small areas to expose brickwork**

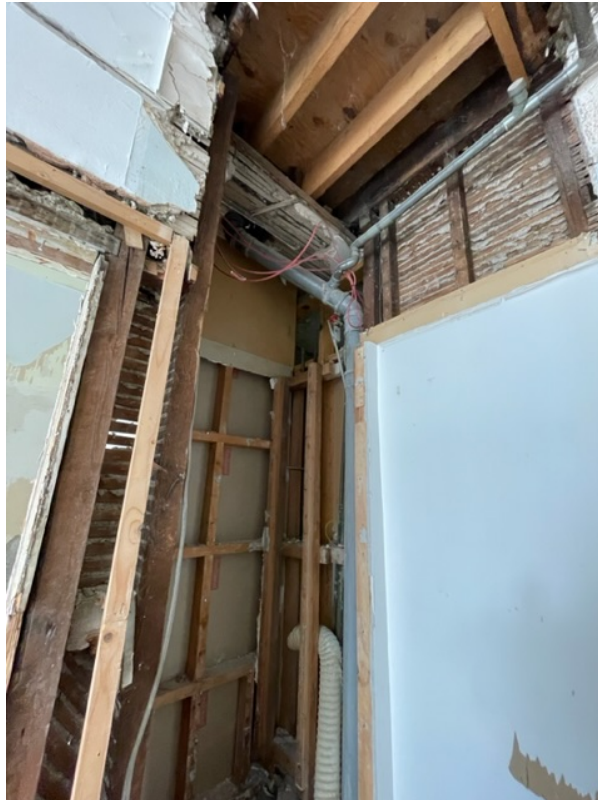
**UGF flat separating wall to communal area stripped back**
