Front Elevation of Lower Ground Floor, 42 Parkhill Road (see diagram 100 - 101 A)

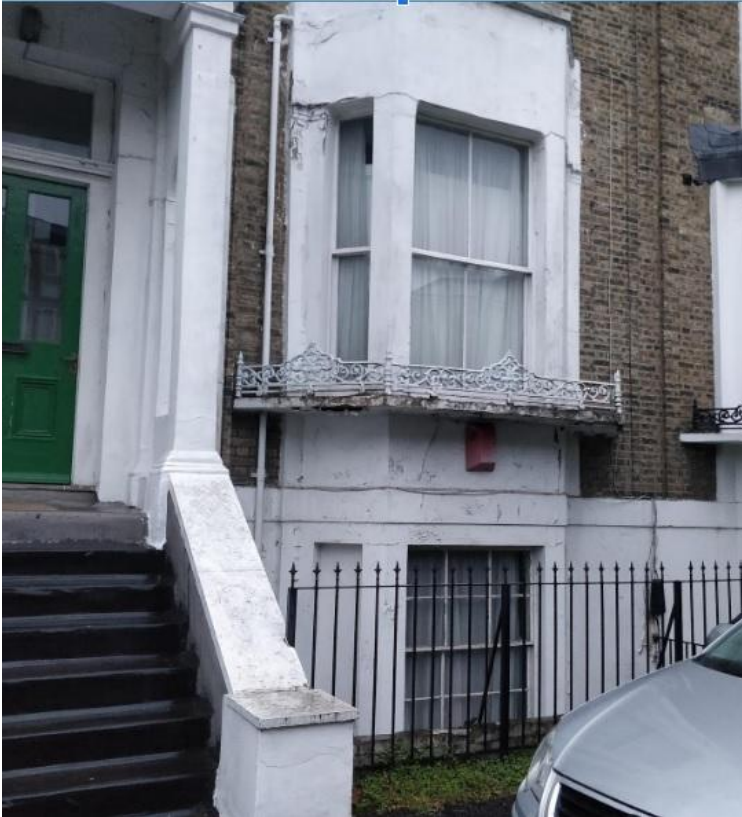
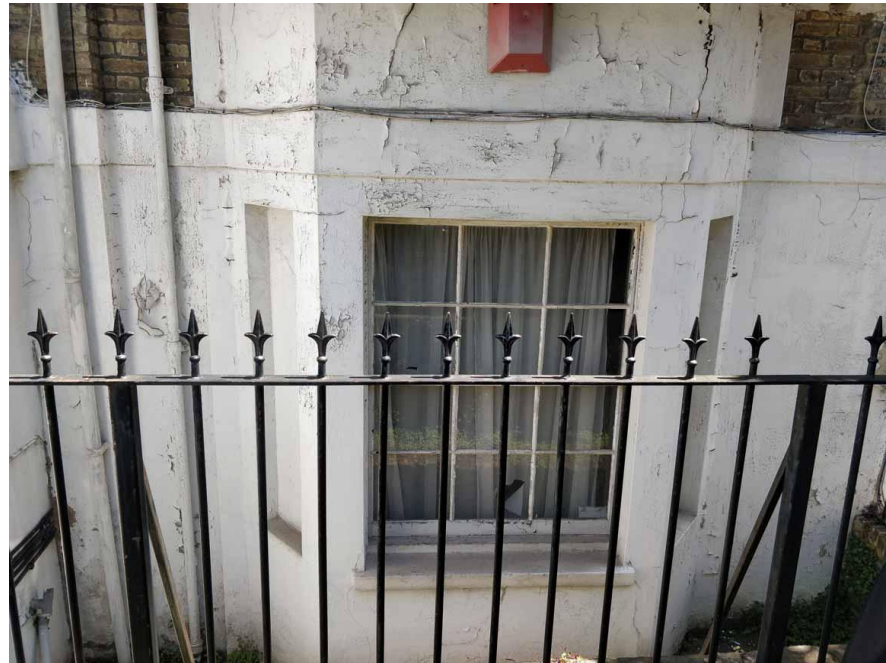
- In the lower ground bay, you can see the white painted plaster that will be restored to glazed timber windows more in keeping with the overall front facade design.
- Central bay window in poor repair, all to be made good.
- Lower portion of this window not visible from street level due to its placement in the front lightwell
