Project

Project Name: SUR003 261120 MUSEUM STREET LONDON WC1A 1JN
Project Description: CCTV/ENTRY TO TAKE DIRECTION FROM SURVATEC.
Project Number: SUR003
Project Date: 26/11/2020
Inspection Standard: MSCC5 Sewers & Drainage GB (SRM5 Scoring)

Section Inspection - 26/11/2020 - AX

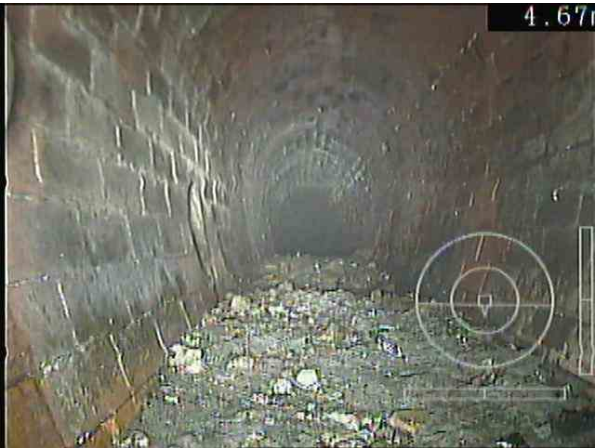
4.67		DEX	Settled deposits, other, 25% cross-sectional area loss: MISC DEBRIS.	00:02:39	AX_039c8bfd-4d4b-45ac-80fa-e		4
6.14		CN	Connection other than junction at 9 o'clock, diameter: 225mm	00:03:18

AX_039c8bfd-4d4b-45ac-80fa-ef92923d29bc_20201126_214340_704.jpg, 00:02:39, 4.67 m
Settled deposits, other, 25% cross-sectional area loss, MISC DEBRIS.

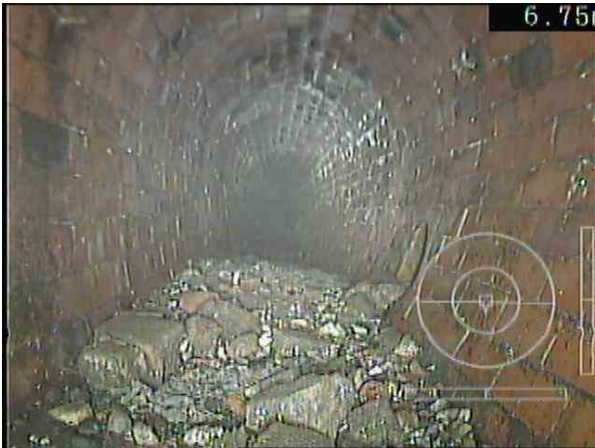
6.75		DEX	Settled deposits, other, 30% cross-sectional area loss: BRICKS.	00:03:56	AX_d7a1fd96-2c30-402f-9ff9-2		4
8.31		CN	Connection other than junction at 4 o'clock, diameter: 225mm	00:05:02

8.31		REM	General remark: UNABLE TO PASS SETTLED DEBRIS.	00:05:06			
8.31		SA	Survey abandoned: SEE NOTES.	00:05:07

AX_d7a1fd96-2c30-402f-9ff9-2106f2f02221_20201126_214524_566.jpg, 00:03:56, 6.75 m
Settled deposits, other, 30% cross-sectional area loss, BRICKS.

MTS CLEANSING
Project Information		
Project Name SUR003 261120 MUSEUM STREET LONDON WC1A 1JN	Project Number SUR003	Project Date 26/11/2020
Project Notes		
CCTV/ENTRY TO TAKE DIRECTION FROM SURVATEC.		
WE MET WITH BEN ONSITE, HE EXPLAINED WHAT HE WANTED SURVEYED, SEE OUR FINDINGS BELOW.		
SECTION 1, MH2410 U/S A.		
SURVEY 1, SURVEY ABANDONED AT 8.31MTRS , UNABLE TO PASS SETTLED DEBRIS ON FLOOR OF PIPE(BRICKS/STONES/SILT ETC), CLEANING IS REQUIRED TO ENABLE A FULL SURVEY OF THIS LENGTH, NO OTHER ISSUES FOUND.		
SECTION 2, MH2410 D/S B.		
SURVEY 1, SURVEY COMPLETE AT 60.15MTRS, WE HAVE SURVEYED AS FAR AS BEN HAS INSTRUCTED, 5-20% SILT/STONES IN THIS LENGTH, RATS ALSO SPOTTED WHILE SURVEYING, NO OTHER ISSUES.		
SECTION 3, MH2410 U/S MH1404.		
SURVEY 1, SURVEY ABANDONED AT 14.06MTRS, UNABLE TO CONTINUE ANY FURTHER DUE TO THE SETTLED DEBRIS ON THE FLOOR OF THE PIPE, CLEANING IS REQUIRED TO ENABLE A FULL SURVEY, NO OTHER ISSUES.

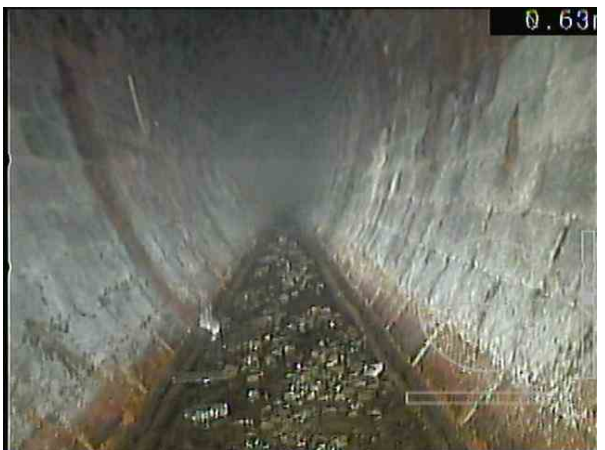
0.00	S01	DEX Settled deposits, other, 10% cross-sectional area loss, start: SILT STONES.	00:00:03	2410X_9b687413-1f07-4015-b	
		5.24	F01	DEX Settled deposits, other, 10% cross-sectional area loss, finish: SILT STONES.	00:02:20		3

2410X_9b687413-1f07-4015-bba7-7a8cbe511628_20201126_215501_877.jpg, 00:00:03, 0.00 m
Settled deposits, other, 10% cross-sectional area loss, start, SILT STONES.

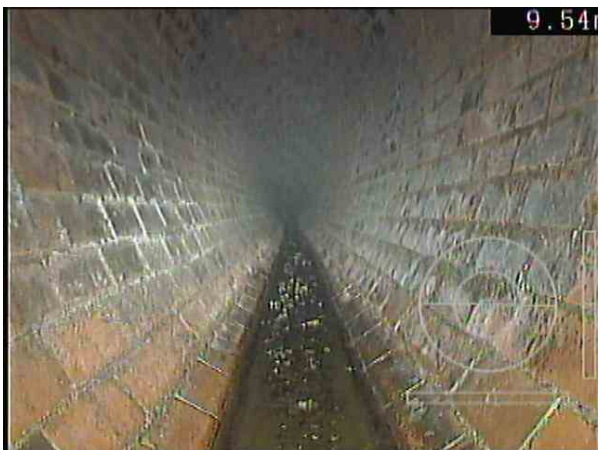
5.29	WL	Water level, 5% of the vertical dimension	00:02:21		
		9.54	JN	Junction at 9 o'clock, diameter: 150mm	00:03:47		
		9.54	S02	DEX Settled deposits, other, 5% cross-sectional area loss, start: STONES.	00:03:57	2410X_9ab88e92-d104-4df6-9a

2410X_9ab88e92-d104-4df6-9a4f-2d35a0df584f_20201126_215846_440.jpg, 00:03:57, 9.54 m
Settled deposits, other, 5% cross-sectional area loss, start, STONES.

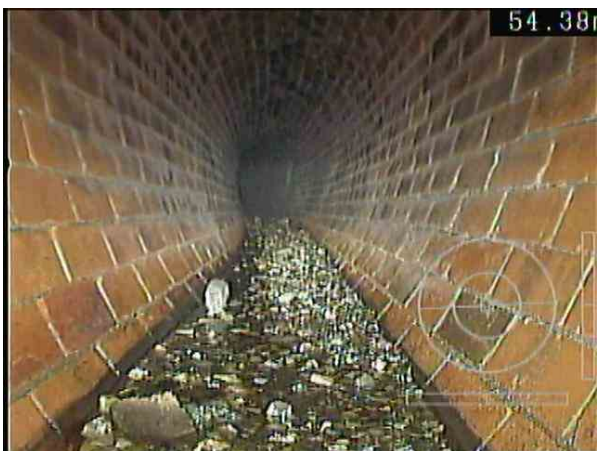
54.38	S03	DEX	Settled deposits, other, 15% cross-sectional area loss, start: STONES/SILT	00:14:54	2410X_7e3257b2-c1f8-49bc-b5	
	54.38		VR	Vermin, rat	00:14:58	2410X_9c30d6a-63c2-4c73-a	
	56.98		LL	Line deviates left	00:15:45		
	60.14		WL	Water level, 5% of the vertical dimension	00:16:25		
	60.15	F03	DEX	Settled deposits, other, 15% cross-sectional area loss, finish: STONES/SILT	00:16:26		3
	60.15		REM	General remark: DESIRED METERAGE COMPLETE.	00:16:26		
	60.15		OCF	Finish node type, other special chamber, reference number: B: SEE NOTES.	00:16:27		
Depth: 0.00 m

2410X_7e3257b2-c1f8-49bc-b568-69946098fc56_20201126_221344_246.jpg, 00:14:54, 54.38 m
Settled deposits, other, 15% cross-sectional area loss, start, STONES/SILT

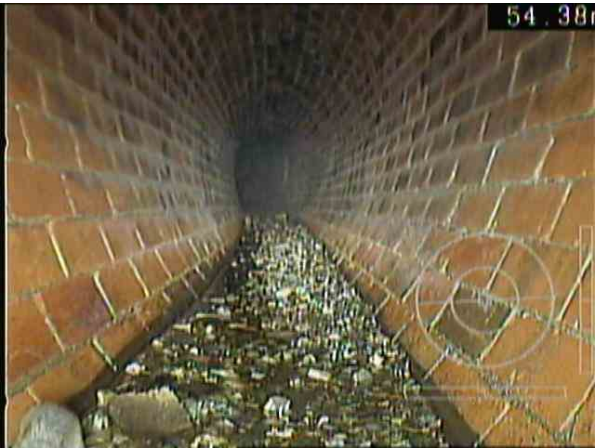
2410X_9cc30d6a-63c2-4c73-a44e-208098dd8370_20201126_221351_535.jpg, 00:14:58, 54.38 m
Vermin, rat

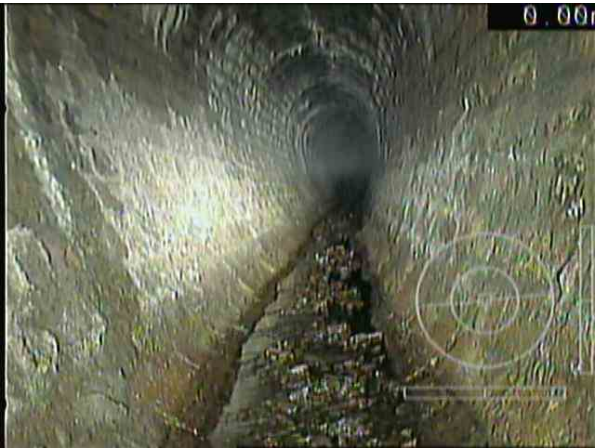
0.00	WL		Water level, 10% of the vertical dimension	00:00:01		
	0.00	S02	DEX	Settled deposits, other, 10% cross-sectional area loss, start: STONES.	00:00:01	1404X_5a6a66f8-2045-4e38-bf

1404X_5a6a66f8-2045-4e38-bf52-cfa7817a955f_20201126_2
23747_361.jpg, 00:00:01, 0.00 m
Settled deposits, other, 10% cross-sectional area loss, start,
STONES.

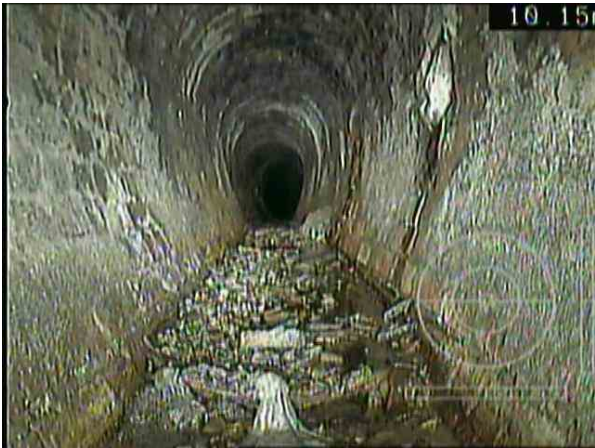
10.15	WL		Water level, 10% of the vertical dimension	00:01:57		
	10.15	C02	DEX	Settled deposits, other, 20% cross-sectional area loss, change: STONES.	00:01:57	1404X_67ff0eed-1d31-49f8-8fc

1404X_67ff0eed-1d31-49f8-8fce-9041d2d427ea_20201126_2
24005_535.jpg, 00:01:57, 10.15 m
Settled deposits, other, 20% cross-sectional area loss, change,
STONES.

14.06	F02	DEX	Settled deposits, other, 20% cross-sectional area loss, finish: STONES.	00:04:05		3
	14.06	REM		General remark: UNABLE TO PASS SETTLED DEBRIS CLEANING REQUIRED TO ENABLE A FULL SURVEY.	00:04:32
