Heritage Response to Consultee Comments, 28 Albert Street, Camden

APPN 2023/1541/L & APPN 2023/0849/P

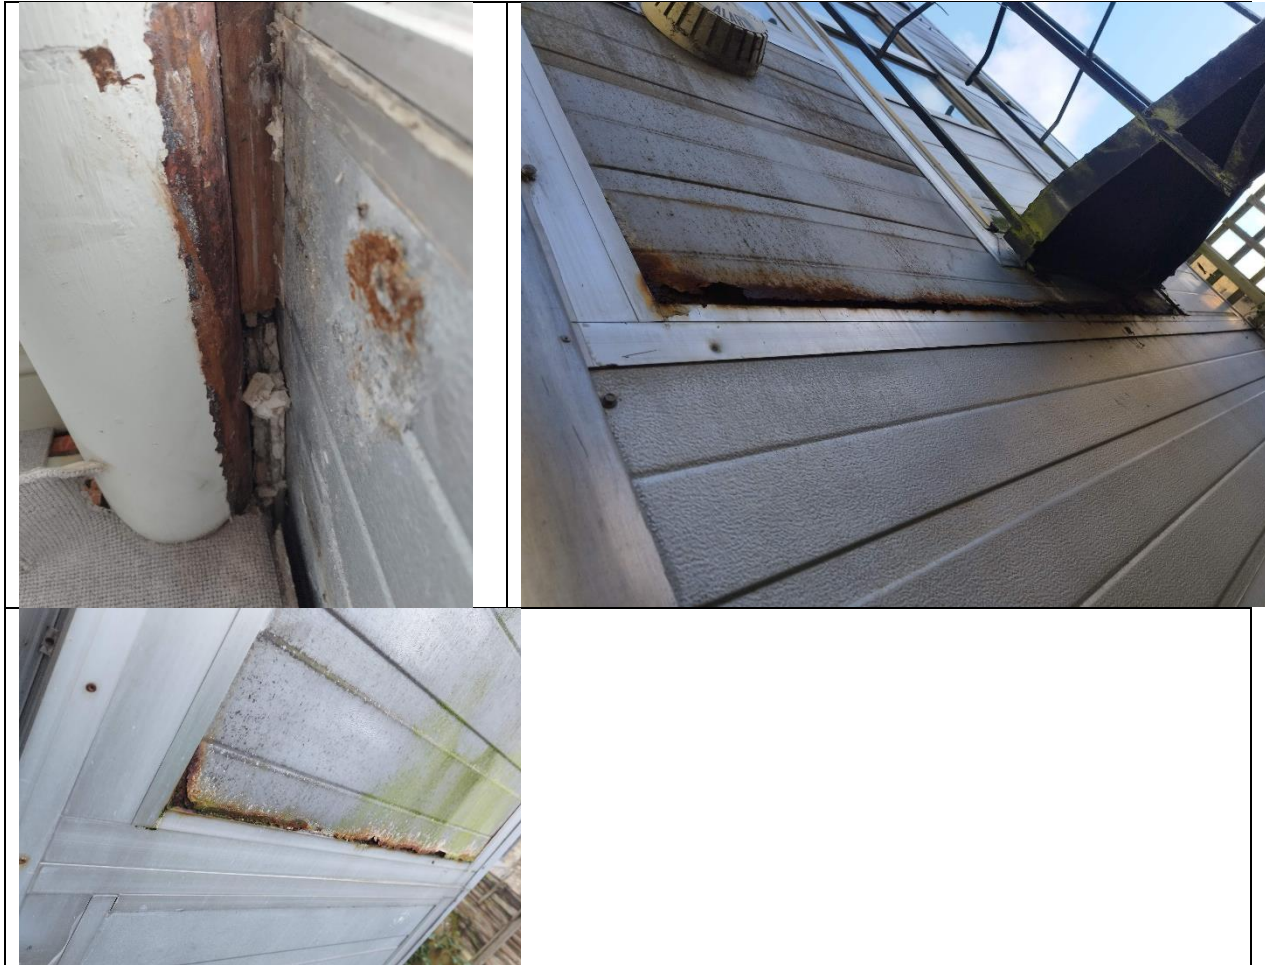
Any value that the rear extension may have once had has been vastly reduced by its current condition. The experimental nature of the cladding has contributed to the fact that it has been subjected to significant water ingress and rust damage. The existing panels are simply no longer fit for purpose and need to be replaced. There is also a need to improve energy efficiency for the property, in order to increase its sustainability and futureproof the building, and it is not possible to add the enhanced insulation behind the existing panels.

The degradation of the original cladding compromised the claddings effectiveness as a weather proof barrier and enabled the ingress of moisture which has resulted in the corrosion of primary structural elements. Most notably the corrosion to the circular steel column shown in the figure below

Photographs showing current condition of cladding

There is therefore a need to replace the panels. Attempts were investigated to match the existing panels, however these are a non-standard design and it is not possible to source a comparable product. Even if it were, this would result in a loss of the original design and a replacement would not have the same heritage value.

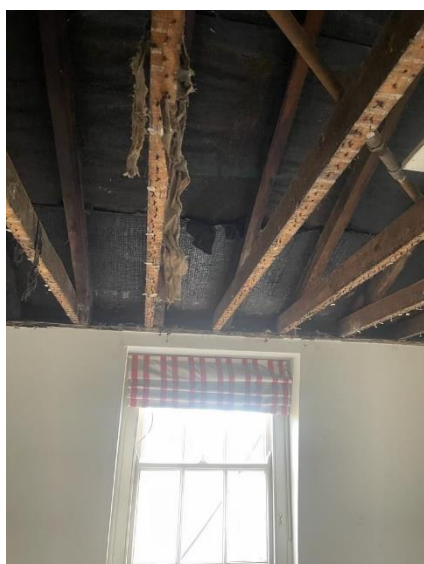
Condition of attic roofspace prior to works (also see Schedule of Repair Works)

LOFT: The plasterboard ceiling in these rooms had suffered significant damage from a roof that was no longer fit for purpose. They were removed as an emergency measure.

However, in this instance, the applicant is happy to re-install a plasterboard ceiling similar to that which existed prior to these works, as we do wish to work collaboratively with you. This will therefore not be shown as a change within these proposals.

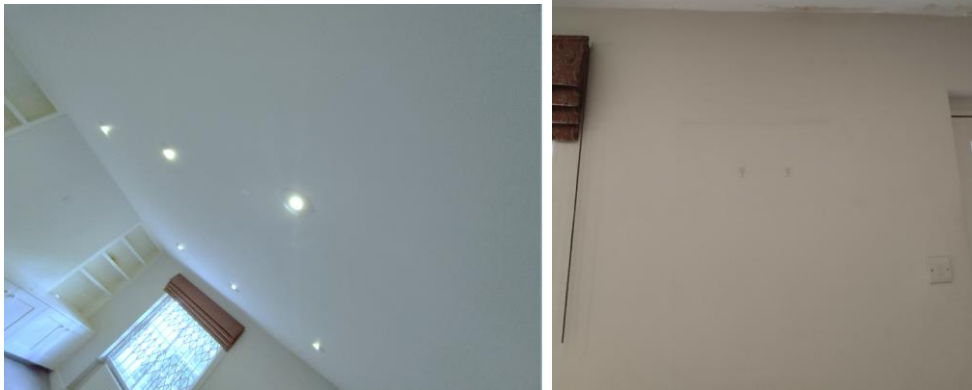
With regards to the basement ceiling, the photographs below show how this had signs of water damage. From a visual inspection the ceiling appeared significantly bowed. Given the signs of water damage and the degree of bowing it was decided to remove the ceiling to inspect the condition of the joists.

Photographs showing damage to basement ceiling

BASEMENT: Structural reinforcements to the joists were required for the basement ceiling following rain damage and bowing in the central area of the ceiling. This is to be replaced with a like for like plaster ceiling. There were no cornices in the basement as evidenced from photographs of the room prior to the ceiling's removal and no historical fabric was removed - which can be corroborated by the plasterboard edges of where the ceiling was removed.

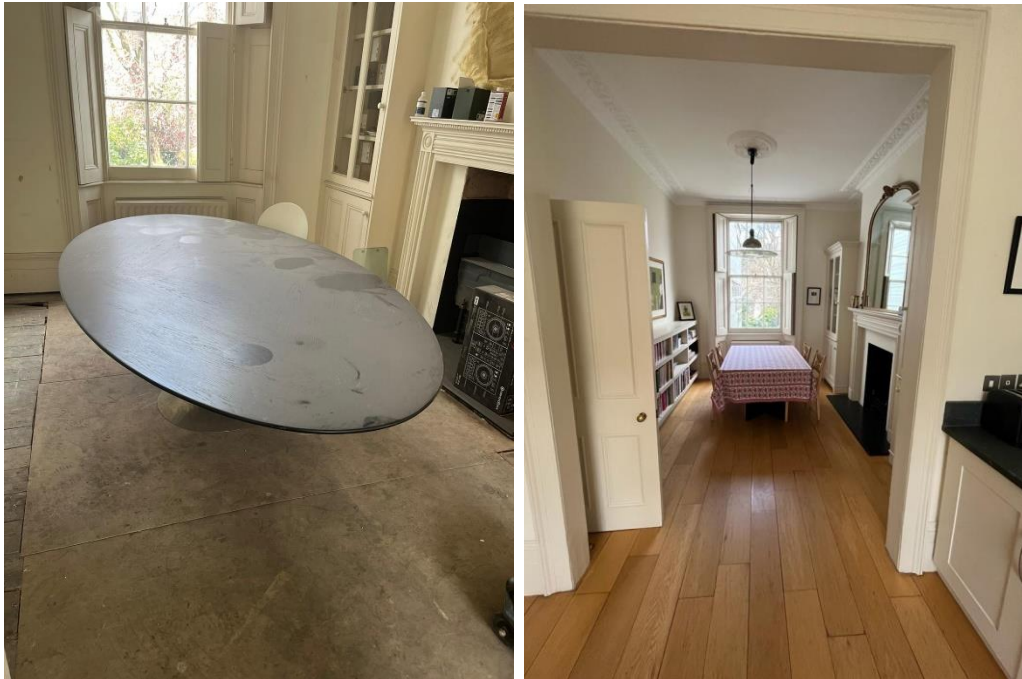
The entire house had been carpeted by the previous owner's except for the kitchen, which had been covered in engineered wood. In the ground floor rooms, 2nd floor bathroom and loft bedrooms, the previous owner's had removed the historical floorboards and replaced them with MDF subfloors and either engineered wood or carpet on top (see photographs below).

Condition of flooring remaining from previous owners showing mdf sub-floors (left image) and engineered wood on top (right).

The only rooms with original floorboards are the drawing room and main bedroom. We are retaining these and sourcing reclaimed floorboards that match them to restore the flooring in the rest of the house where previous owner's had removed the original floorboards.
