Arboricultural Consultancy for Lloyds Bank

Insured		Address	42 Roderick Road, LONDON, NW3 2NL
Client	Subsidence Management Services	Contact	Ian Domigan
ES Ref		Consultant	Kirk Thompson
Report Date	01/12/2022

2. Property and Damage Description

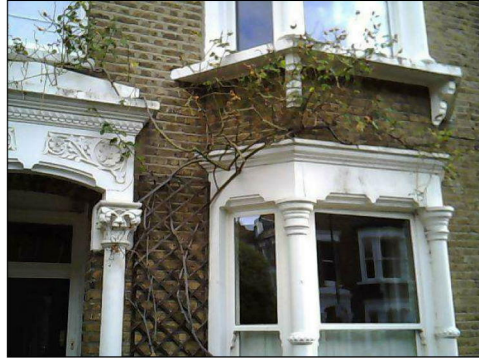
C1 - Rose

However, C1 (Rose) cannot be discounted as contributing to the overall level of soil drying proximate to the area of damage and is therefore also considered to retain a contributory influence, albeit in a limited / localised capacity when compared to T2.

Consequently, we have advocated the complete removal of C1 (Rose) and T2 (Lime) as it will offer the most certain arboricultural solution likely to restore long-term stability.

Tree No.	Species	Age Cat	Approx. Height (m)	Distance to Building (m) *	Ownership	Action	Requirement
C1	Rose	1	3	0.3	C - Insured	Remove	Remove close to ground level and treat stump to inhibit regrowth.
T2	Lime	1	11	7.8	B - Local Authority	Remove	Remove close to ground level and treat stump to inhibit regrowth.
Age Cat: 1 = Younger than property; 2 = Similar age to the property; 3 = Significantly older than property

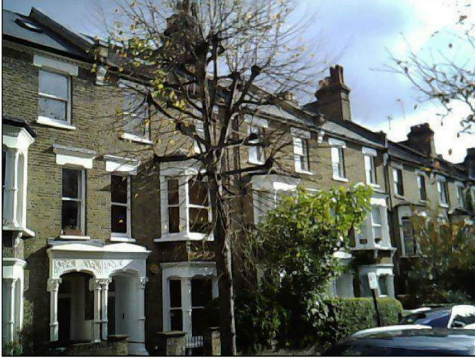
T2 - Lime

With due regards to species profile, size and proximity, T2 (Lime) is considered the dominant feature proximate to the focal area of movement and accordingly, where vegetation is confirmed as being causal, we have identified them as the primary cause of the current subsidence damage.
