88 Albert Street, London

Design & Access Statement

88 Albert Street,
London,
NW1 7LX
June 2023

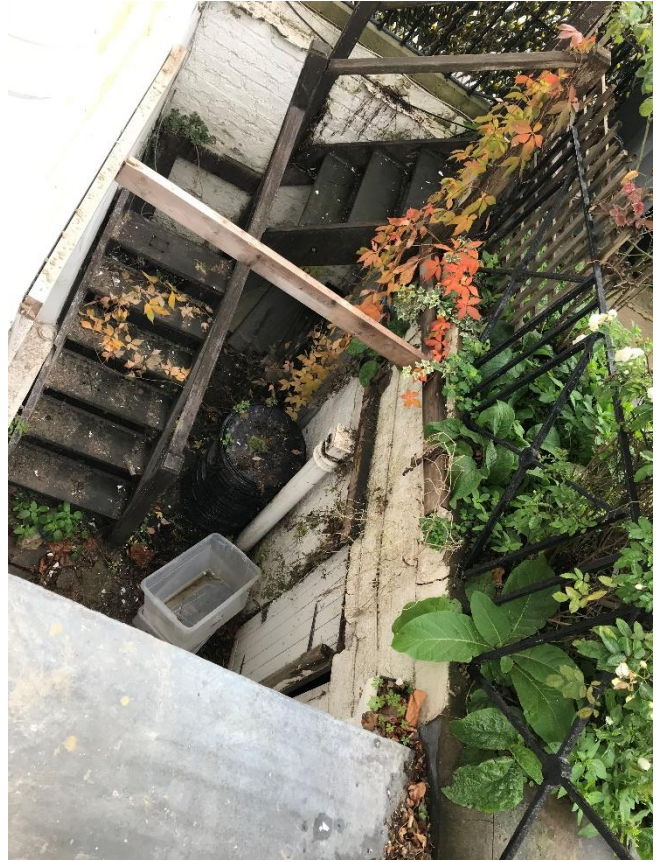
The vaults are masonry arch structures which can be accessed via timber doors set in the retaining wall opposite the site's front elevation. This wall has a significant deformation and cracking through the entire thickness of the wall, and the internal arches are starting to deflect downwards, indicating high risk of collapse. This damage has been caused by age, poor waterproofing and potentially the removal of a large nearby tree.

The lightwell and existing retaining wall

Berrys propose that the external facing wall is rebuilt in materials to match existing, and the hole in the internal vault wall is infilled with replacement brick to match the original structure. External brickwork will be painted white to match existing and the coal chute will be retained with a protective glass capping to assist waterproofing the vaults.

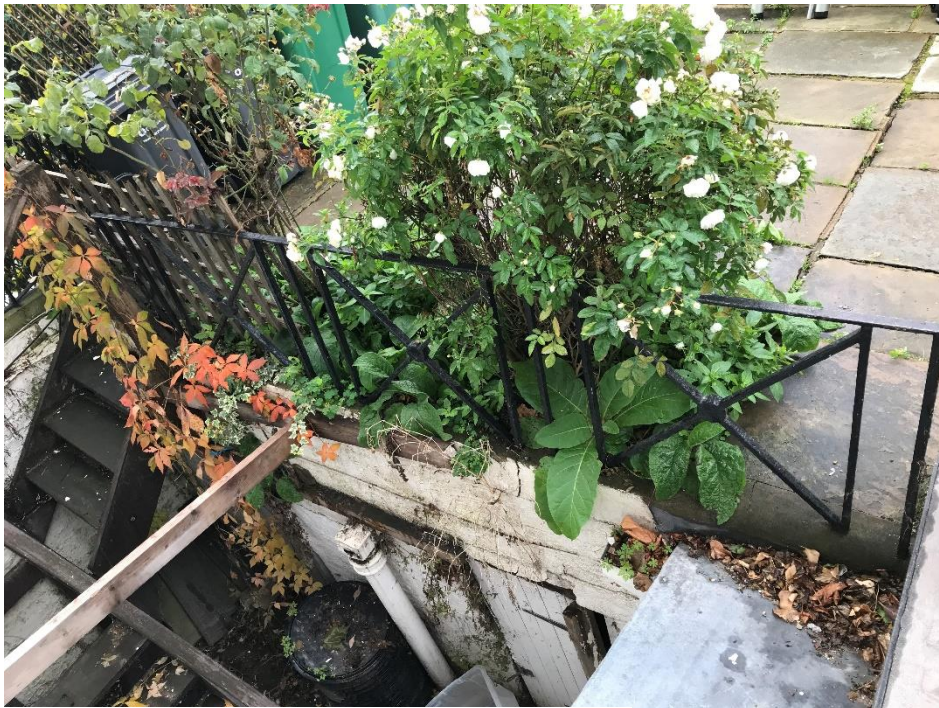
Flagstones to the existing front garden are in good condition, as is the painted black metal railing above the lightwell, both of which are being retained.

The existing railings to the front garden

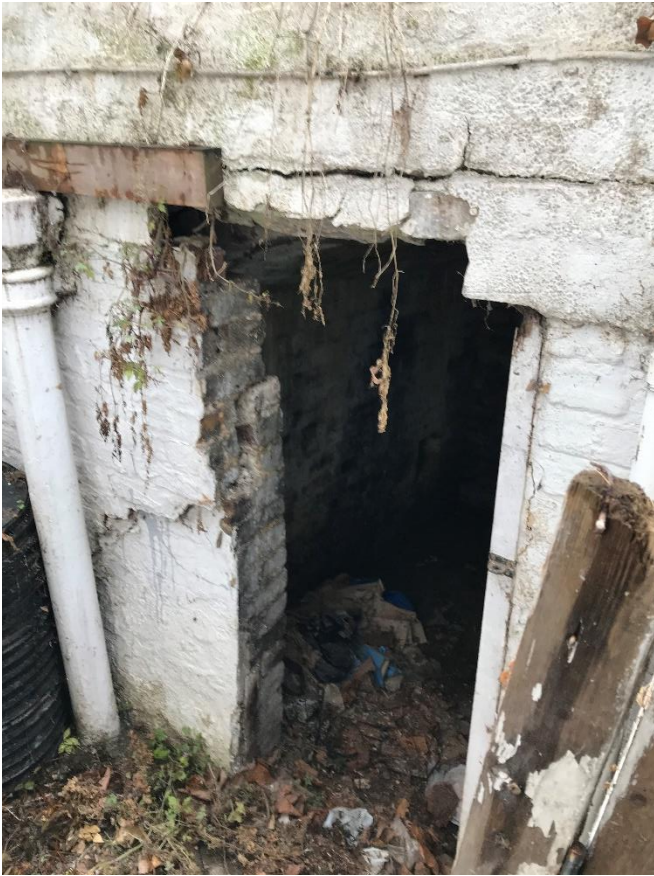
Existing doorway into the middle vault

New hardwood timber lintels will be installed above the external doors, flush to the retaining wall, and the doors will be replaced with vertical boarded timber doors. All ironmongery will be painted black to match existing ironmongery on site.

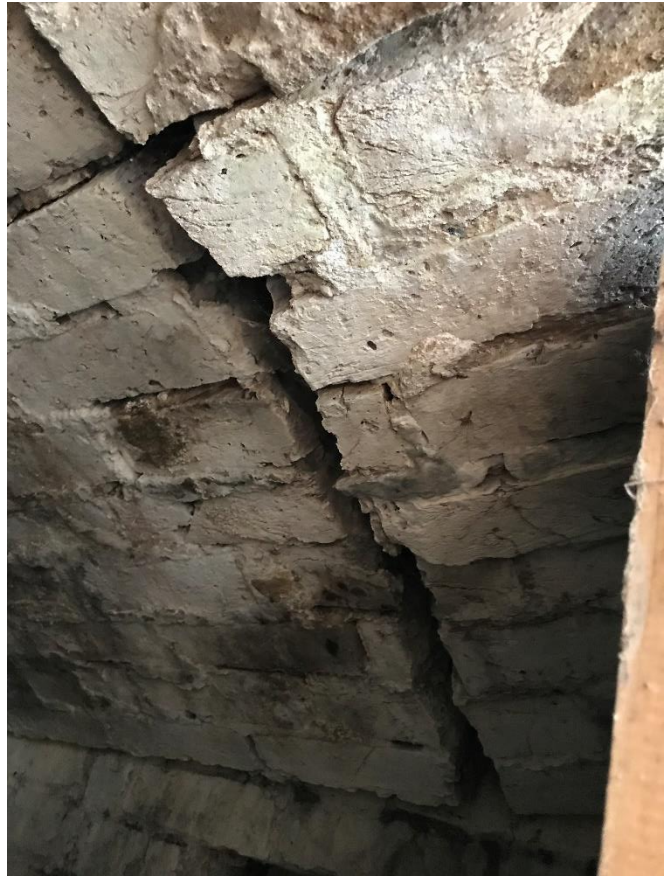
Severe cracks in the existing arches

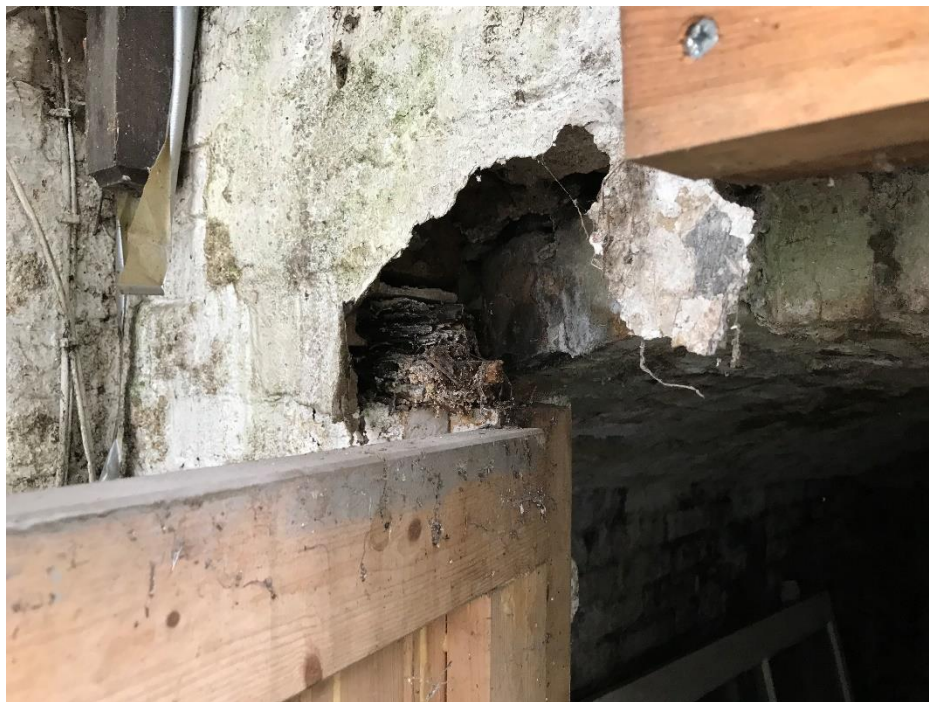
Cavity left following original lintel rotting away

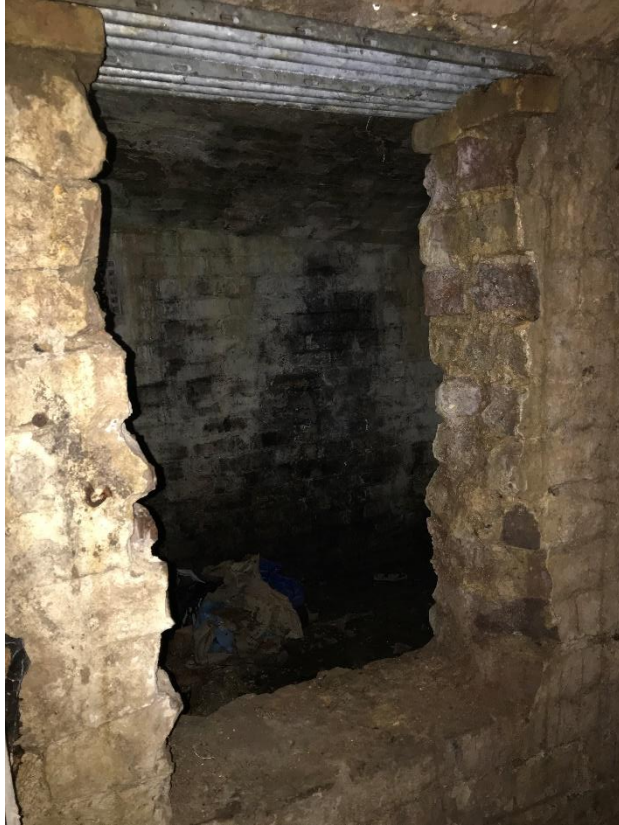
The middle vault has a large hole in the wall leading to the vault being directly accessible from the interior of the property. Due to the poor condition of the existing doors and external wall, this poses a large security risk with limited resistance should someone wish to intrude.

Hole in wall of vault leading to internal of property

Infilling the internal wall of the vaults will also prevent unwanted access to the main house providing a higher level of safety and security.

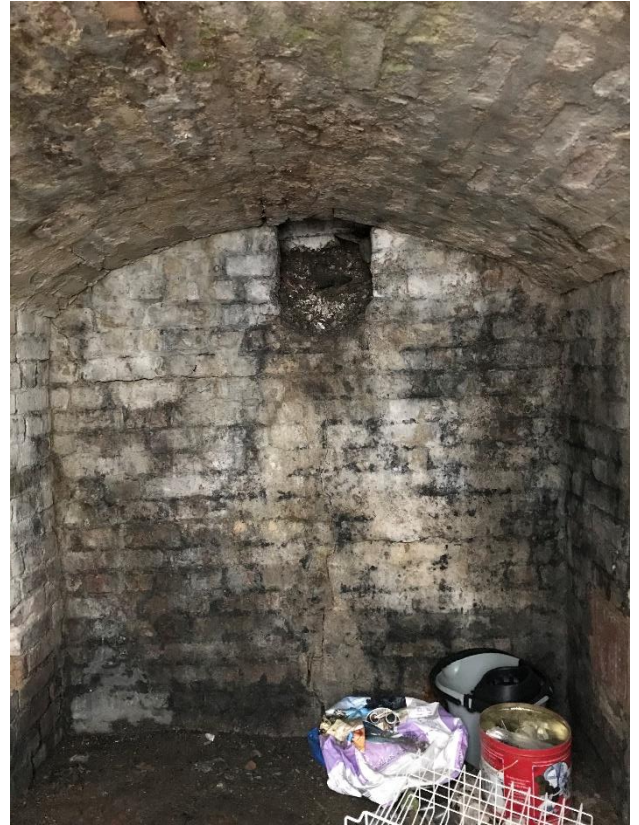
Interior of one of the vaults, with coal shute on the rear wall

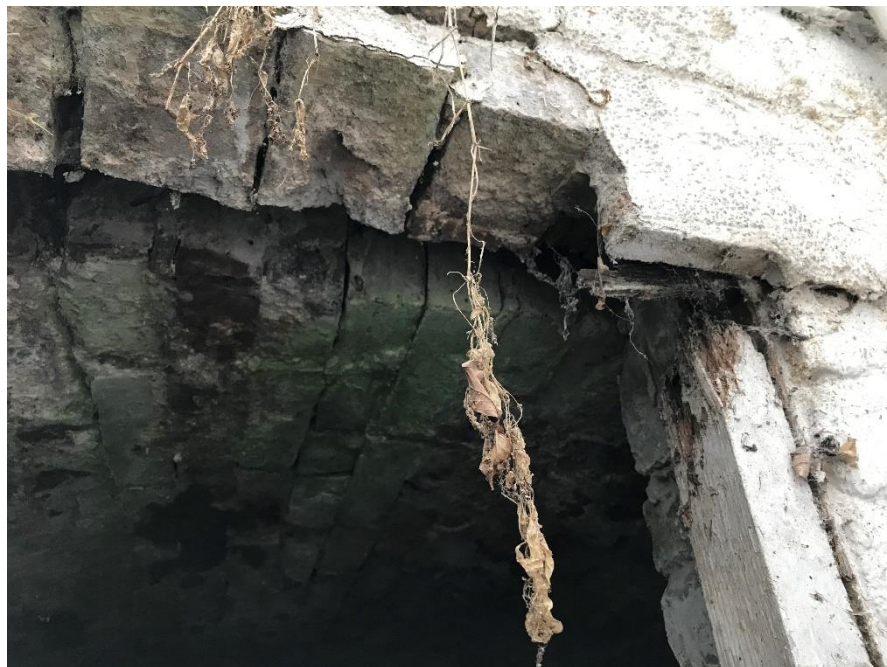
Retaining wall separated from vault ceiling
