## Arboricultural Consultancy for LV=

Insured		Address	29 Edis Street, London, NW1 8LE		
Client	Subsidence Management Services	Contact	Robbie Taylor	Claim No.	
ES Ref		Consultant	Kirk Thompson	Contact No.	
Report Date	09/03/2023

# GEOTECHNICAL

**29 Edis Street, London, NW1 8LE**

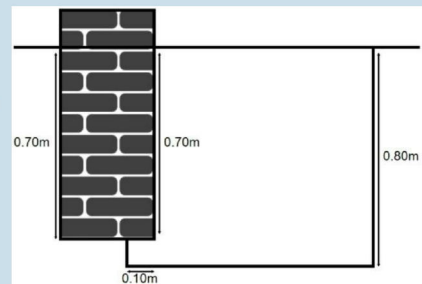
## TP/BH1 Foundation Detail and Borehole Log

Addition foundation comprised of brick wall to 700mm bgl with no projection from the elevation. Underside of foundation (USF) was exposed to 100mm back from the face of the foundation and probed 400mm back from the face of the foundation.

At 0.70m bgl UNDERSIDE OF ADDITION FOUNDATION in TP/BH1.
