35 Great Queen Street Heritage Impact Assessment

12 July 2023

- 1.1 This Heritage Impact Assessment (HIA) has been prepared by Lichfields on behalf of our clients, The United Grand Lodge of England. It assesses the effect of the proposal at 35 Great Queen Street, a Grade II* listed building.

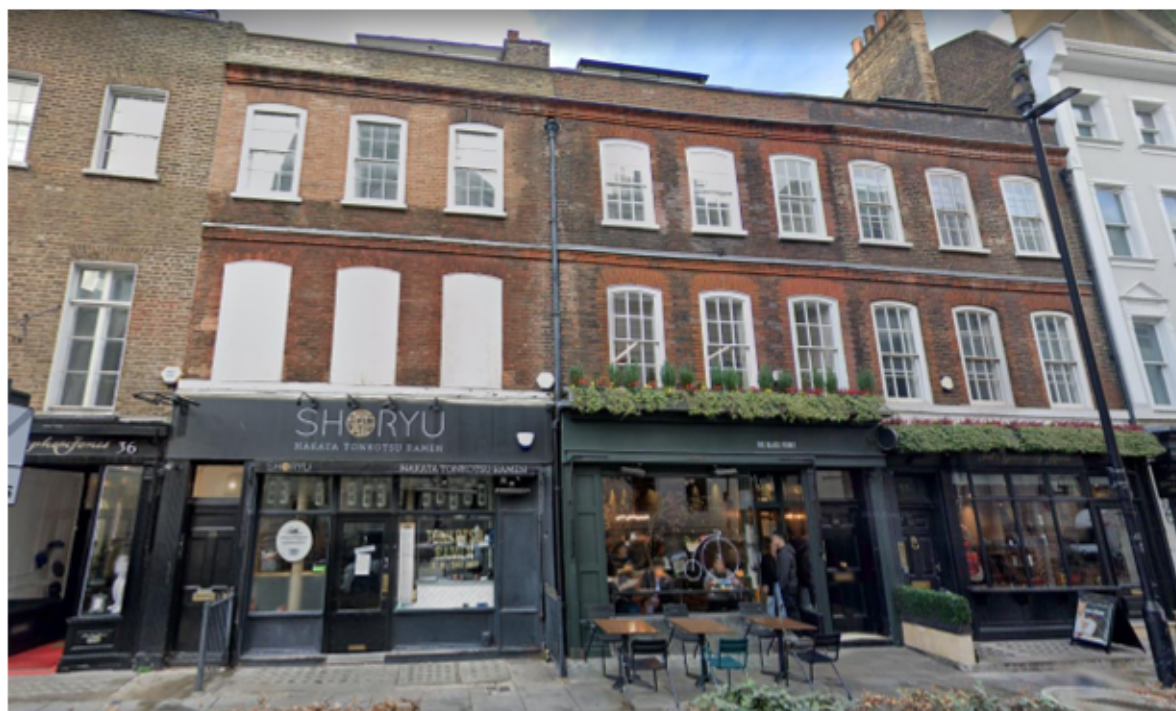
Figure 4.1 35 Great Queen Street on the left, with boarded up first floor windows. The rest of the listed terrace is to the right

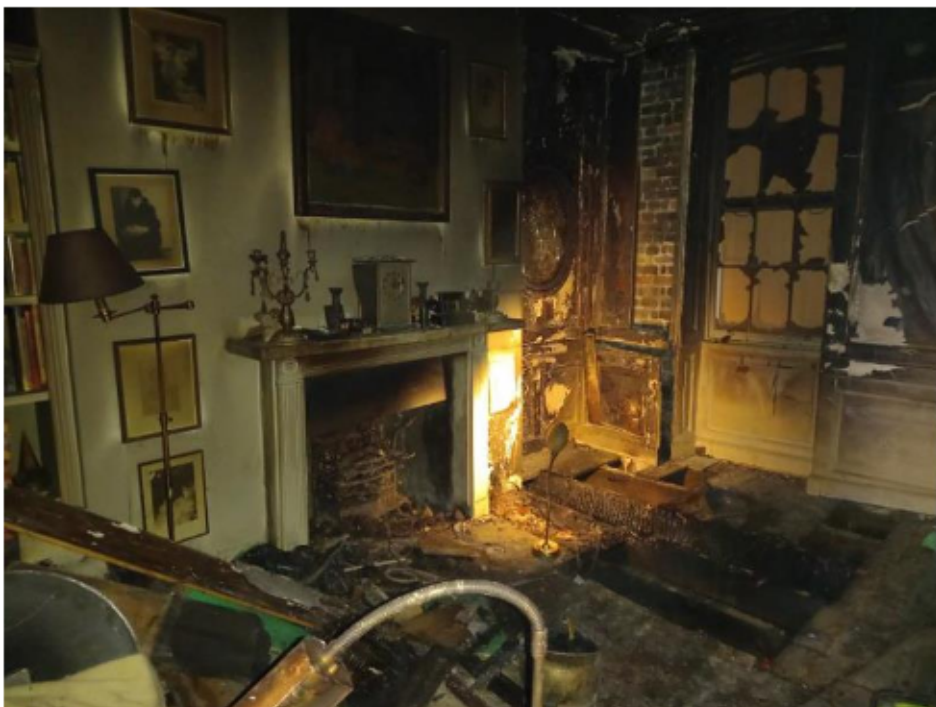
- Smoke damage was observed throughout the first floor flat and communal stairs at first floor level;
 - In addition to the timber floorboards being locally burnt away at the front right-hand corner of the first floor flat, the front chimney breast trimmer is severely charred, along with the end of the adjacent trimming joist across the front of the breast and the end of the adjacent floor joist;

- Further localised charring of the side faces of the adjacent floor joist and main floor beam up to 10mm depth has also occurred;
 - The timber panelling and stud structure to the front wall has also been locally burnt away, along with charring to the party wall panelling;

Figure 4.3 This shows the corner which is most fire damaged. The floor and the front wall panelling can be seen to be damaged. The exposed brick face is the part of the wall which did not have panelling before the fire. The fire surround can be seen as fire damaged.

- 'Given the extent of the fire damage observed to the timber floor joists and trimming members, in addition to the replacement of the destroyed timber floor boarding, it is recommended that these members be replaced, which will also require the replacement of the hearth and adjacent un-affected floor joists across the front of the chimney breast';

- c Strip out fire damaged wall panelling, coving and sash window. Refer to drawing no. 713.0000.WD.100 for extent of removal.
 - d Replace fire damaged wall panelling and coving with new to match the existing as detailed on drawing 713.0000.WD.100-1st Floor Extent of Proposed Works. All new timber is to match the original species.

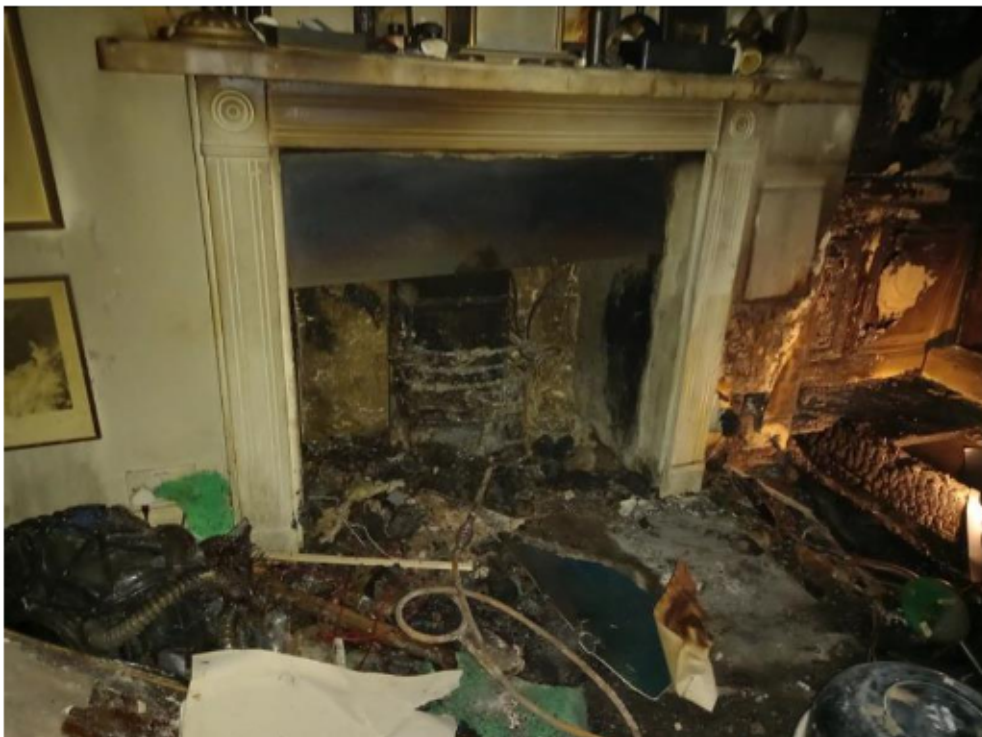
Figure 4.4 Fireplace and surround damage.

- g Replace fire damaged timber surround to fireplace match existing as detailed on drawing 713.0000.WD.100-1st Floor Extent of Proposed Works. New timber is to match the original species. Fireplace to be closed off to prevent use going forwards, with the opening boarded up with surround left in situ.

- 6.8 The existing fireplace surround will be repaired and decorated to make good. The fireplace itself will be closed off to prevent further use. The fireplace itself will be boarded up, with the exact method of closing the fireplace subject to agreement, with the surround left in situ. This could be re-opened at any point in the future and so would not be considered to harm the listed building's overall historic and architectural significance.

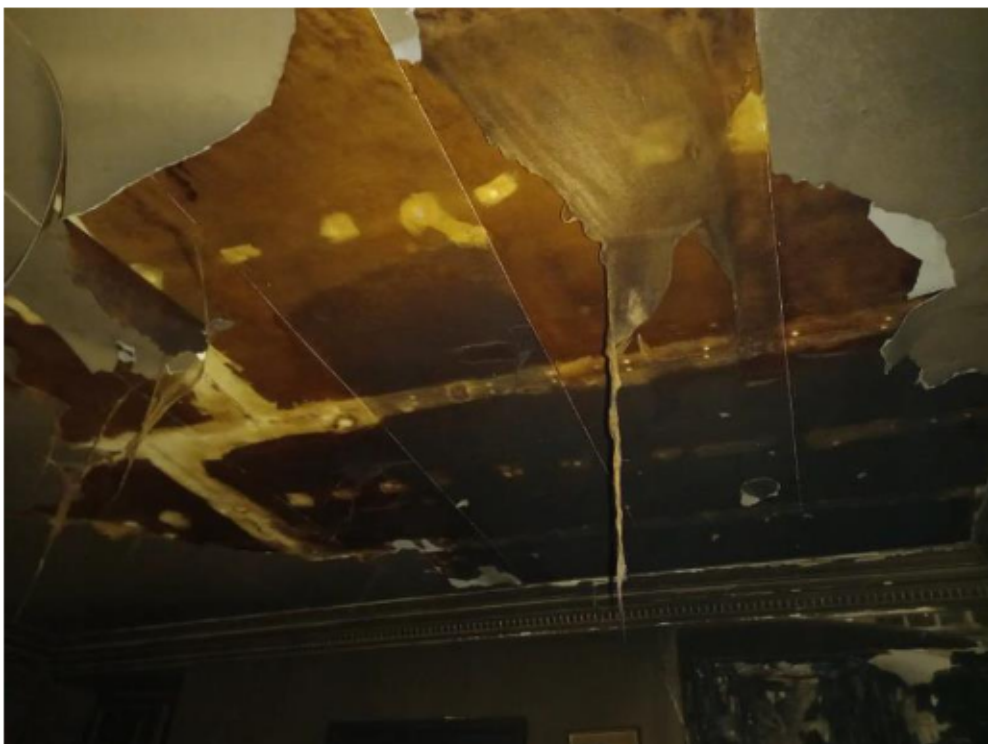
- Localised smoke damage was also noted to the second-floor joist and underside of the floor boarding over where they are exposed following an area of the suspended plasterboard ceiling locally collapsing;

Figure 4.5 Plasterboard ceiling

- a Within the living area strip out the existing suspended plasterboard ceiling and insulation batts above.
 - b Replace fire damaged ceilings to the first floor flat with GypFloor Silent flooring system to underside of existing joists finished with a skim coat of plaster ready for decoration. Existing ceilings are plasterboard with insulation batts above and the replacement will be to match the existing appearance.
