Tree Condition Report

2 Park Village East, London NW1 7PX

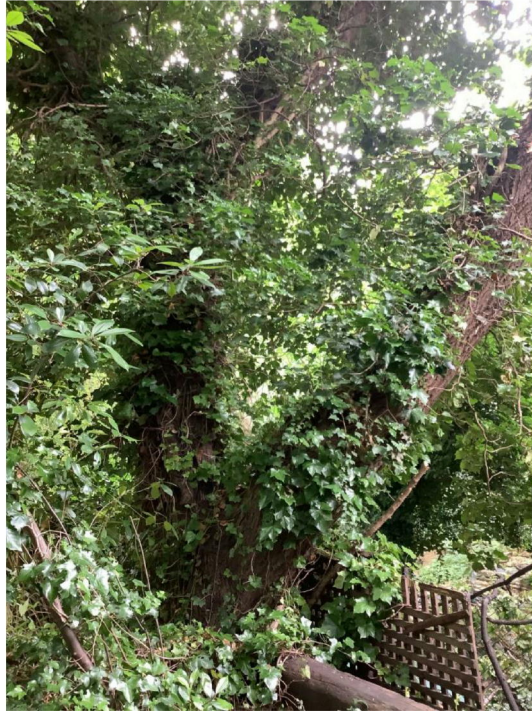
Photo.1

Tree is twin stemmed specimen with bifurcation at 2m (Photo.1). Extensive ivy growth enveloping remaining canopy. The tree has very little central growth due to the extent of ivy cover. The visible canopy is sparse and showing signs of dieback (Photo.3 and Photo.4), which is most likely chalarra [Ref.1], as are a number of other ash trees in the vicinity.

Fell the tree in sections to ground level and treat/grind the stump out. Plant replacement tree within 2m.

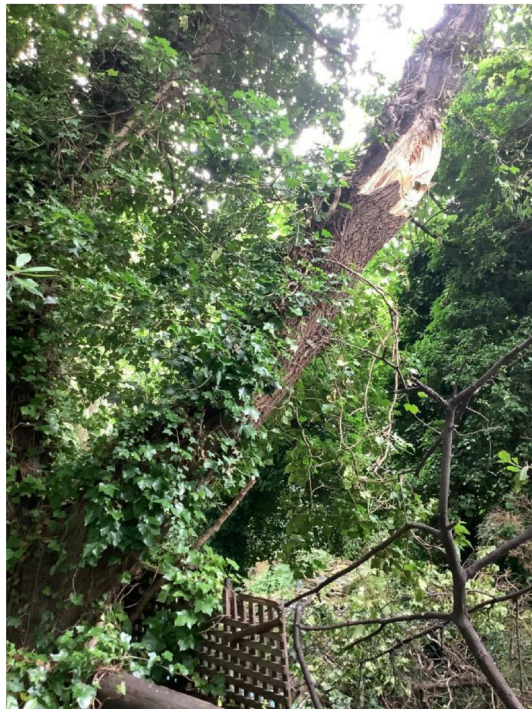
Photo.2

Tree has recently suffered large limb failure over adjacent bridge causing serious damage. Limb failed over a pedestrian footpath and onto high traffic road. The resulting damage to the tree is a large tear out at 6m on secondary leader to the NW (Photo.2).

Because of the prominent position of the tree and the proximity to high value targets, remedial work is necessary. The torn-out limb has left a large wound mid-way up a main stem which has compromised the structural integrity of the stem.
