University of London
Senate House
Malet Street
London
WC1E 7HU

The University of London submit this Request for listed building consent to carry out maintenance, repair and performance enhancement works to fire doors in Senate House located on Fire Escape Route Staircases within the University of London's demise.

PROPOSED ADDITIONAL FIRE RATED GLAZING TO ORIGINAL 1930S STAIRCASE DOORS TO IMPROVE FIRE PROTECTION TO PROTECTED ESCAPE STAIRCASE.

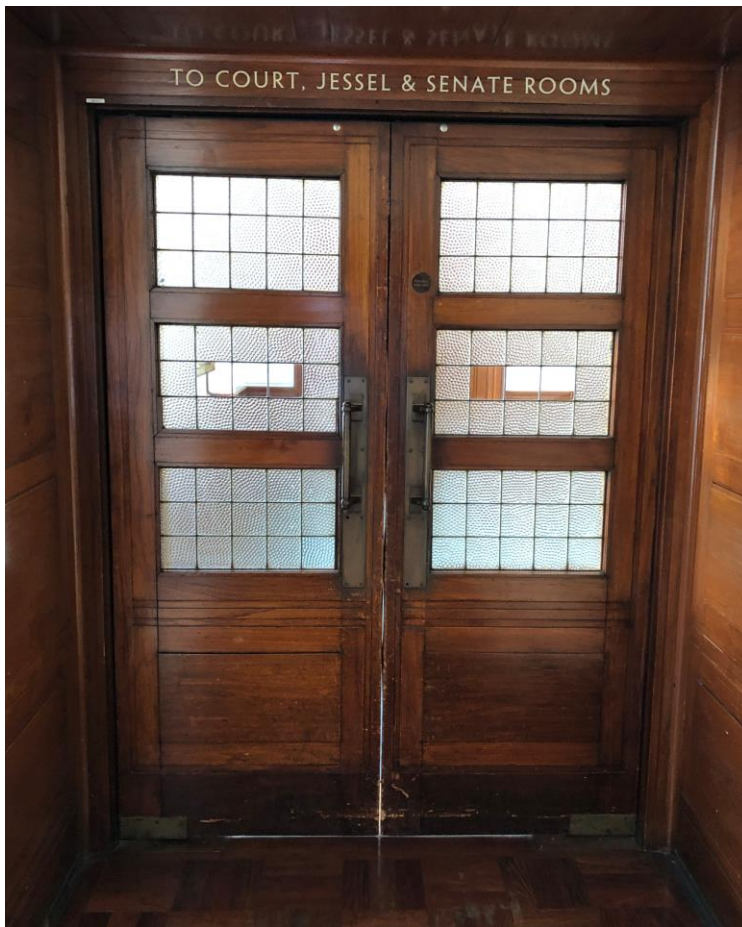
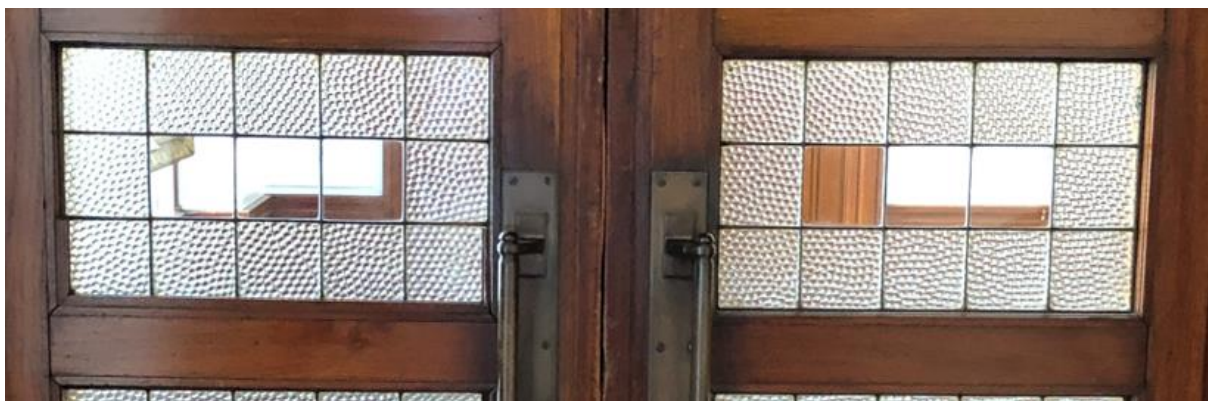
Proposed additional glazing to glazed doors. Typical for both 5 x3 and 4x3 multi panel doors.

Note the left hand leaf of this set of double doors leading to the Court, Jessel & Senate Rooms already has a small slotted bead applied (for signage) on top of the original glazing beading. The proposal is to fit additional solid beading to secure the new fire rated glass of the same thickness 12mm and stained, finished to match door. See drawing SENATE FRAW 0001 below.

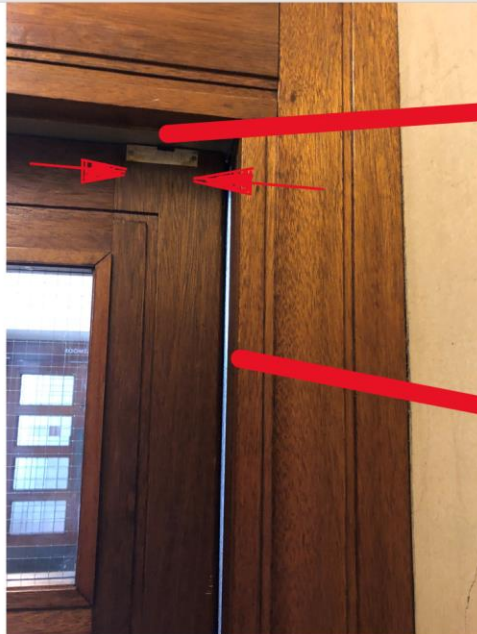
Door SHS2/14 (Typical Example)

Generic issue to doors with floor boxes

Excessive movement of door in frame at top pivot point.
Door to be removed, cause to be investigated.
Repair existing or replace pivot as applicable.

Excessive gap between door and frame when closed.
New cold smoke seals and intumescent strips to be fitted.

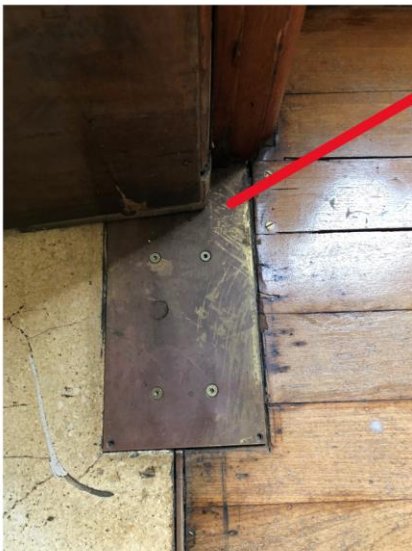
Example of:
Original 1930'3 floor box, doors not centralising due to worn mechanism or adjustment required.
Cover plate is loose and moves whendoor is operated.

Options.

1. Floor box cover to be removed, mechanism adjusted or overhauled if required/possible.
2. Remove internal of floor box and replace with a new

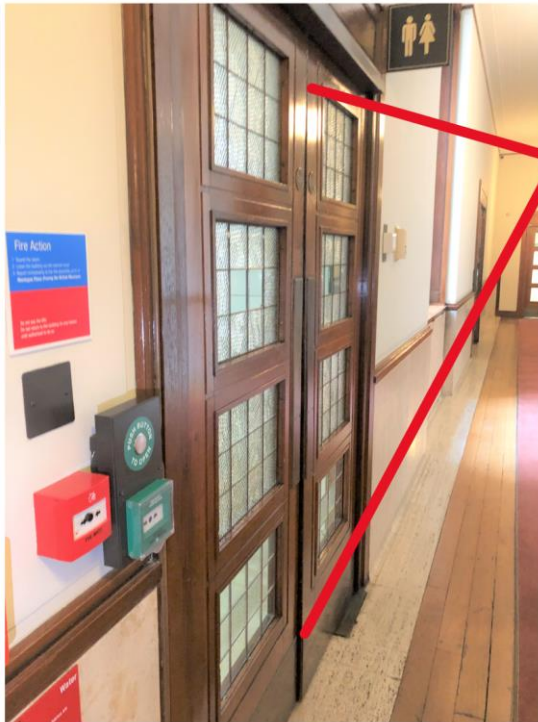
Door SHS 2/16

Example of a warped door leaf, doors not fully centralising.

Options.

- 1, Adjust both doors, move about their axis to achieve best centralisation possible.
- 2, Remove the door, un assemble and remove the warped style.

If style is unrepairable and can't be straightened manufacture a new style to match the original. Finishes to match existing.

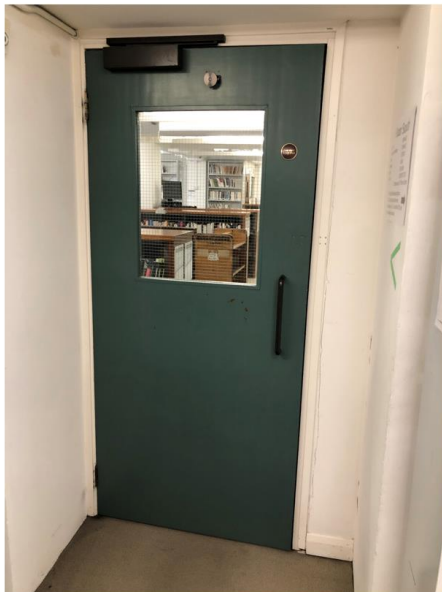
Door SHS 5/2

Example of modern style door fitted 2008 – 2012.

Door has suffered damage and does not self-close. Small nib of wall to the right is not fixed at floor level.

Proposal to replace the whole door set and the nib of stud wall and centralise the new door in the opening.

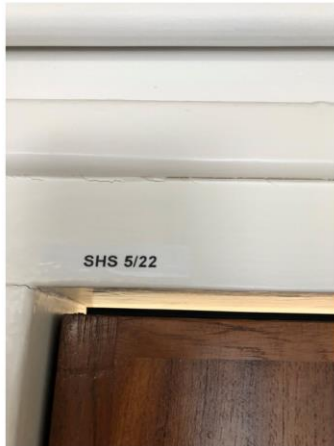
Door SHS 5/22

Example of excessive gap at top of door.

Options

- 1, Fit extended cold smoke seal and combined intumescent strip.
- 2, Fit an additional lipping to top of door to reduce the gap to a maximum of 4mm router out and fit new standard combined intumescent strips.
