**STRUCTURAL REPORT**

**26A FERNCROFT AVENUE  
LONDON  
NW3 7PH**

**PROJECT NO: P5641**

**JULY 2023**

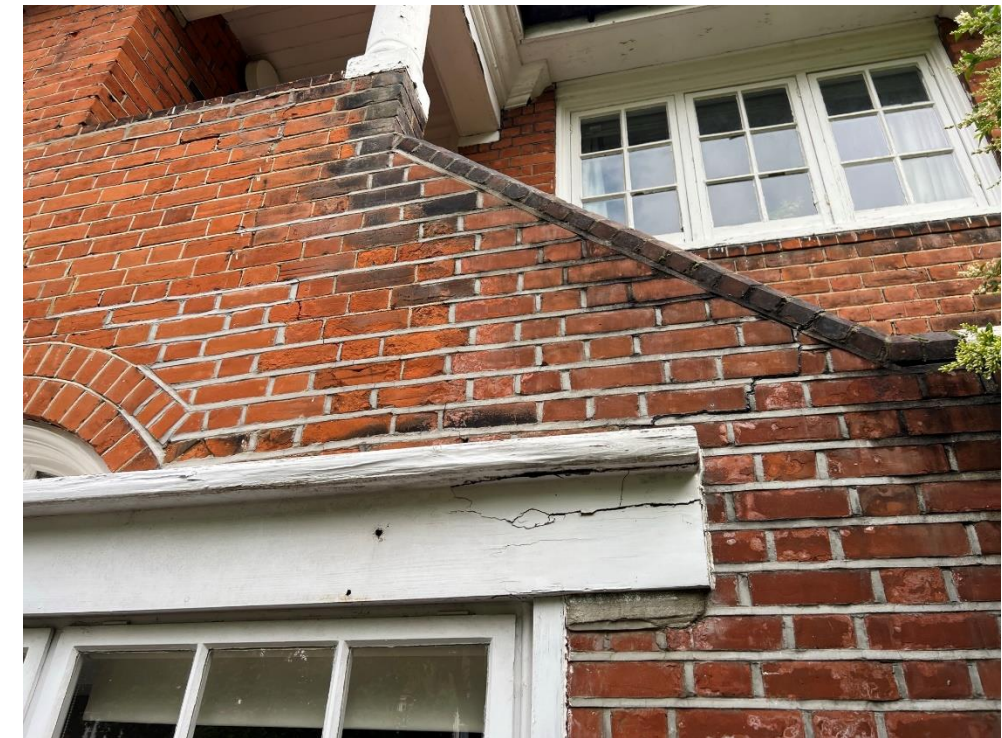
**Photo 3.05**

- 3.05 The brickwork of the front elevation appears to be in generally good condition. There is a crack above and to the right of the right-hand opening, which we assume relates to a defect in the lintel. Refer **photo 3.05**.

The opening on the right will be reduced to a smaller window, using the existing masonry arch. The assumed later addition of a lintel will be removed, and the remainder of the existing opening will be infilled with masonry.

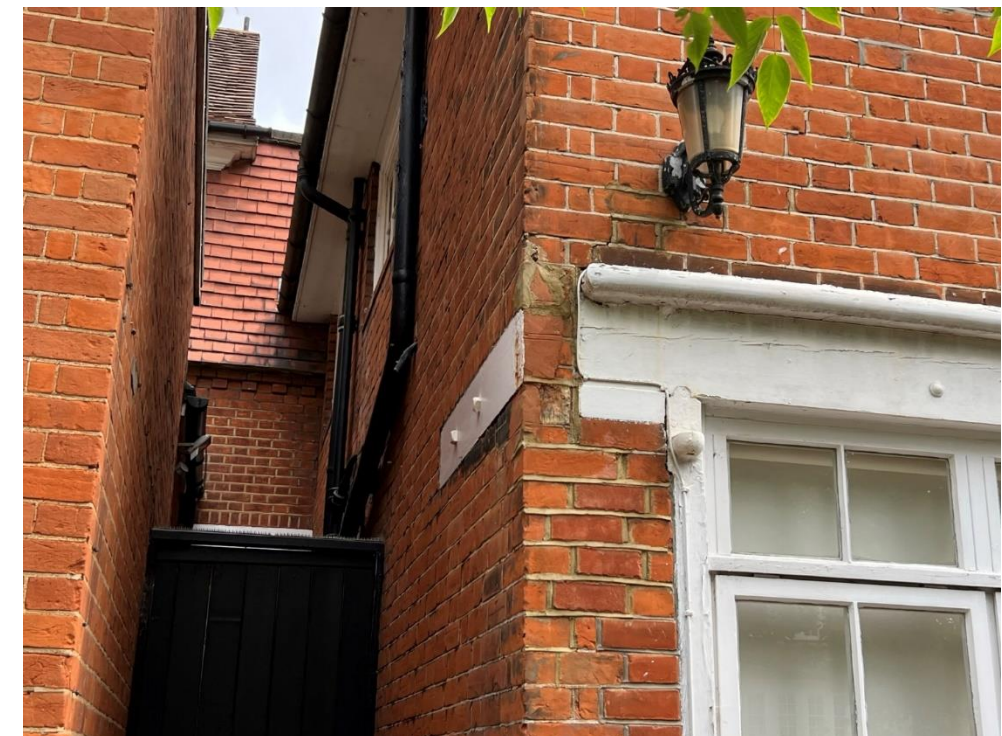
**Photo 3.07**

- 3.07 There is a slight bulge to the left-hand side of the side elevation, at first floor level. A restraint detail is visible on the side of the house at this level. Refer **photo 3.07**. It is assumed this is due to a lack of connection between floor joists and masonry wall, which has not been rectified. This will be verified by opening up works, once the building work begins, and additional ties added as required.

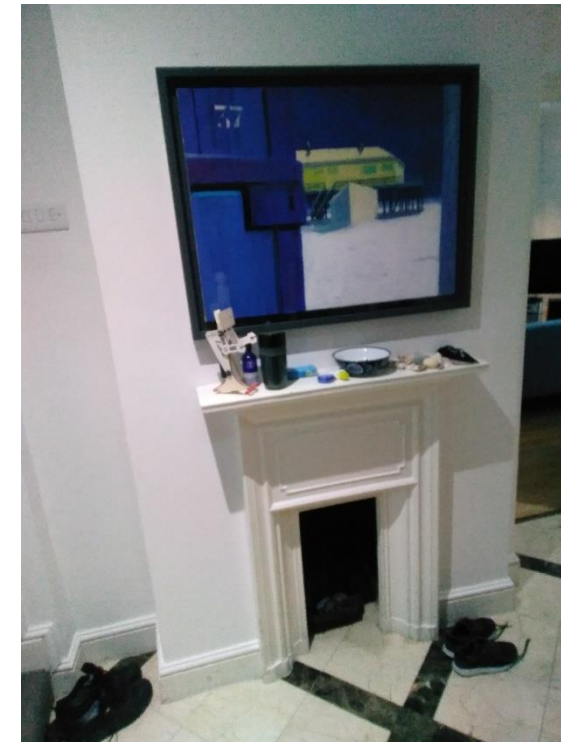
Photo 3.09/1

- 3.09 It is assumed that the main loadbearing wall internally is the central spine wall, running from front to back. There are fireplaces on this wall at ground and first floor, and a chimney stack above. Refer **photo 3.09/1** and **photo 3.09/2**. Other walls at ground floor are assumed to be partitions added later and not load bearing.
- 3.10 The fireplace and chimney breast in the living room, on the external wall, is decorative only, as there is no chimney breast at first floor and above.

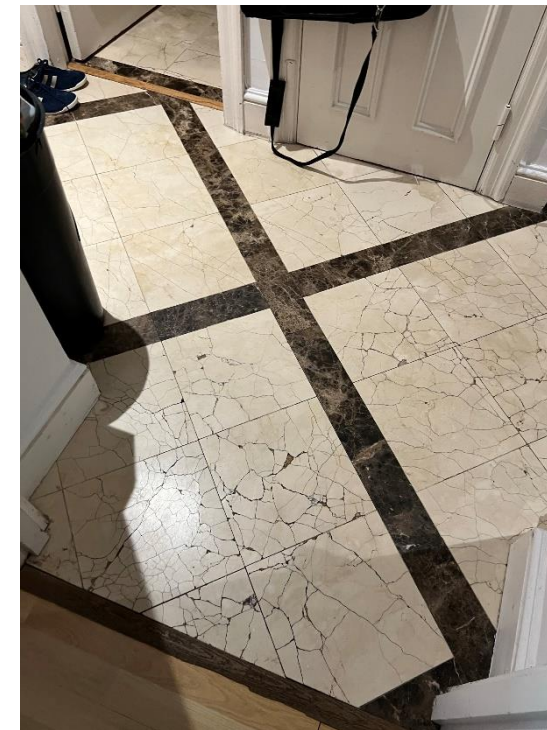
**Photo 3.11**

- 3.11 The ground floor is of generally solid construction, with the exception of the rear reception room, which has a timber suspended floor. The tiling to the hallway shows extensive crazing/cracking. Refer **photo 3.11**
- 3.12 The ground floor is on three different levels. To the rear, there are steps up to a living area, and a further set of steps up to the kitchen. Refer **photo 3.12**

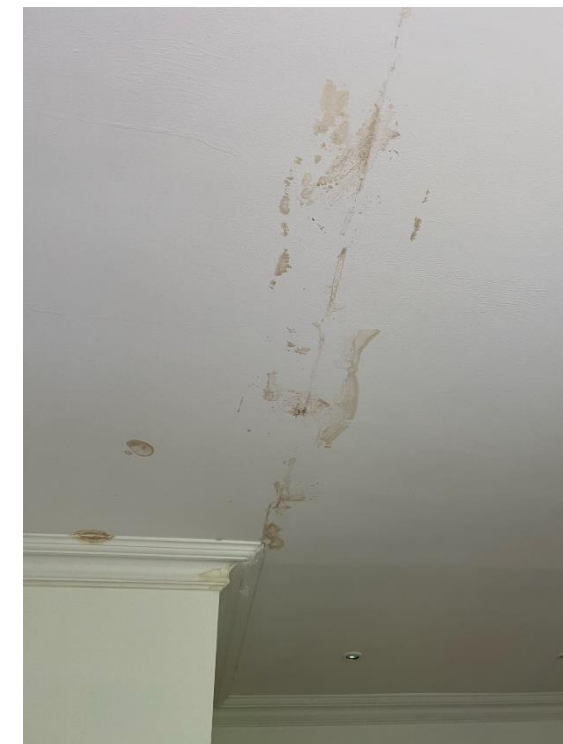
Photo 3.16

- 3.13 The first floor is formed of timber joists spanning side to side, bearing on the flank walls and the central spine wall described in 3.09 above.
- 3.14 To the rear, the extended areas are constructed from masonry, with assumed timber joist floors.
- 3.15 Some cracking is apparent in the ceiling of the ground floor living room, and in the first floor bathroom above. The floor joists in this area will be inspected and rectification works carried out if required.
- 3.16 On the ceiling of the rear bedroom, there was a line of staining. This is believed to be at the junction of the flat roof to the pitched roof, and so is likely to be associated with water ingress at this junction. Refer **photo 3.16**.

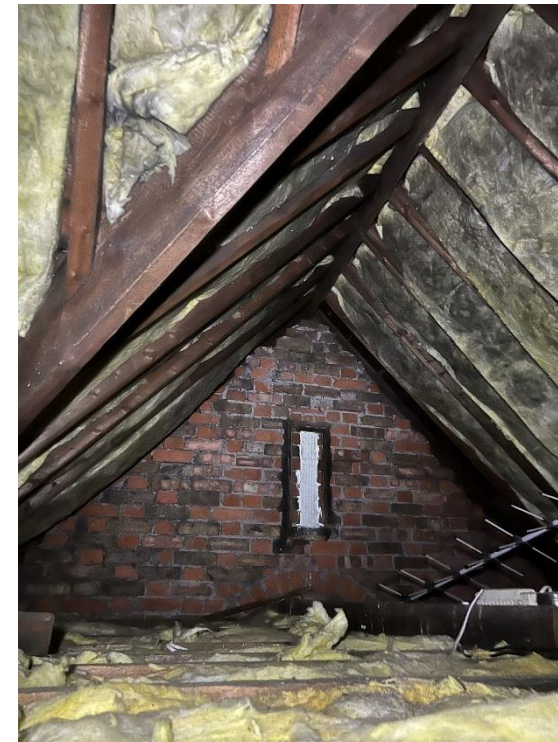
Photo 3.17

- 3.17 The attic space is currently empty, and is not used for storage. The attic has been insulated at rafter level and within the loft floor. Refer **photo 3.17**.
- 3.18 There was limited visibility of the attic joists, but from what could be seen, they appeared to be in reasonable condition.
- 3.19 The chimney breast was visible in the attic space, and looked to be in good condition. Refer **photo 3.19**.
- 3.20 The pitched roof structure was visible from the attic space. The rafters appeared to be in good condition, with some obvious distortion of the roof.

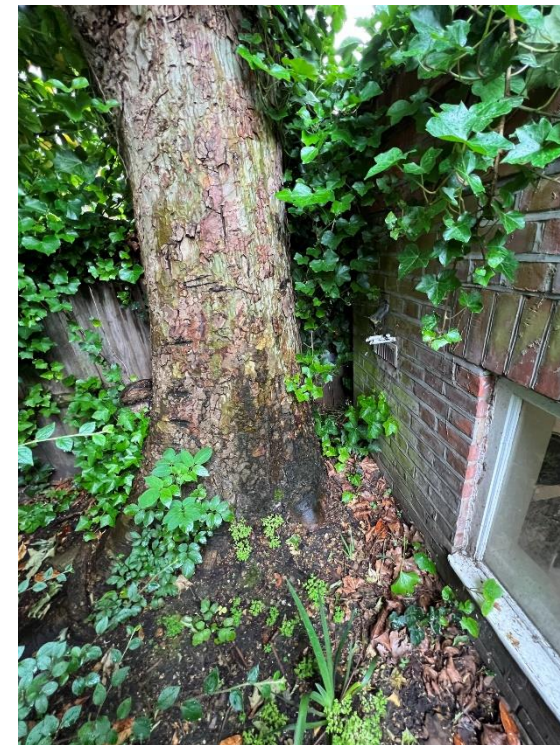
Photo 3.21

- 3.21 The rear garden contains a large tree, immediately adjacent to the rear of the house. Refer **photo 3.21**.
- 3.22 There are short retaining walls around the patio, with steps up, to allow access between the area immediately behind the house, which is paved, to the main garden level at the rear. Refer photo **3.22**
