## Arboricultural Appraisal Report

### Subsidence Damage Investigation at:

138 Haverstock Hill  
London  
NW3 2AY

| REPORT DATE: | 13/04/2023 |

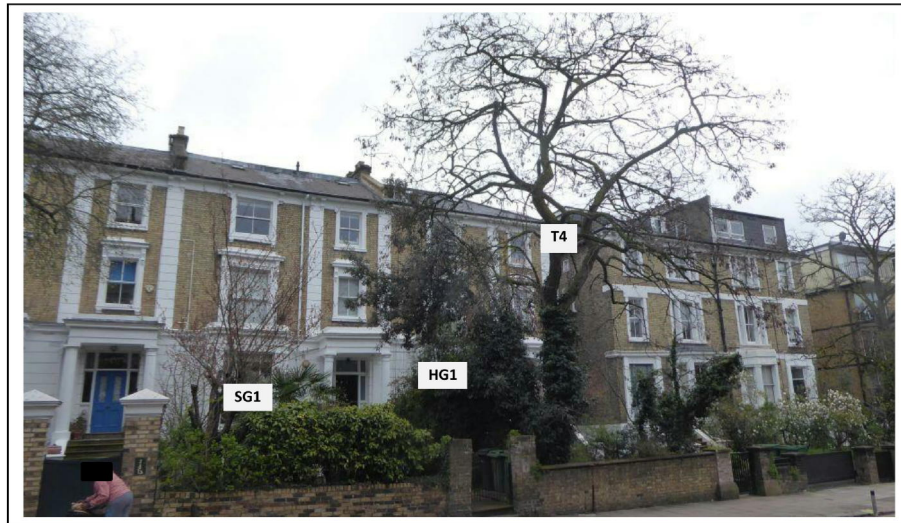
Roots were observed below foundation depth in TP/BH1 and BH2 and recovered samples have been positively identified (using anatomical analysis) as *Pittosporum* spp. and *Leguminosae* spp.; the origins of which will be the *Pittosporum* of HG1 and the False Acacia T4, confirming their influence on the soils below the foundations.

Overview of T4 False Acacia, HG1 hedgerow group and SG1 mixed spp. shrub group

If an arboricultural solution is to be implemented to mitigate the influence of the implicated trees/vegetation we recommend that the T4 False Acacia is removed and that HG1 hedgerow group is subject to significant crown management. Other vegetation recorded presents a potential future risk to building stability and management is therefore recommended. Recommended tree works may however be subject to change upon receipt of additional information.

| Tree No. | Species | Ht (m) | Dia (mm) | Crown Spread (m) | Dist. to building (m) | Age Classification | Ownership |
|---|---|---|---|---|---|---|---|
| Recommendation | | Remove (fell) to near ground level and treat stump to inhibit regrowth. | | | | | |

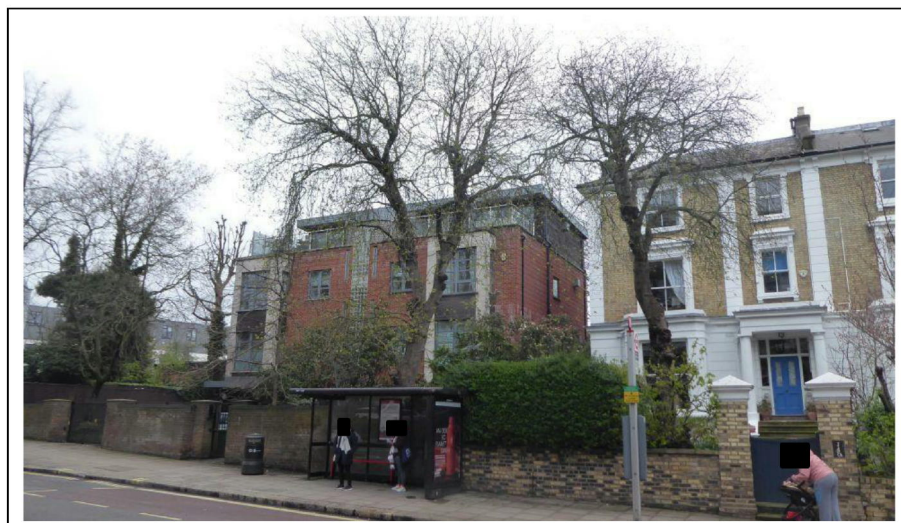
View of TG3 Horse Chestnut group

| Tree No. | Species | Ht (m) | Dia (mm) | Crown Spread (m) | Dist. to building (m) | Age Classification | Ownership |
|---|---|---|---|---|---|---|---|
| Recommendation | | Maintain broadly at no more than current dimensions by periodic pruning. | | | | | |

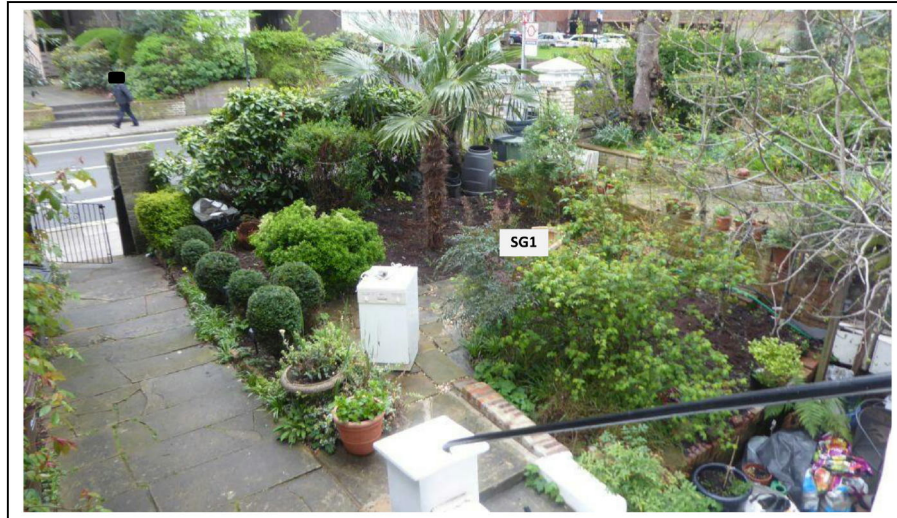
View of SG1 shrub group

| Tree No. | Species | Ht (m) | Dia (mm) | Crown Spread (m) | Dist. to building (m) | Age Classification | Ownership |
|---|---|---|---|---|---|---|---|
| Recommendation | | Maintain broadly at no more than current dimensions by periodic pruning. | | | | | |

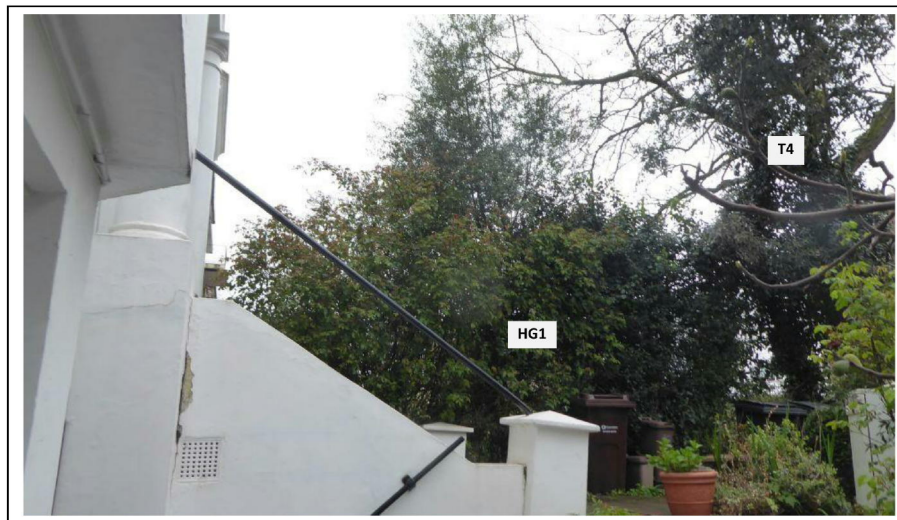
View of HG1 hedgerow group and T4 False Acacia

| Tree No. | Species | Ht (m) | Dia (mm) | Crown Spread (m) | Dist. to building (m) | Age Classification | Ownership |
|---|---|---|---|---|---|---|---|
| Recommendation | | Reduce height to 2.0m and cut back sides to leave no wider than 1.0m. Trim thereafter on an annual cycle to maintain at broadly reduced dimensions. | | | | | |
