4.1 Mecklenburgh Square No. 47

Mecklenburgh Square No 47

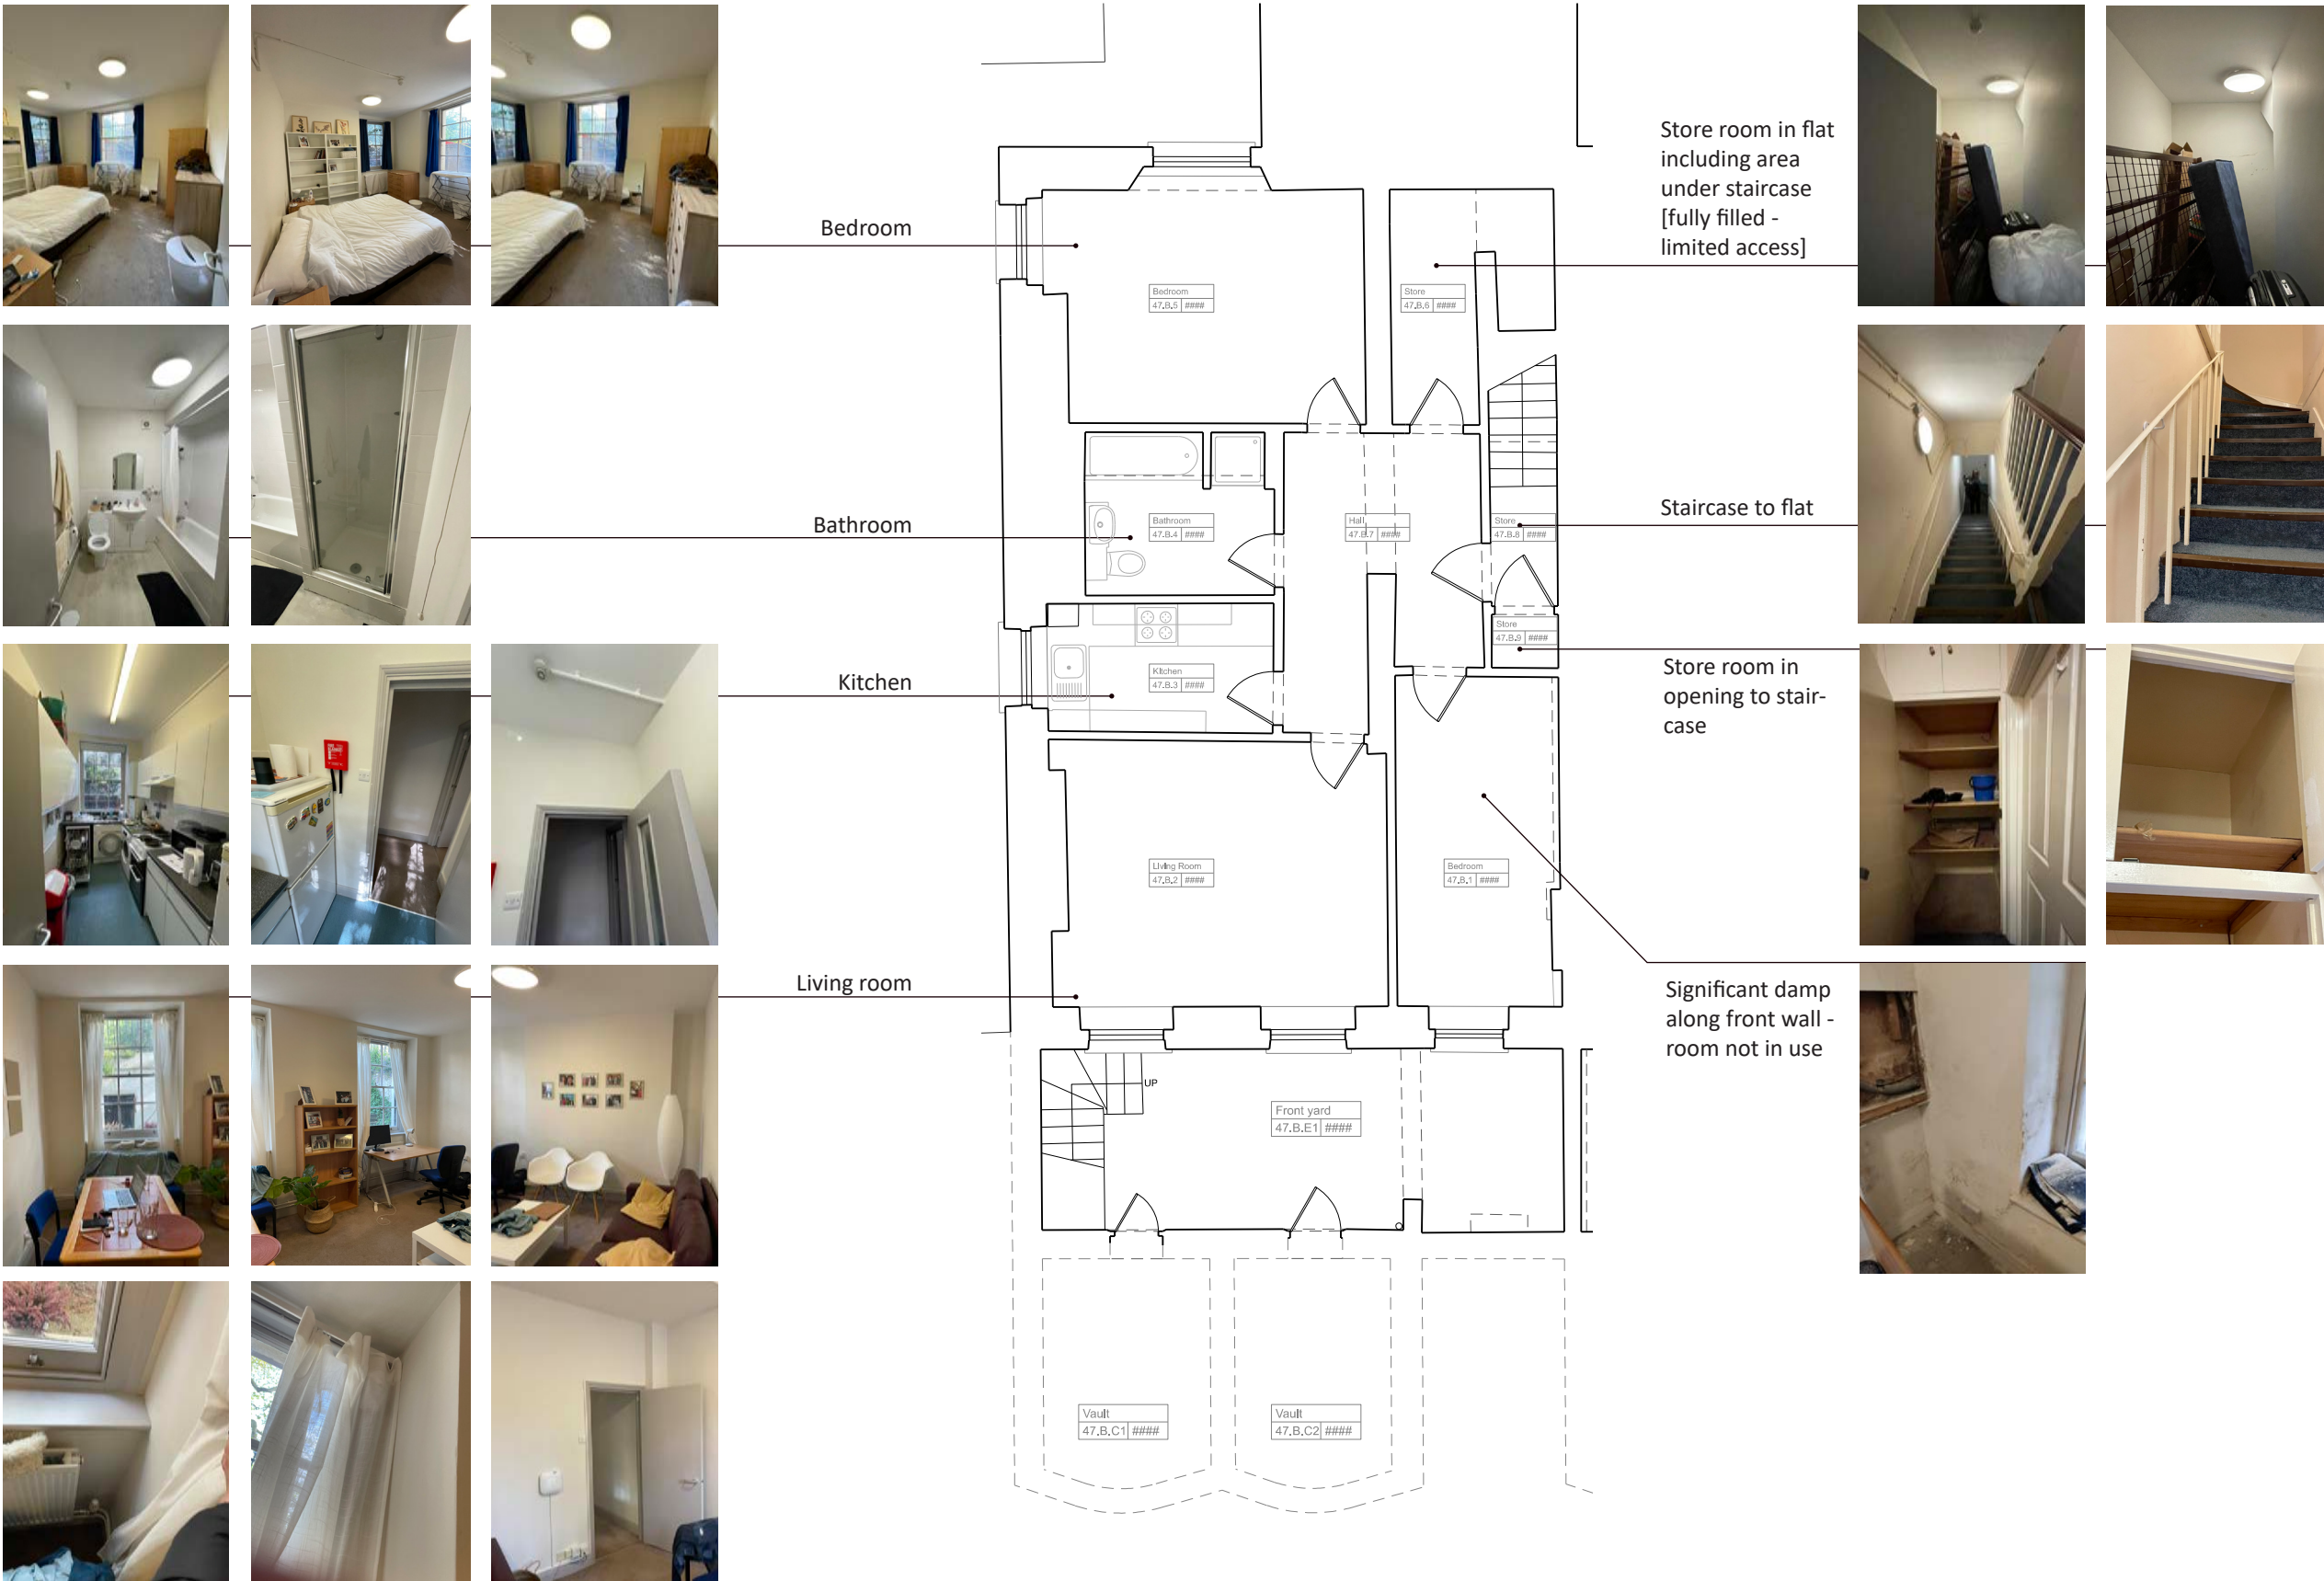
4.1 Mecklenburgh Square No. 47 | BASEMENT

Description	Note / Features	Walls	Ceiling	Floor	Windows
No 47						
Basement						
47.B.1	Bedroom	not inspected, report of damp	Recommendation for room to be opened up for team to inspect

47.B.4	Bathroom	Bath, separate shower, WC and sink. Fan to outer wall with access panel adjacent.	Tiled around bath and half height to sink.	Painted, plasterboard, crack visible in centre towards outer wall	Vinyl	N/A
