4.2 Mecklenburgh Square No. 46

Mecklenburgh Square No 46

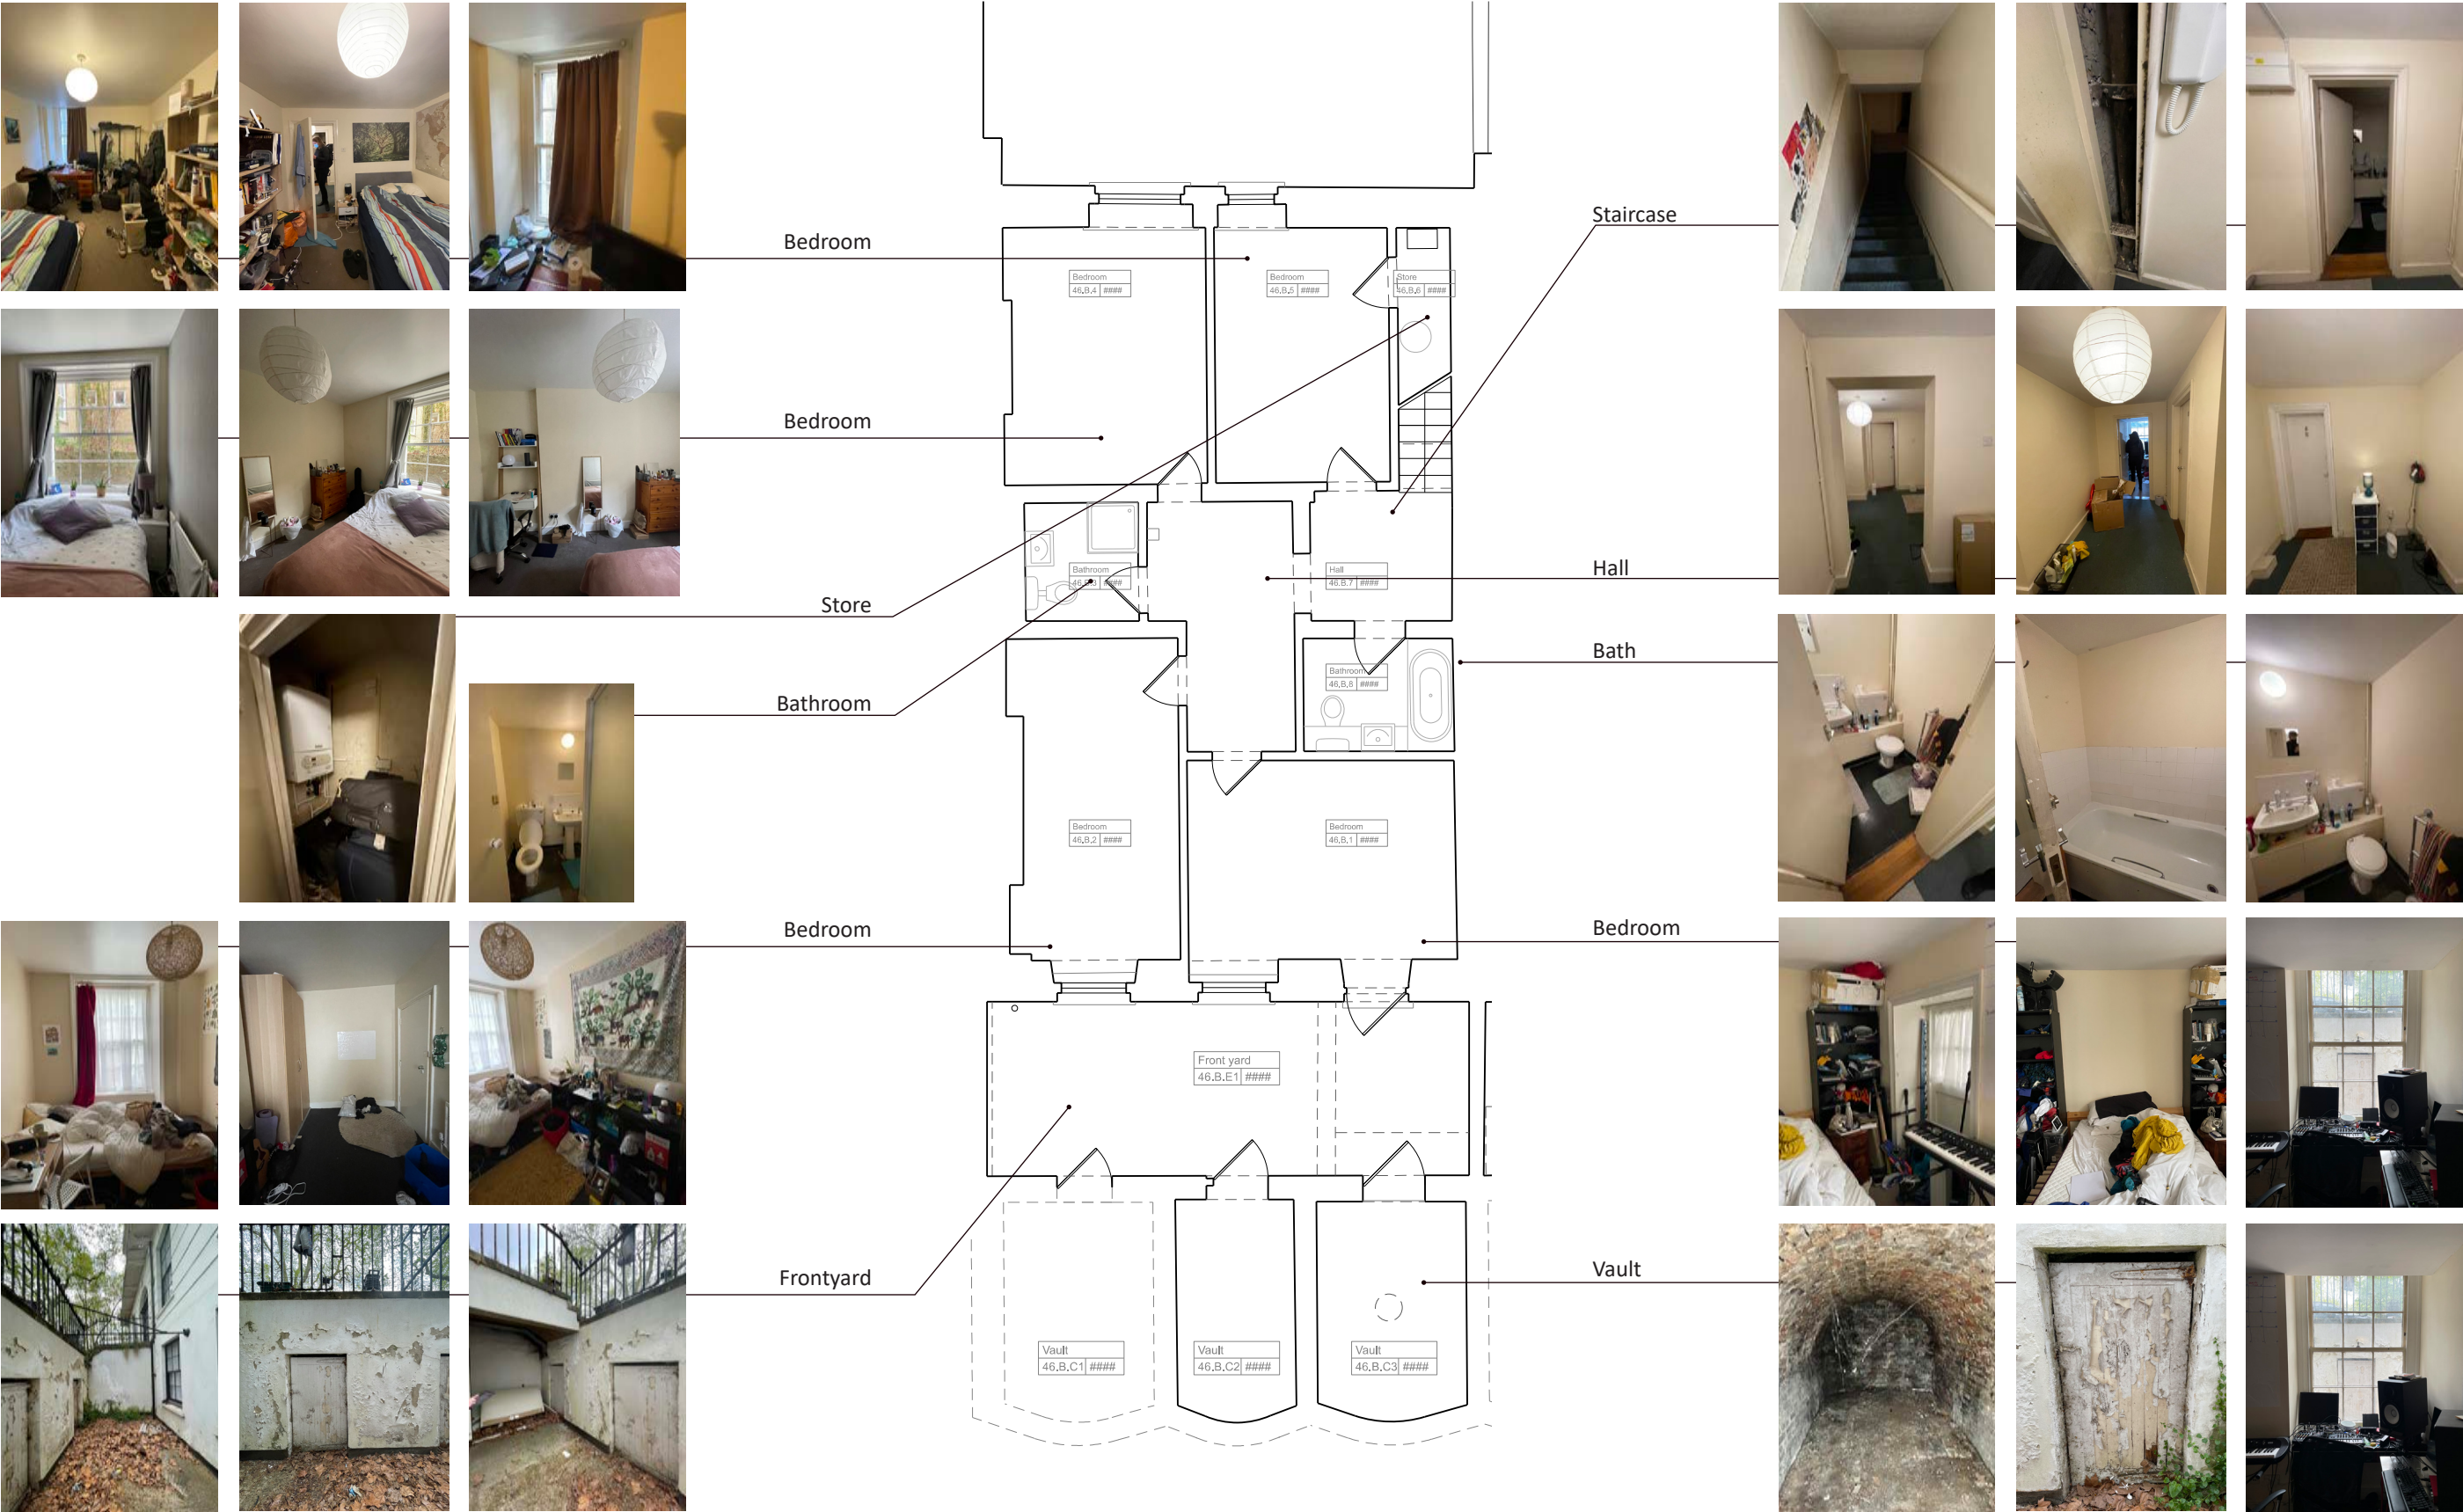
4.2 Mecklenburgh Square No. 46 | BASEMENT

Description	Note / Features	Walls	Ceiling	Floor	Windows
No 46						
Basement						
46.B.1	Bedroom		Painted plasterboard, surface mounted skirting board	Painted plasterboard, no features	Carpet	Sash window timber surround no shutter or timber surround

46.B.2	Bedroom		Painted plasterboard, surface mounted skirting board	Painted plasterboard, no features	Carpet	Sash window timber architrave to floor
46.B.3	Bathroom		Painted plasterboard, cove skirting	Painted plasterboard	Vinyl

46.B.4	Bedroom		Painted plasterboard, wallpaper to	Painted plasterboard, no features	Carpet	Sash window timber architrave to window cill
46.B.5	Bedroom		Painted plasterboard, surface mounted skirting board	Painted plasterboard, no features	Carpet	Sash window no timber reveal

46.B.6	Store	Boiler	Painted plasterboard, surface mounted skirting board	Painted plasterboard	Board	No windows
46.B.7	Corridor		Painted plasterboard, surface mounted skirting board	Painted plasterboard	Carpet	No windows

46.B.8	WC	Bath	Plaster	Painted plasterboard	Latex black	No windows
46.B.C1	Vault	not inspected, blocked				
46.B.C2	Vault		Brick	Brick vault	Brick / soil

46.B.C3	Vault	not inspected, not openable				
46.B.E1	Frontyard		Painted render	Concrete	Cement concrete	
Ground Floor						
46.0.1	Entrance	Gas main running on east side	Painted plasterboard, skirting and dado rail at 1.3m	Painted plasterboard with cornice	Stone	Fanlights for external door and inner door similar

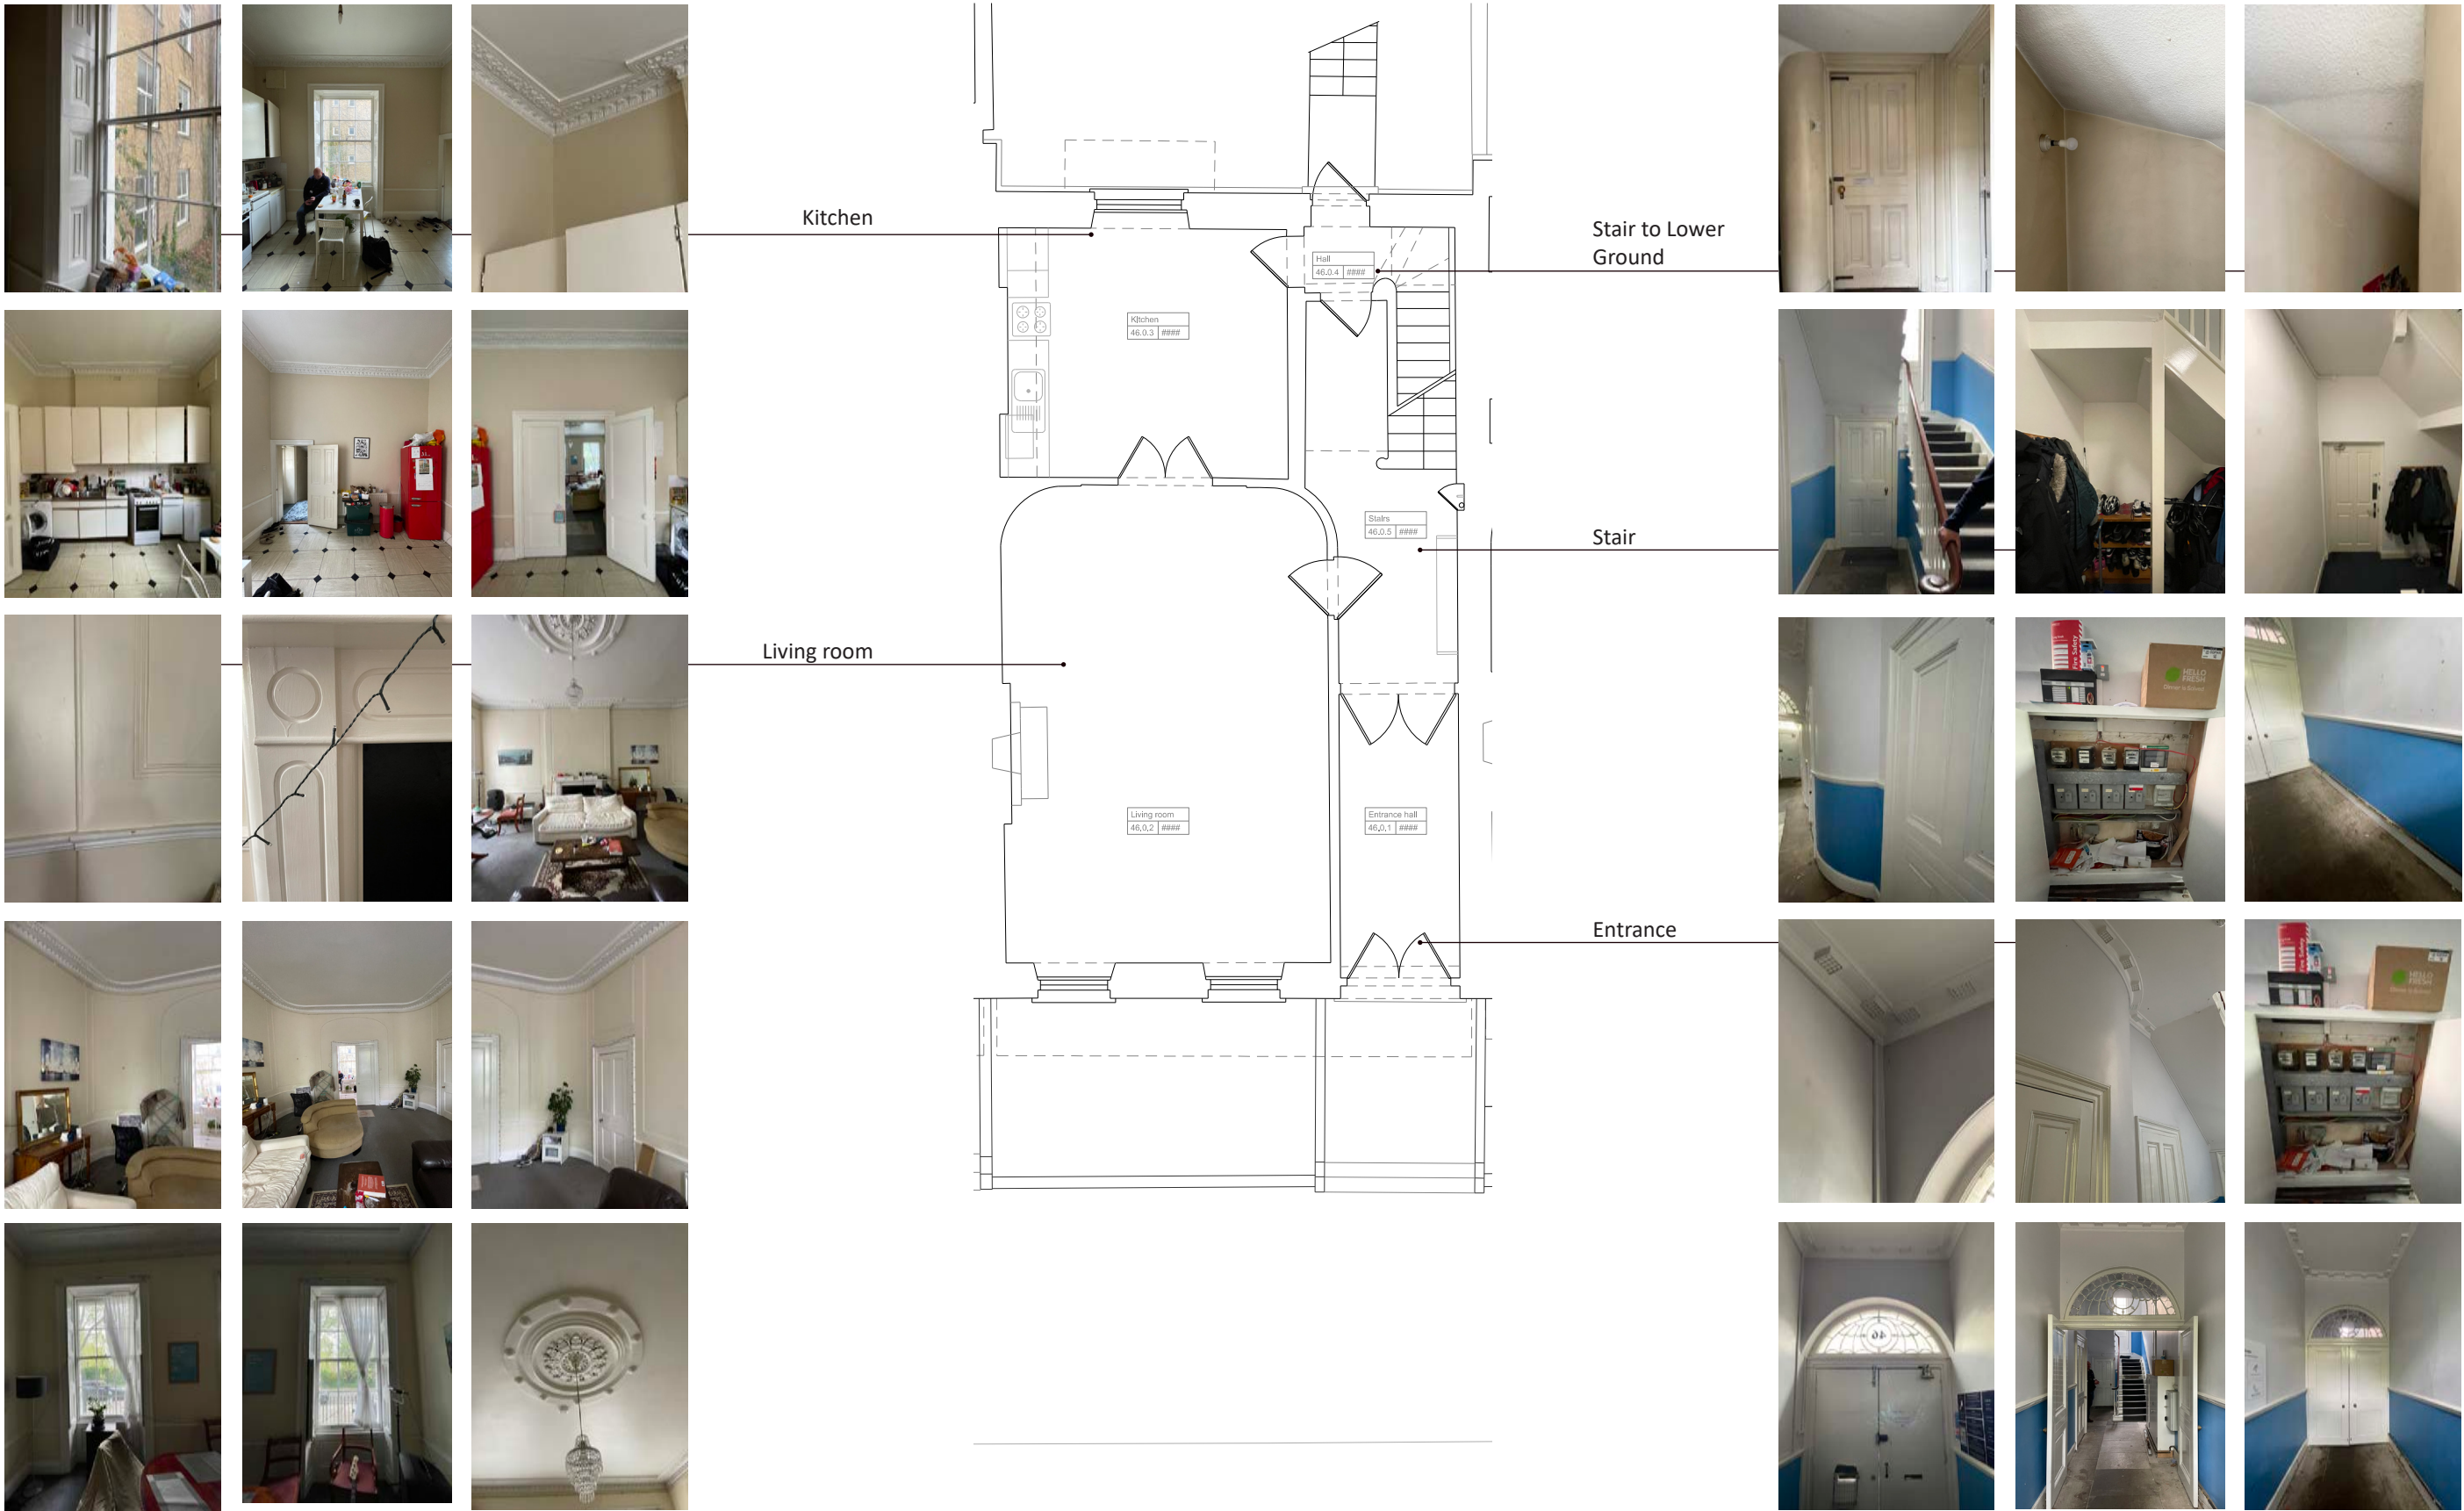
No. 46 | GROUND FLOOR

46.0.2	Front Room	Picture rail, Fireplace, painted surround possible timber, iron centre,	Painted plasterboard, surface mounted skirting, Dado Rail and picture rail	Painted plaster with central rose mould and cornice	Carpet	Sash window with architrave going down, weight cut.

46.0.3	Kitchen	Access point to chimney breast, no visible fire place feature however kitchen installed in front	Painted plasterboard, surface mounted skirting, Dado Rail	Painted plasterboard with cornice	Vinyl	Sash window architrave to floor shutters painted in, nobs removed.

46.0.4	Staircase to Basement	Curved junction, including curved skirting.	Painted plasterboard, skirting	Painted woodship ceiling	Carpet	Timber door with glazing at upper part. Timber surround.

46.0.5	Staircase	Gas main running on east side, Balustrade steel with plain timber top, curved junctions	Painted plasterboard, Skirting and dado rail at 1.3m	Painted plasterboard with cornice	Stone	Timber split casement with timber shutter
First Floor

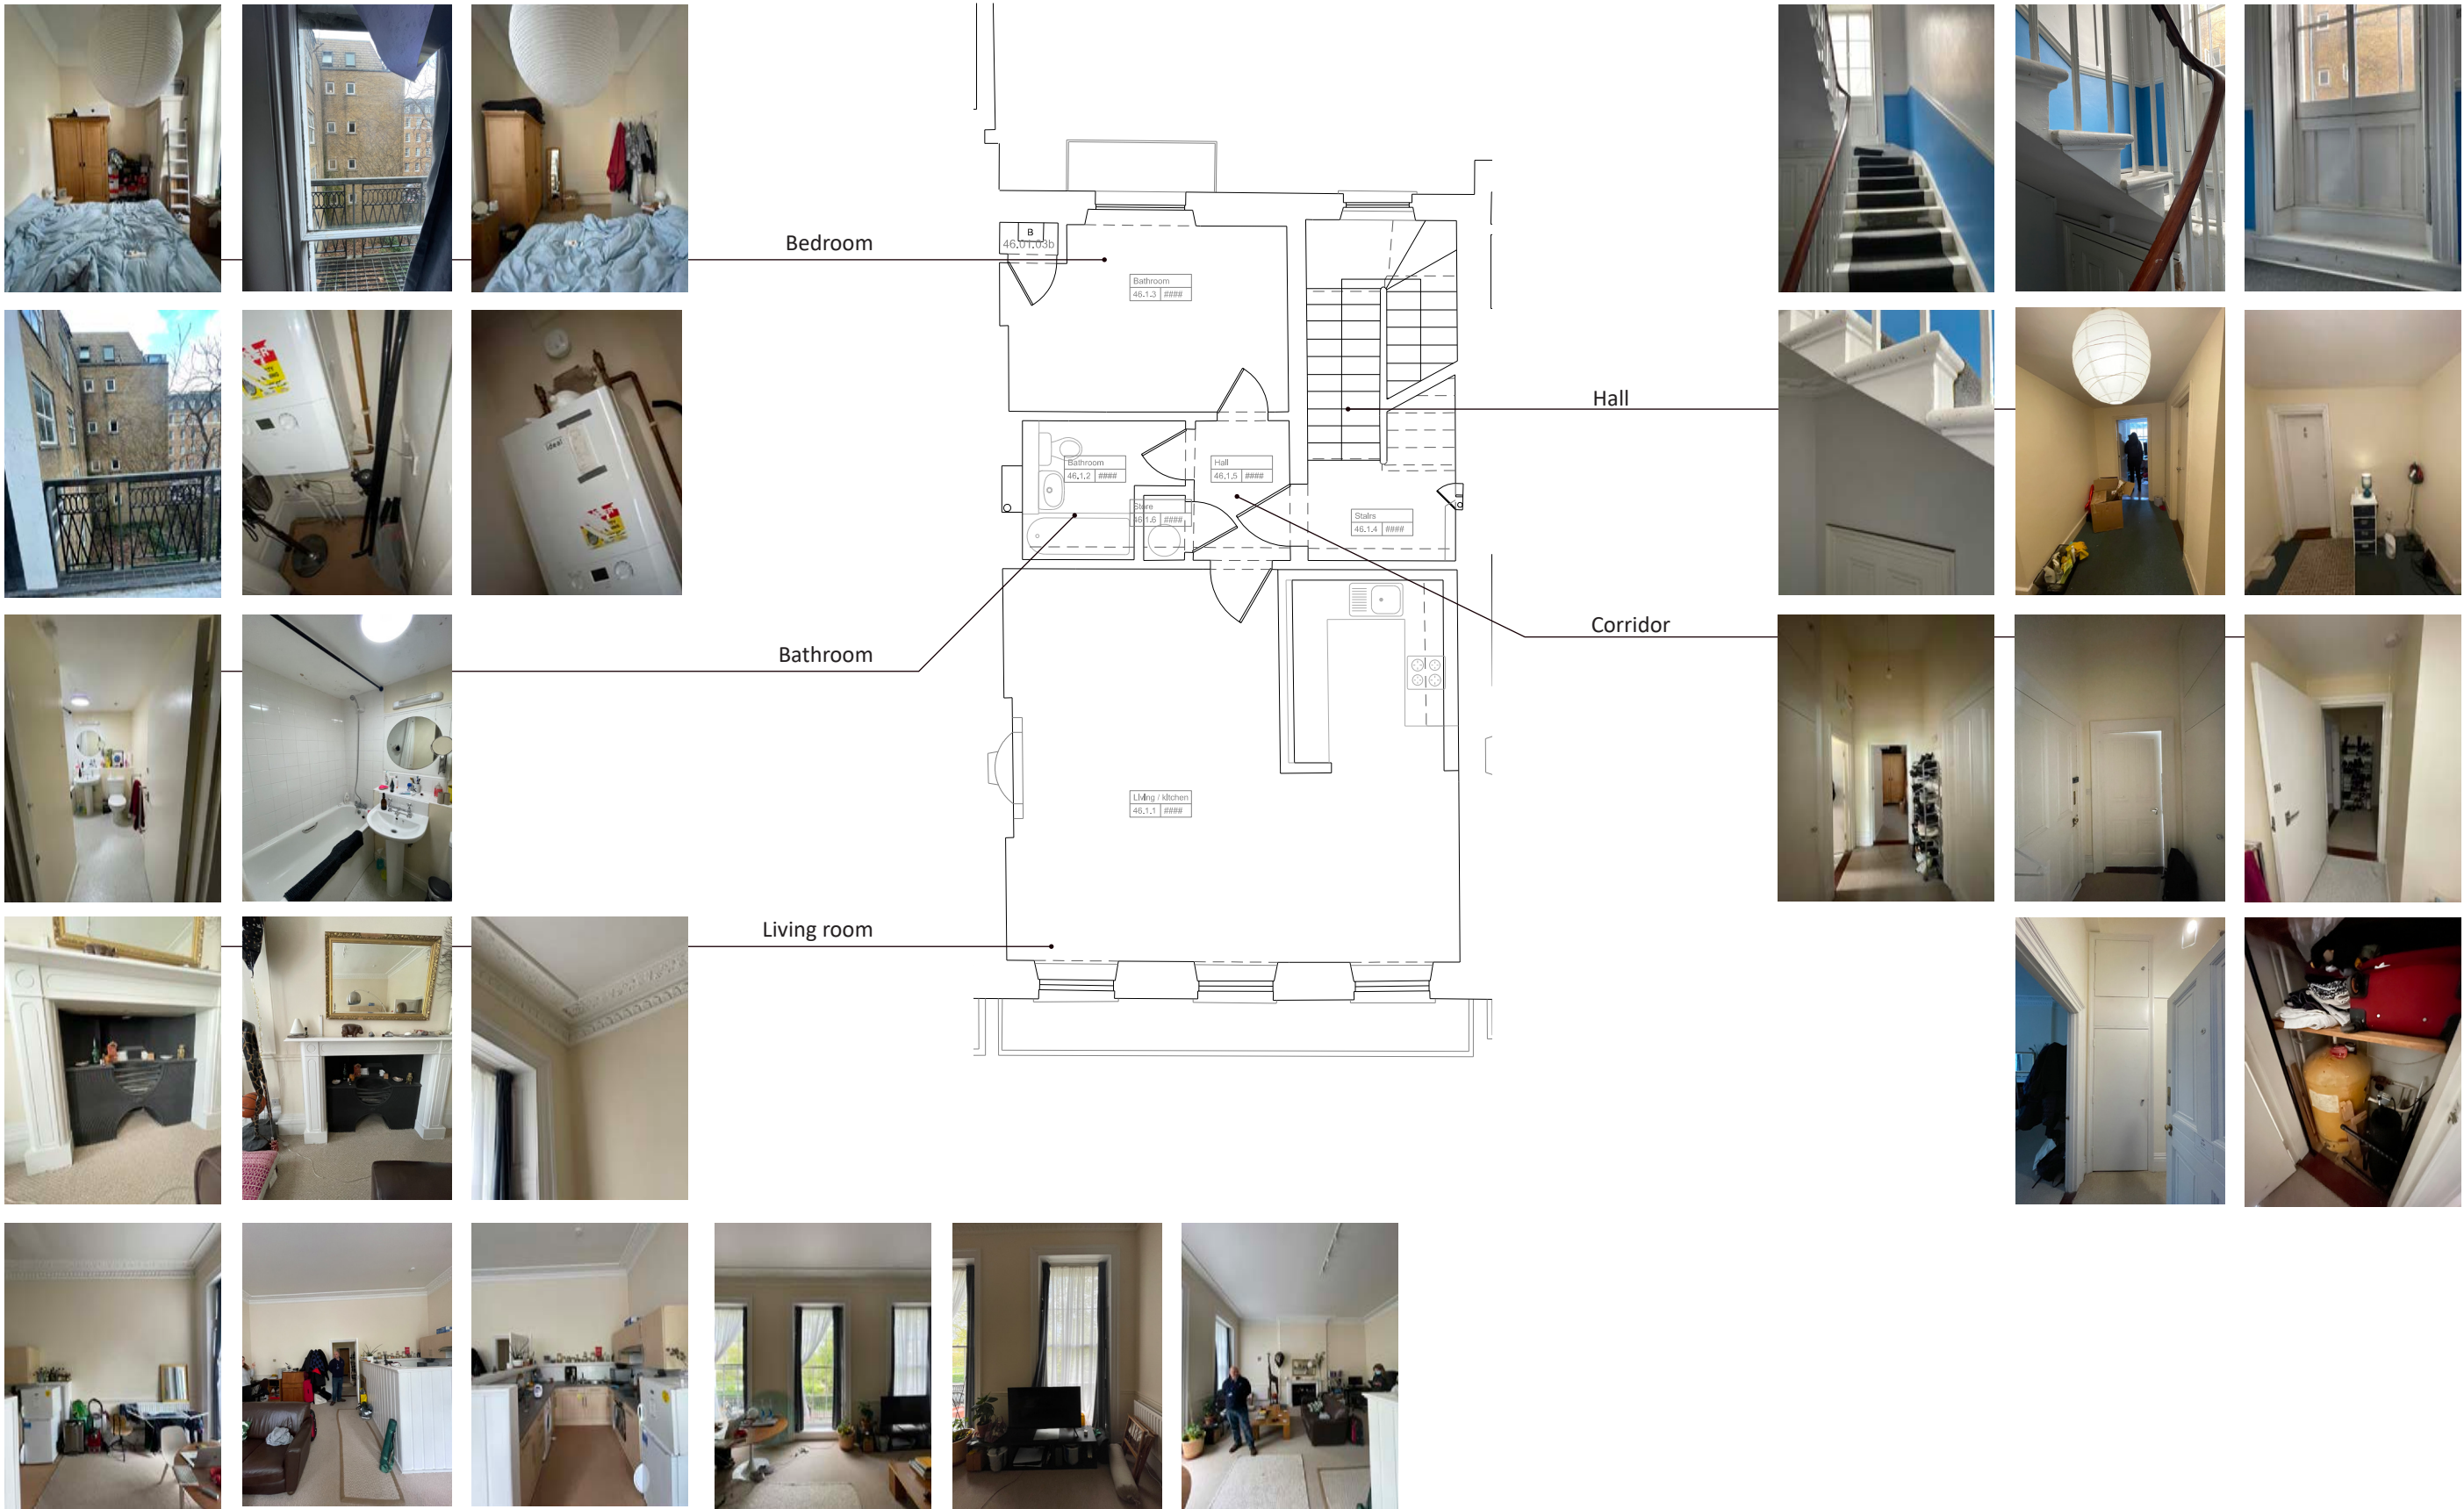
No. 46 | FIRST FLOOR

46.1.1	Front room	Kitchen with timber pannelling surround, Fireplace iron inner carcass artdeco style, timber surround	Painted plasterboard, with skirting and Dado Rail at 1m, cornice.	Painted plasterboard with cornice	Carpet, vinyl	Timber sash window and shutters closed and painted over

46.1.2	Bathroom	Fan, no access panel.	Painted plasterboard with skirting, tiled behind bath	Painted plasterboard	Vinyl	No window
46.1.3	Bedroom	Balcony to back window, with modern frame / large RHS and potential inserts from original balconies. RHS galvanised not painted	Painted plasterboard, skirting and picture rail mould	Painted plasterboard	Carpet	Timber sash window architrave to floor

46.1.4	Staircase	Vertical panel with Access panel within, access to drainpipe and gas main	Plaster skirting balustrade mould and skirting	Painted plasterboard with cornice	Stone / concrete timber runner.	Timber window with balustrade height in timber and window swing window, different to all other windows, shutters similar to access panels to rodding points within staircase.

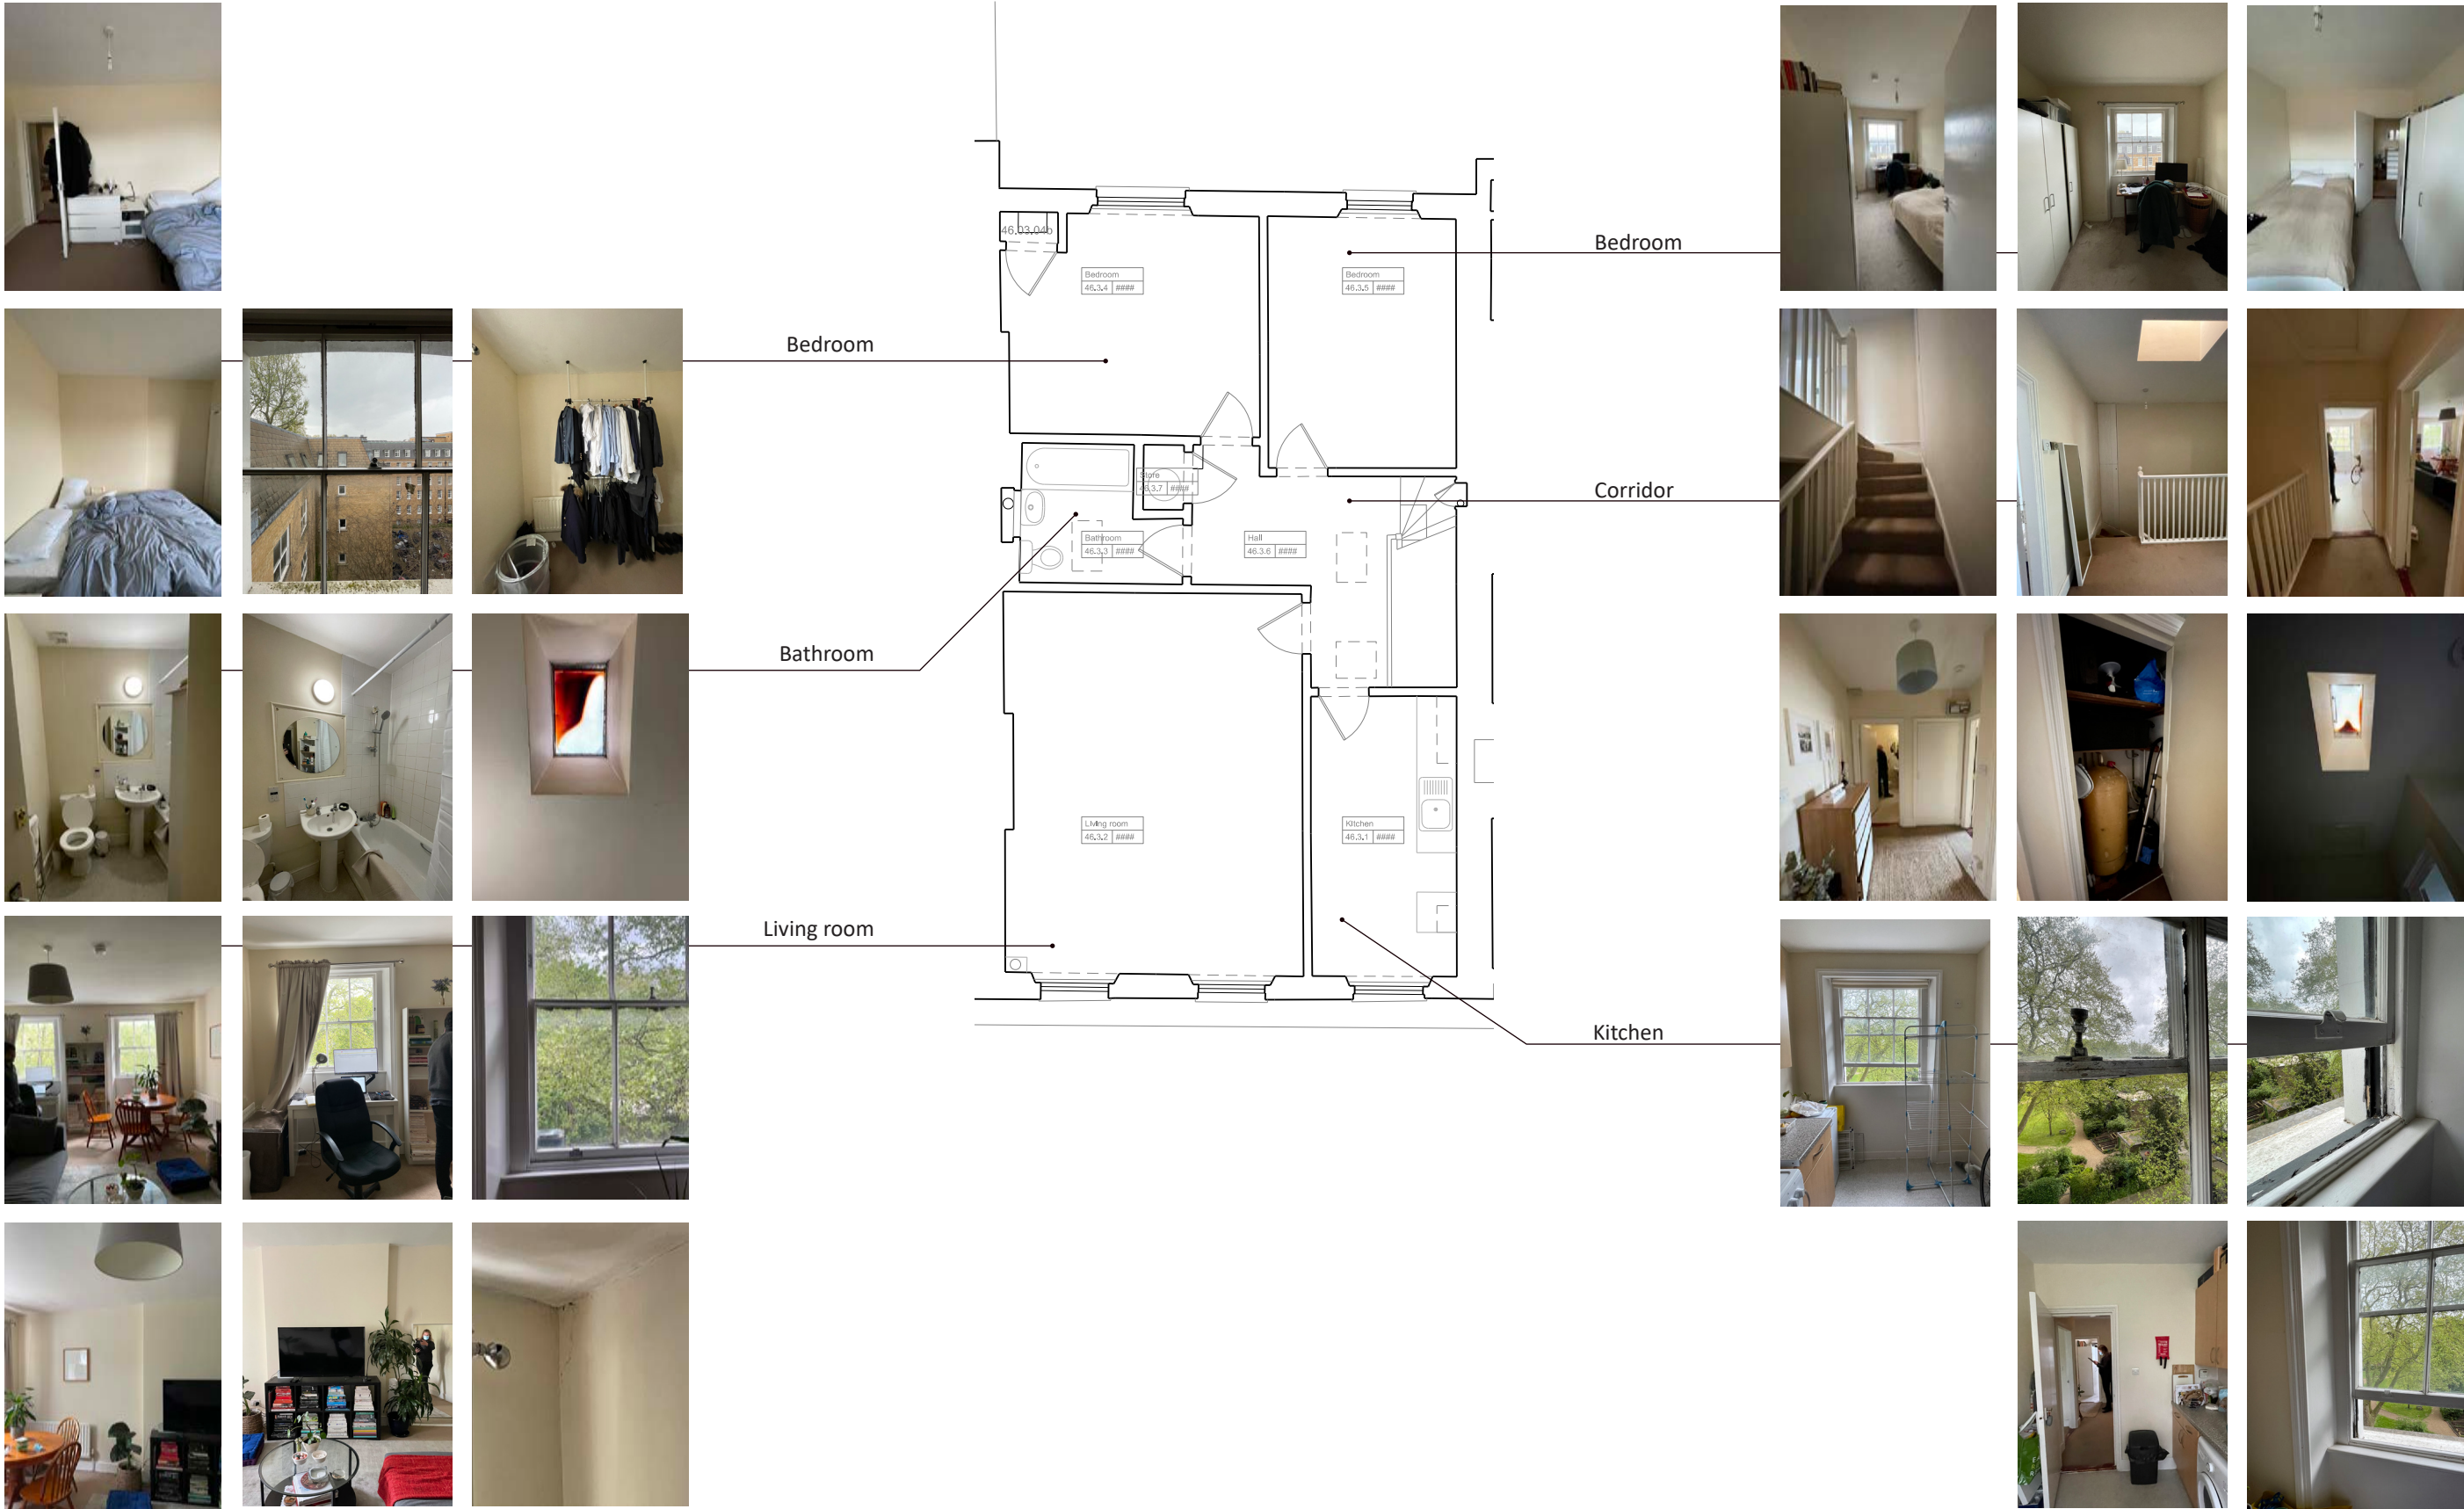
No. 46 | THIRD FLOOR

46.3.1	Kitchen		Painted plasterboard skirting	Painted plasterboard	Vinyl	Sash window timber surround to floor
46.3.2	Front room	Vent instead of fireplace. Damp in front upper corner to partywall.	Painted plasterboard skirting	Painted plasterboard	Carpet	Sash window timber surround to floor

46.3.3	Bathroom		Painted plasterboard skirting	Painted plasterboard	Vinyl	Roof light
46.3.4	Back room 1	Vent where fireplace	Painted plasterboard skirting	Painted plasterboard	Carpet	Sash window timber surround to floor

46.3.5	Back room 2		Painted plasterboard skirting	Painted plasterboard	Carpet	Sash window timber surround to floor
46.3.6	Corridor	Access panel in corner similar to others in staircase.	Painted plasterboard skirting	Painted plasterboard	Carpet	Roof light

46.3.7	Boiler room		Painted plasterboard skirting	Painted plasterboard	Board	
Other external features						
Loft		Not accessible				
Garden	Japanese knotweed					
Garden elevation	No detailed inspection from outside					
Street elevation	No detailed inspection from outside					
Balconies
