4&5 St Georges Terrace, Primrose Hill, Camden Town NW1 8XH

Front Elevation - Existing and Proposed

P10

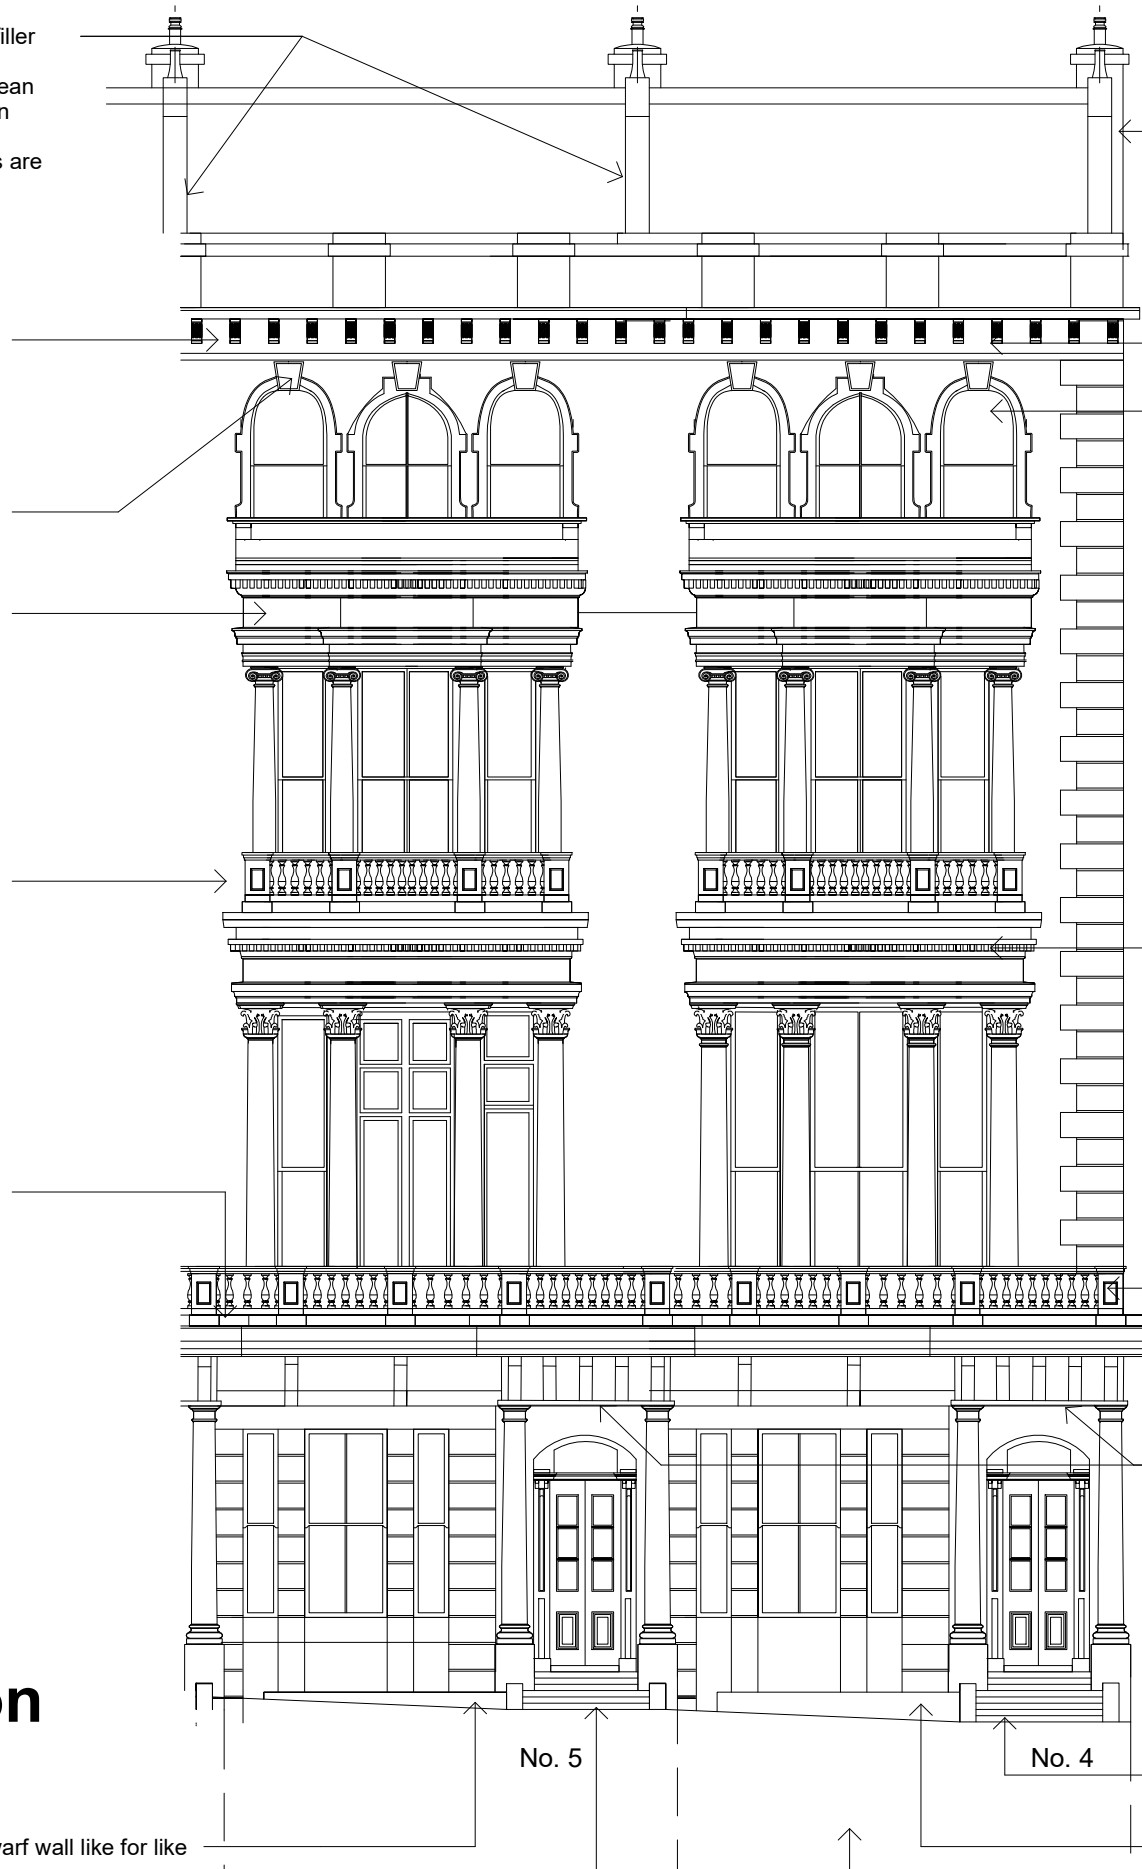
Front Elevation

Chimney stack to east party wall, break off damaged render, allow to re-render. Parapet wall to east side from chimney stack to front wall, render finish to be broken out to the vertical face and across top edge as necessary, re render, prep and decorate.

Structural repair work to vault below following failure and reconstruction above ground like for like. Refer to engineers scope of works - Option 2 vault repair methodology. Coal hole and drop retained.

Party walls to either side are painted rendered finish with trellising affixed to, carefully dismantle trellising and allow for decoration of the render up to the existing render line. A number of cracks within the flaunch detail to the chimney heads and these need to be broken out, repaired with flexible flaunch filler and allow preparation for decoration. Allow to lift all paving slabs off the feet, clean beneath surface, remove all detritus. Upon cleaning reset paving slabs. Front parapet wall inside and top surfaces are to be decorated.

Balcony/ Parapet to No. 5 - Strip decorative render, expose the corroded steel and grit blast, apply an anti-corrosion primer, apply the repair mortar and then reinstate the decorative render.

Like for like repair of head of arched windows as needed. Allow for leadwork detailing across the surface dressed back into the elevation.

Like for like repair of cornice matching any existing details.

Like for like repair and redecoration of existing doors and windows to both properties. All sash windows to be rebalanced.

Like for like repair of balcony. Strip decorative render, expose the corroded steel and grit blast, apply an anti-corrosion primer, apply the repair mortar and then reinstate the decorative render.

Balcony to both properties - surface asphalt is to be cleaned and prepped ready for Giromax/Cuprinol waterproofing liquid coating and apply coats as necessary to provide guarantee. Drainage from first floor balcony, rod through and clear and ensure drainage runs to the underside of the balcony are left in good working order and do not drip in any way. Full decoration of previously decorated surfaces.

Existing wrought iron railings to both properties to be rubbed down, prepared and redecorated in black metal paint.

Rebuild dwarf wall like for like

Remove base 3 steps to reset position
Repair Step 3
Replace base step like for like.

Like for like decoration of painted surfaces for both No. 4 and 5

Like for like repair of balcony and cornice as required

Balcony to both properties - Strip decorative render, expose the corroded steel and grit blast, apply an anti-corrosion primer, apply the repair mortar and then reinstate the decorative render. Decorate like for like.

Entrance Porticos: Remove all the vegetation, defective concrete, expose the corroded steel and grit blast, apply an anti-corrosion primer, apply the repair mortar and then reinstate the decorative plaster. All historic details to be repaired or replicated like for like. Like for like decoration

Replace failed steps like for like once new step support beam is in place. Steel to be boxed in Detail to replicate existing
