**Tree Report**  
**Picus Testing – 258 Camden Road, London, NW1 9AB.**

**1.1 Inspection date:** 15<sup>th</sup> June 2023 by Mr. Kim Gifford, undertaken in the area of test and at the time of inspection.

**1.6 London Plane (*Platanus x hispanica*)/ @ level: 150cms ground level approximately from ground level. Test point 1 at south orientation. Height 19m Crown 10m dbh 100cm, very mature. Rear garden by wall and fence.**

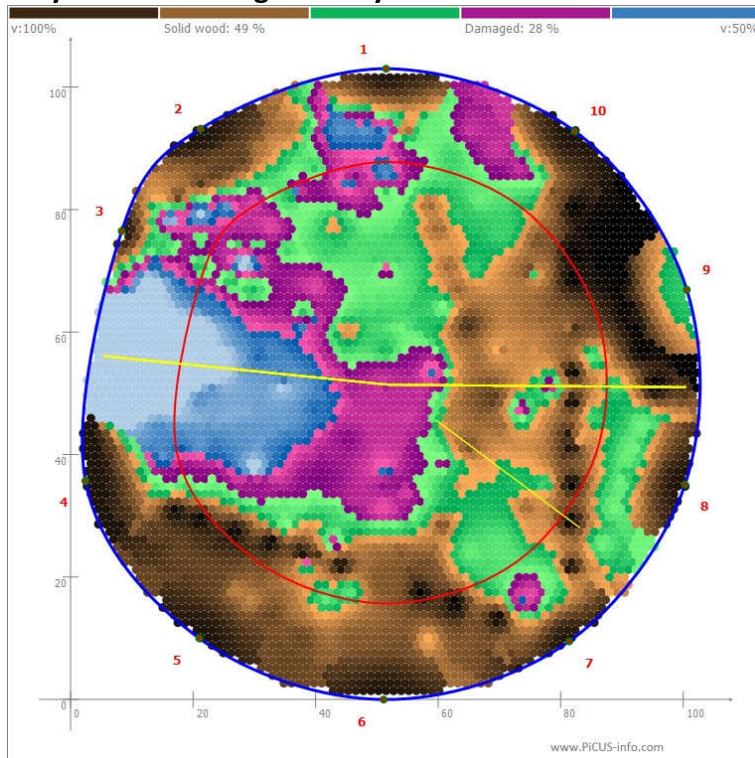
The measuring point readings give evidence of low velocities overall in the area of test representation showing decay timber. The tomographic images shown above has a percentage amount of altered timber. With reference to the 'colour chart see figure 2', the slower sonic speed of sound is represented by three bands of data representation blue/violet/white being the slowest altered/decayed timber, green being faster altered timber, brown being fast sonic-speeds solid timber.

The resulting Picus tests are of unacceptable limits in relation the altered timber. This ratio called a 'trunk ratio' TR (*reference Claus Mattheck*) has been calculated to be a guideline in terms of stability and rigidity of cylindrical structure. Although a debated theory in arboriculture in general terms the TR of 30% is an average.

The results show extensive decayed timber in the area of test. Major cavity on east side of trunk 30cms x 2m visual evidence of hole into root plate.

It would now be appropriate to recommend that consideration be given to the complete removal of this specimen on the grounds of further damage and health & safety in this location.

**Within 6 months.**

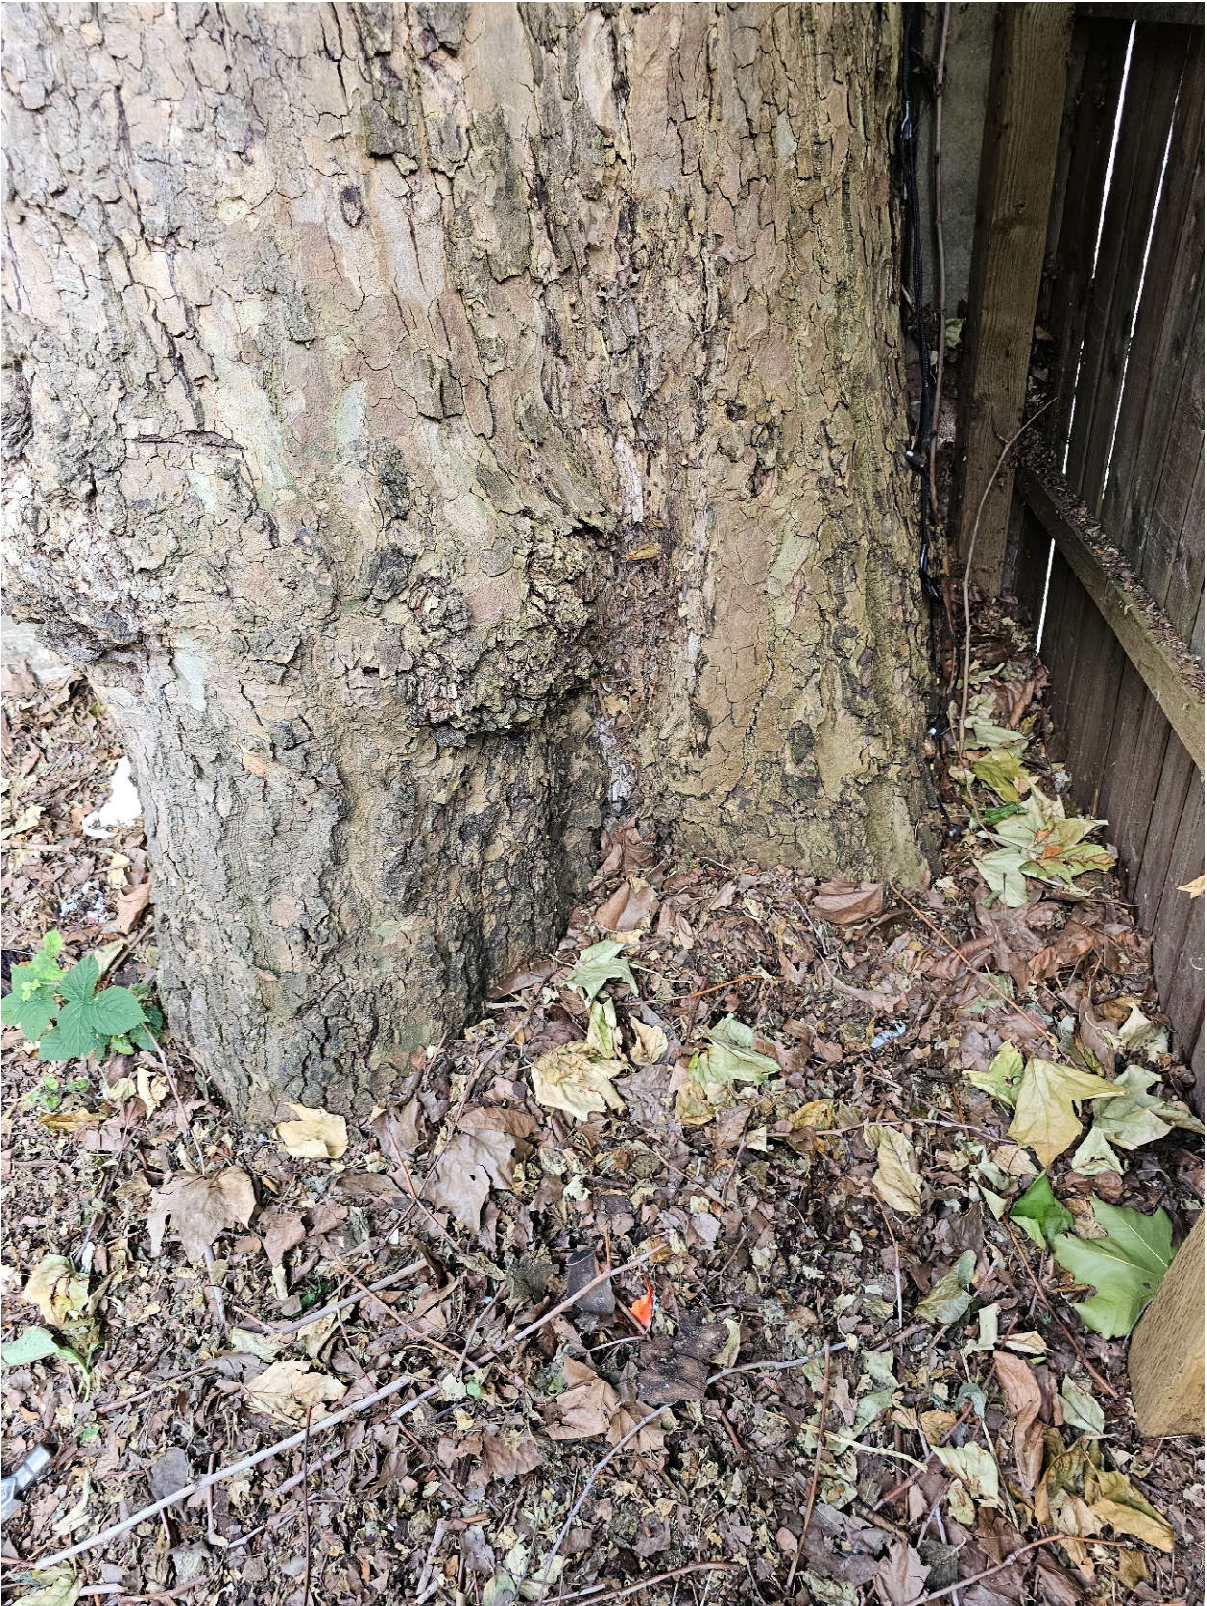
Figure 3 – Decay at the base

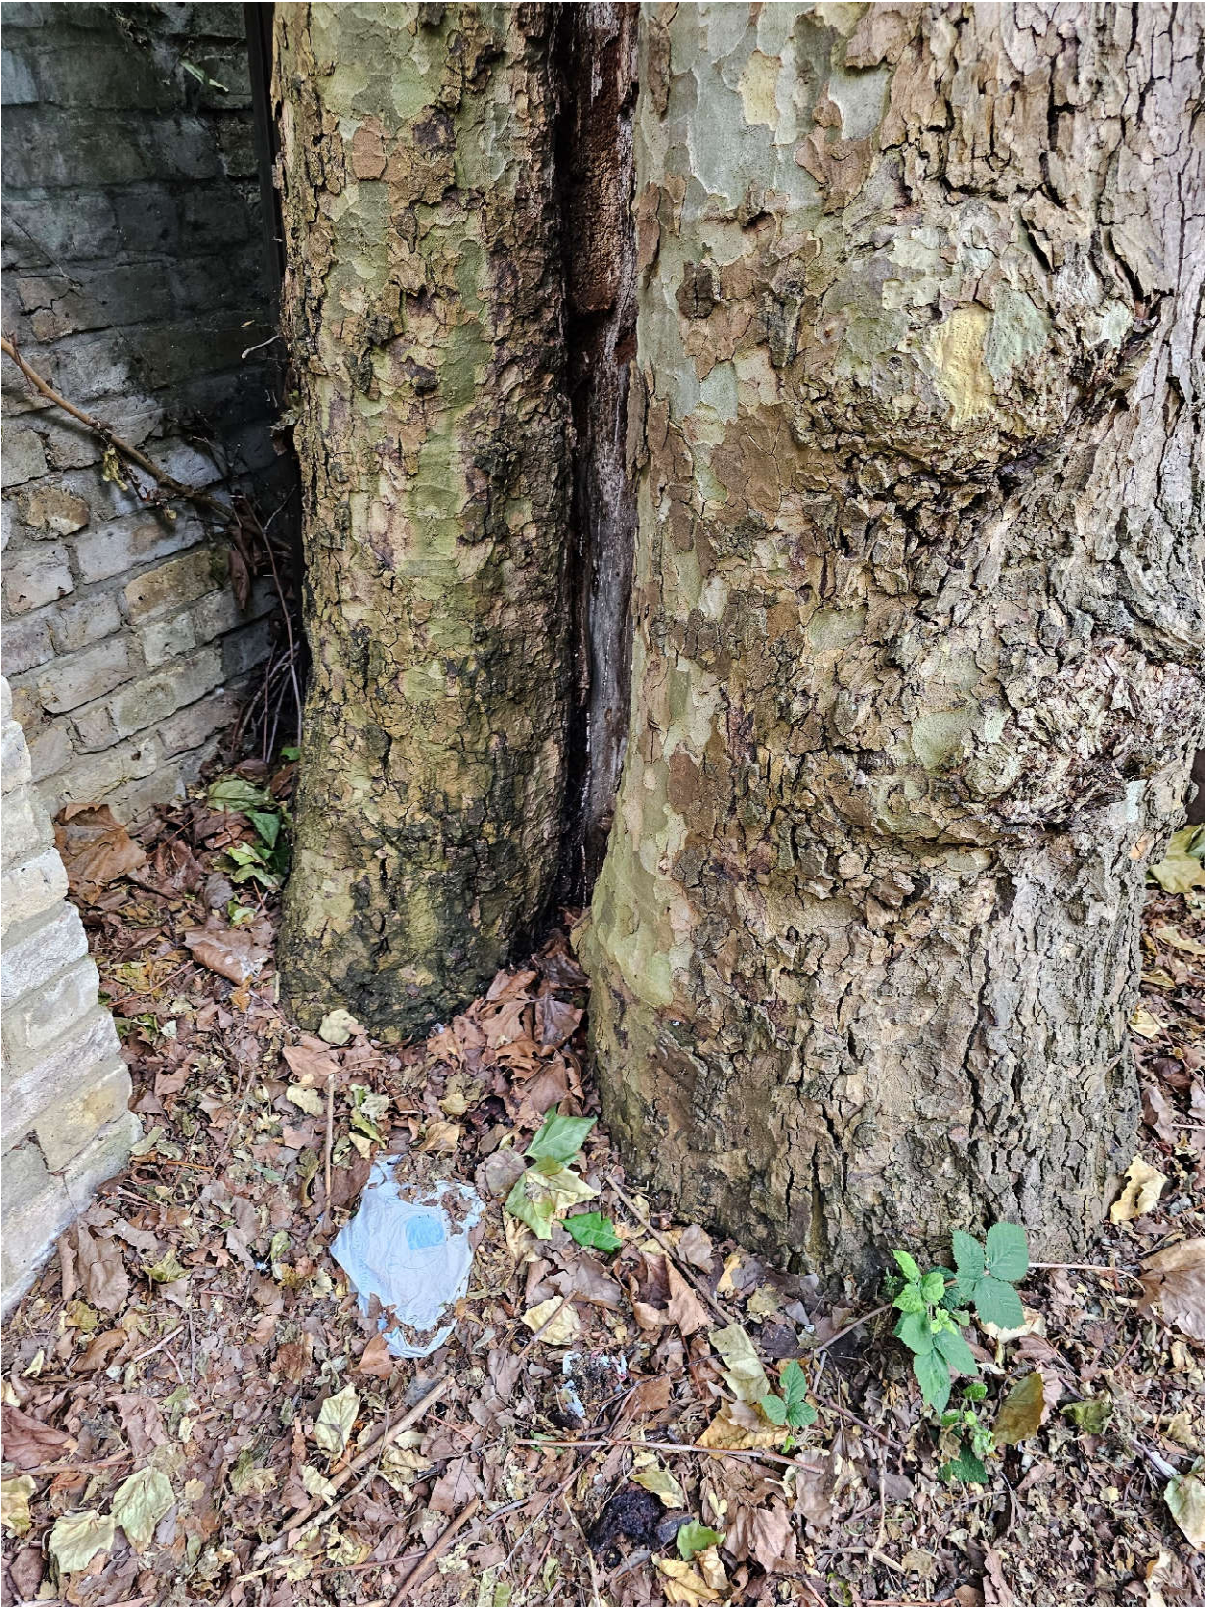
Figure 4 – Extensive cavity on east side decay in roots.
