# ELITE ENGINEERING

12020-c230511cl-kam

11 May 2023

## **47 ETON AVENUE BELSIZE PARK LONDON NW3 3EP: STRUCTURAL ENGINEERS REPORT**

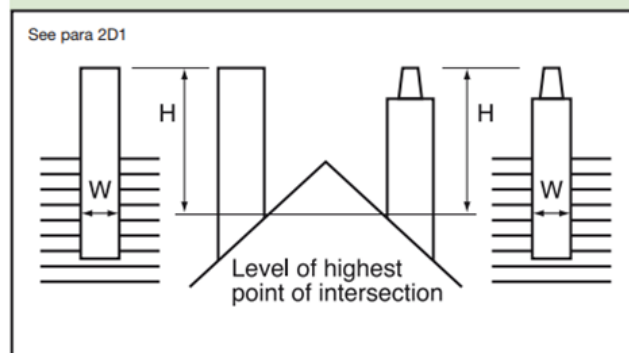
Diagram 20 Proportions for masonry chimneys

**2D1** Where a chimney is not adequately supported by ties or securely restrained in any way, its height if measured from the highest point of intersection with the roof surface, gutter, etc. should not exceed  $4.5W$ , provided the density of the masonry is greater than  $1500\text{kg/m}^3$ , where:

**W** is the least horizontal dimension of the chimney measured at the same point of intersection, and

**H** is measured to the top of any chimney pot or other flue terminal (see Diagram 20).

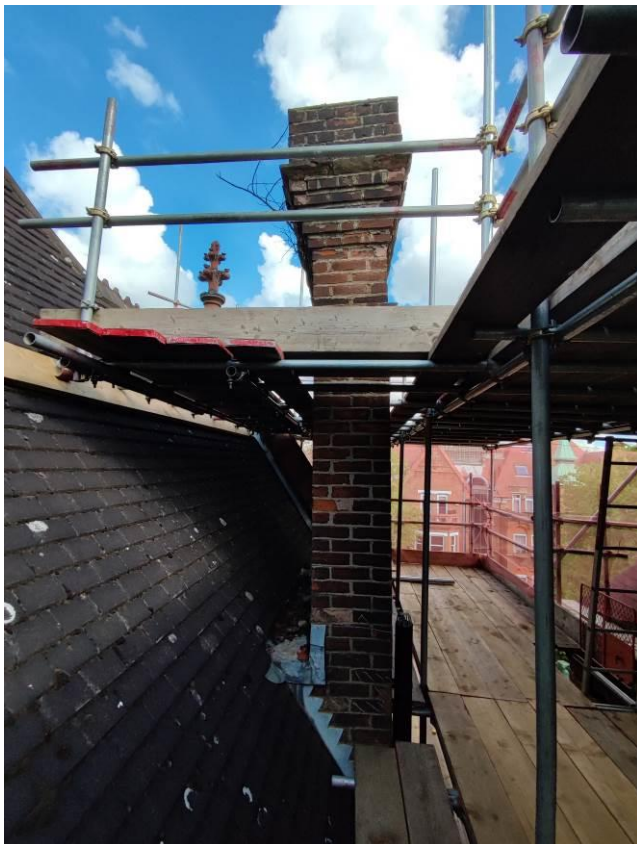
- 2.4 The two chimney stacks have a noticeable lean towards the right side. Specifically, the front stack is particularly significant and prominent because it lacks support from its base. Without a plumb line survey, it is difficult to determine the exact extent of the lean, but it seems excessive, especially in the upper 1.5 meters of the stack. On the other hand, the rear stack is partially restrained by the pitched roof, resulting in a less pronounced lean. However, the top portion of both chimney stacks is tilted.

- 3.1 We comment on our observations as follows:
- 3.2 Both chimney stacks lean towards the right, but the front stack is leaning more severely than the rear stack. The main cause of this is the inadequate support for the front stack throughout its entire height of 4 meters, aside from an ineffective tie rod. In contrast, the rear stack receives partial support from the rafter, resulting in a slightly lesser degree of leaning.

Plate 2: View of front stack leaning towards the building

- 4.1 The front chimney stack height significantly exceeds the slenderness limit, (exceeds  $4.5 \times$  the width of the chimney stack. The height of the stack includes the chimney pots). If it is demolished and rebuilt plumb the new stack would need to comply with modern design standards and codes.
- 4.2 The rear chimney stack is less of an issue as it is tied to the rafters. The top section of approximately 1.5m height can be rebuilt and tied to the existing rafters for restraint.
- 4.3 We recommend that the front chimney stack is demolished down to approximately 4m and rebuilt with matching bricks (minimum  $1500\text{kg/m}^3$  density) with 1:1:8 cement:lime:sand mix.

- 4.4 Reconstructing the front chimney stack will present a challenge due to its unrestrained height of 4m. The existing single rod solution is unlikely to provide adequate support, so a properly designed solution is necessary to withstand wind loads and to comply with current standards. This may involve using a steel band around the chimney stack with multiple rods and likely reinforcing the existing rafters to support the load effectively. Refer to sk01 for illustration. Note the roof tiles will need to be removed exposing the rafters. If this space is habitable then there will be disturbance internally to gain access to the rafters.

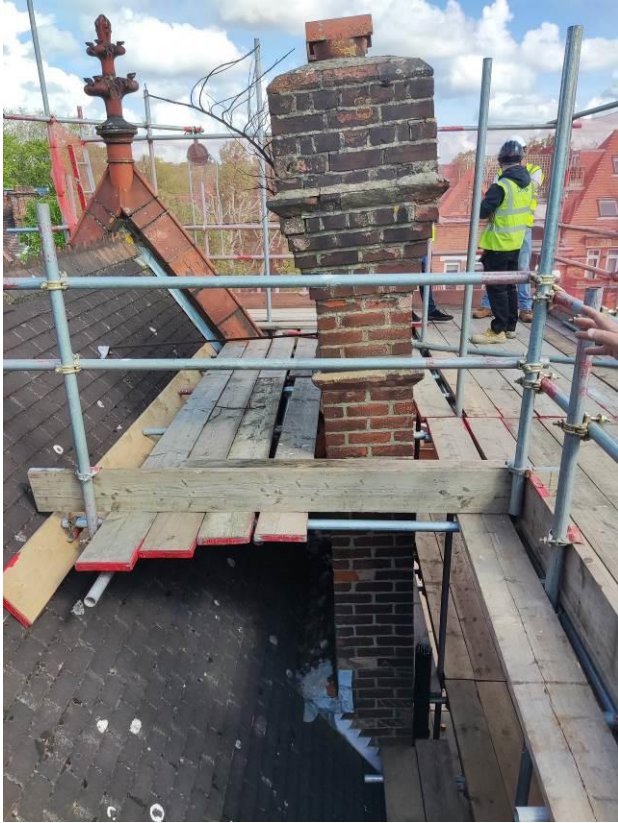
Plate 3: Top section lean is more pronounced.

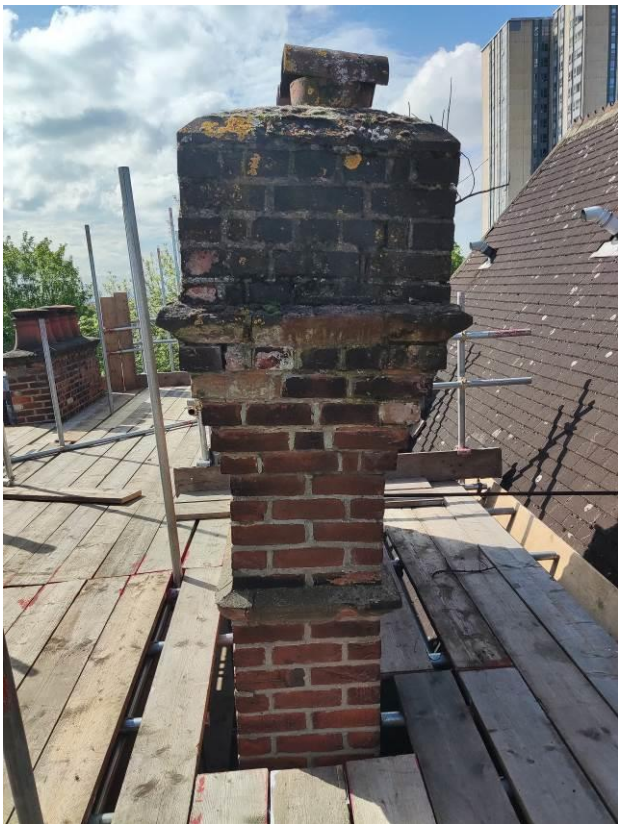
- 2.6 Both chimney stacks have defaced brickwork and spalling pointing including cracked haunching. This type of defect is commensurate with the age and type of construction.

Plate 4: Top section of front chimney stack

- 4.6 In general the existing stacks repointing appears to be spalling and it should be repointed to match by raking out at least 25mm and by ensuring the new pointing is well rammed in. Additionally, all the haunching, as well as any cracked or broken pots, should be replaced during the renovation process.

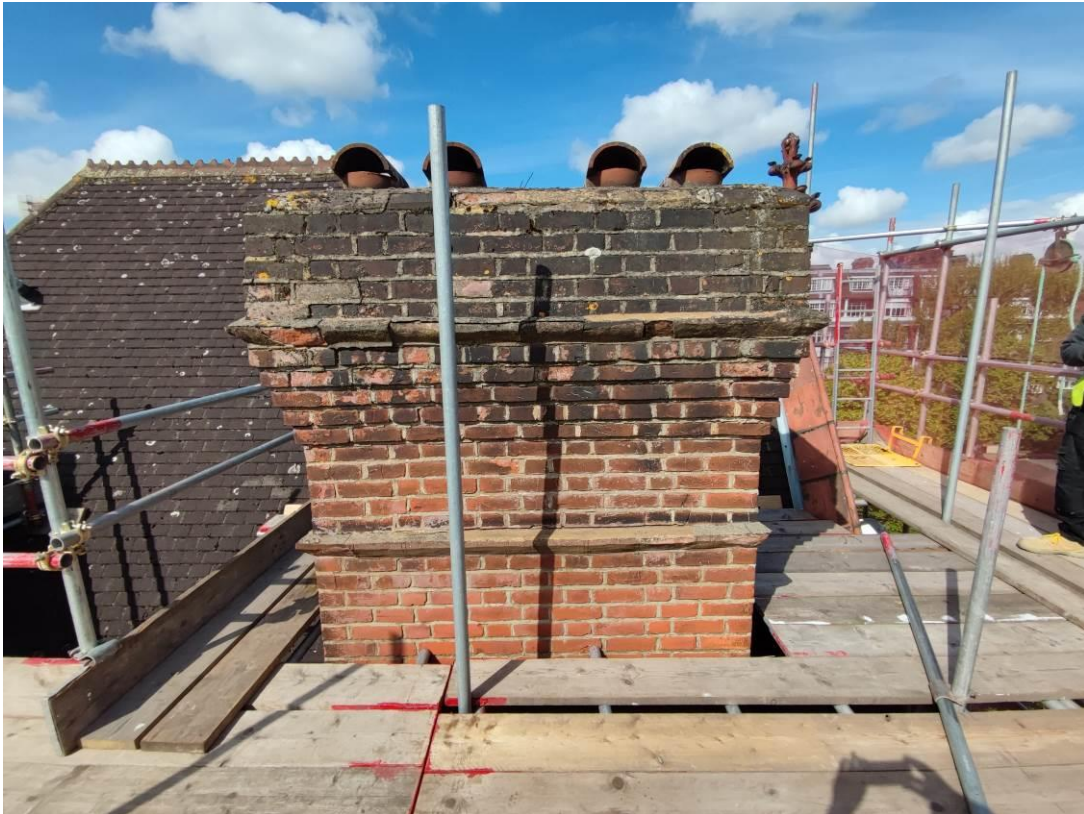
Plate 5: Front stack side view

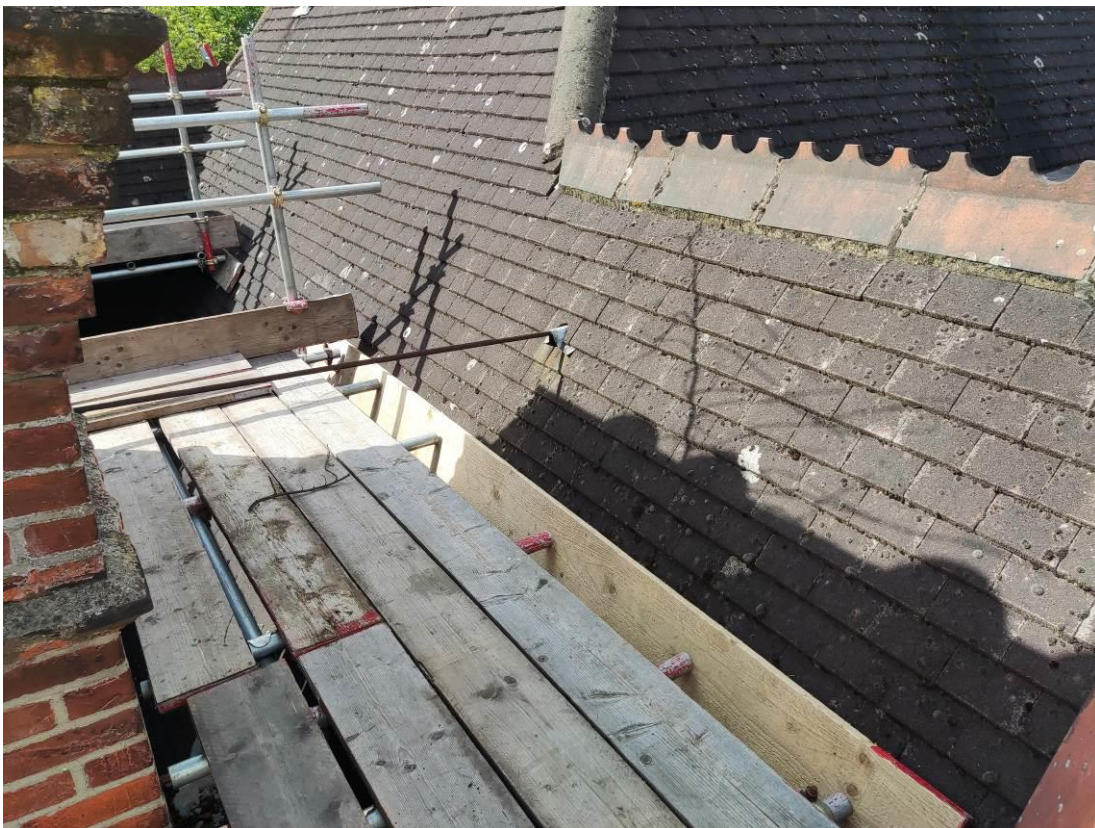
- 2.5 The front chimney stack has a steel tie rod embedded within it, which is connected to the rafter to provide some restraint. However, the tie rod has corroded over time and has become loose. In its current state, it is unlikely that the tie rod offers any support to the stack.

Plate 6: Front stack with tie rod between stack and roof

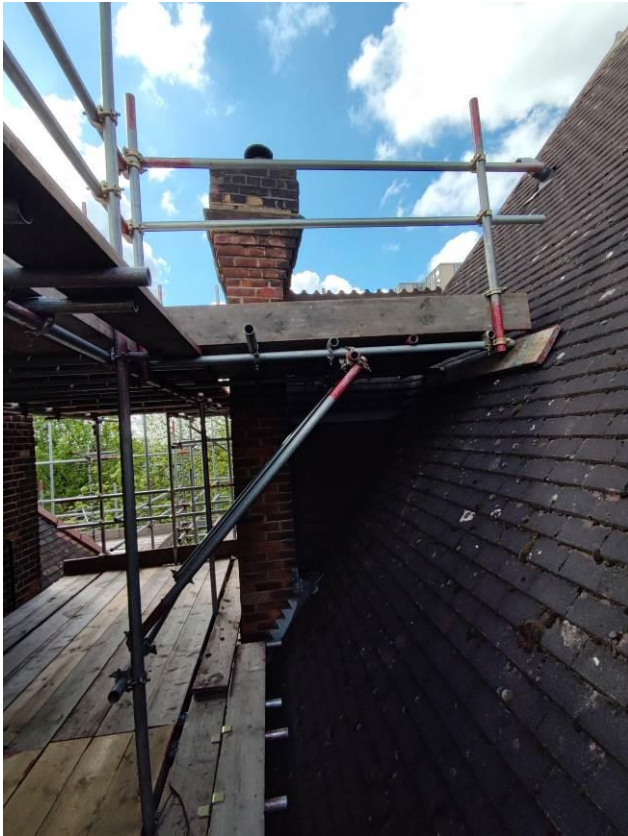
Plate 7: Rear chimney stack

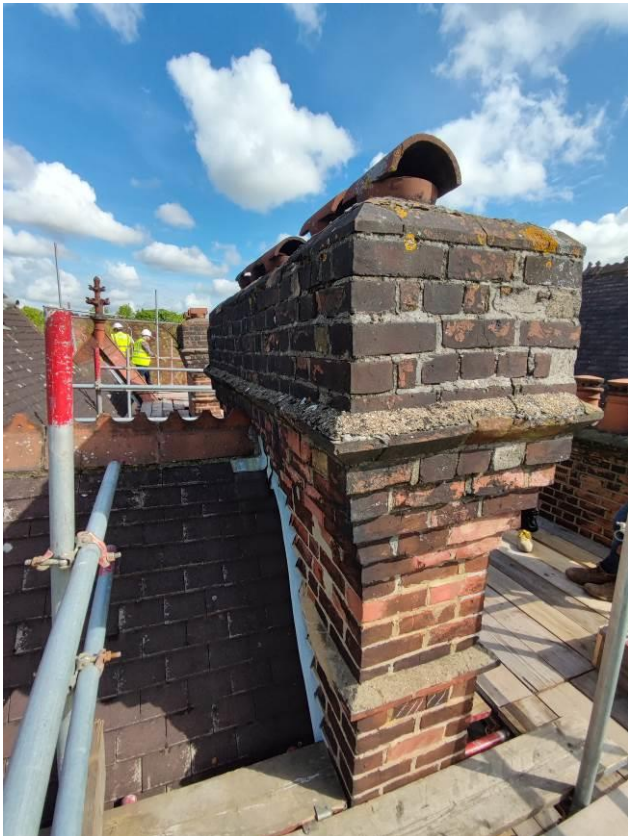
Plate 8: Rear view of rear stack leaning against the roof
