Repair Design and Access Statement

Alexandra and Ainsworth Tenants
Residents Association Hall,

Report Document

Roof Survey Report & Recommendations

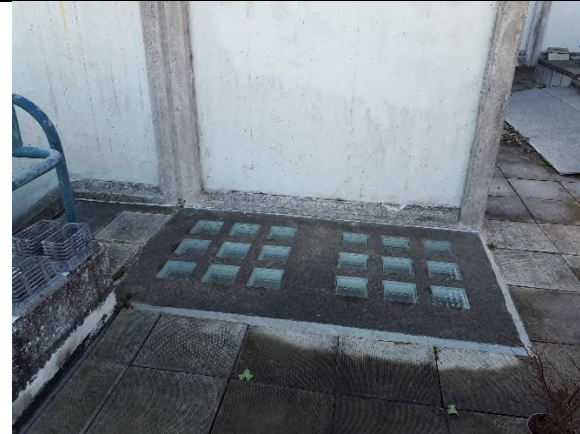
- 3.4 Additionally, there is relatively small pavement light panel adjacent to the access stairs rising from the main pedestrian access to the hall. There is staining near this internally that also suggests that this may be leaking. There is no sign of broken glass blocks and so it is likely the joint between this unit has lost its waterproofing integrity. Photographs of this are also attached at appendix B.

7. TRA Hall – Roof terrace – Pavement light

Pavement lights are to have supracoating RLV installed to the perimeter edges.

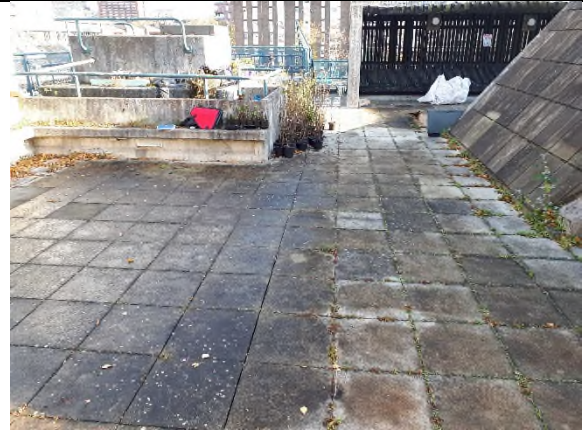
8. TRA Hall – Roof terrace – Main area to front with access steps to rear

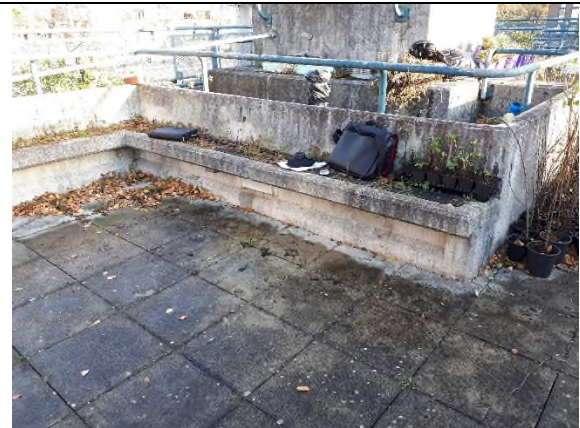
9. TRA Hall – Roof terrace – Main area showing built seating and irrigation sump and channels beyond around presumed water tank housing

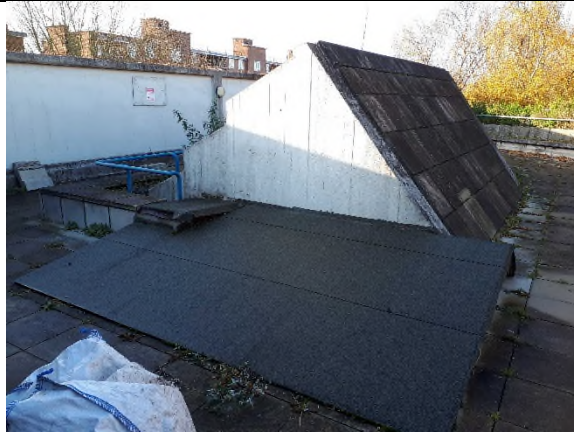
19. TRA Hall – Roof terrace – Area to centre ‘Skylight’ to TRA hall below and felt and timber covering in foreground.

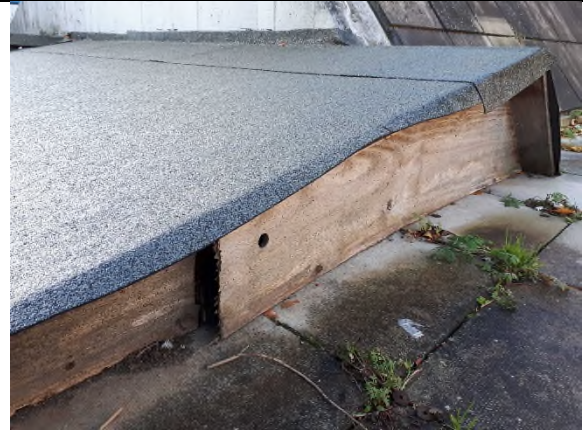
20. TRA Hall – Roof terrace – Felt and timber covering by ‘Skylight’ detail

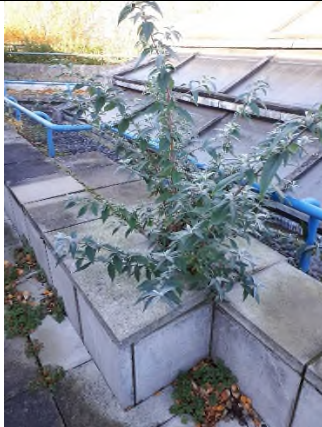
21. TRA Hall – Roof terrace – Area to centre to rear of ‘Skylight’. Invasive shrub growth.

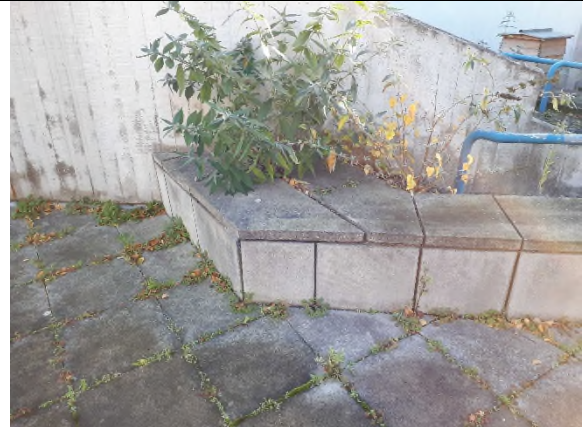
22. TRA Hall – Roof terrace – Area to centre to right side of ‘Skylight’. Further invasive shrub growth.

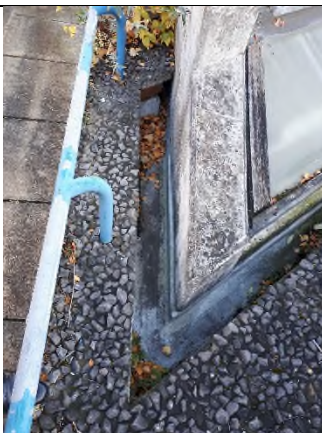
23. TRA Hall – Roof terrace – Area to centre to rear of ‘Skylight’. Channel and upstand detail..

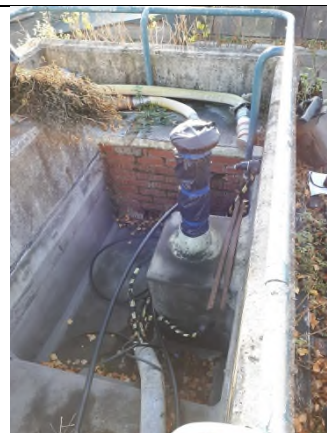
- 3.5 A further item noted was that the pump to the sump of the irrigation channels appeared not to be functioning which to some extent explains why the plants within the planters appeared to be generally in poor condition.

24. TRA Hall – Roof terrace – Recessed water channel and sump with irrigation pump (broken) housed in brickwork

- 6.11 Additionally, an allowance has been included to repair and service the existing irrigation pump such that it can function as originally intended which assist in promoting better condition of the surrounding planting

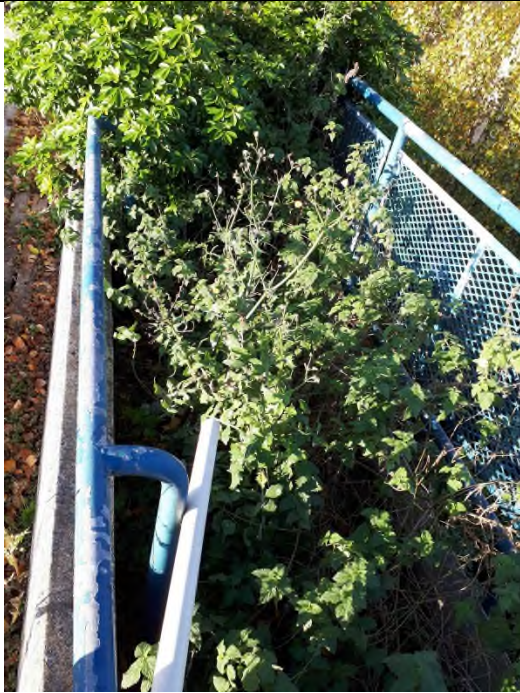
25. TRA Hall – Roof terrace – Planters to front right perimeter – Ad hoc shrub growth

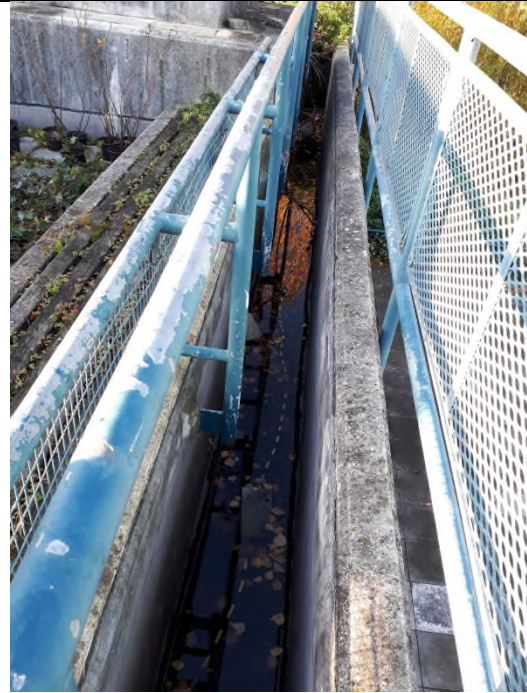
26. TRA Hall – Roof terrace – Recessed channel for rainwater discharge from roof linked to sump

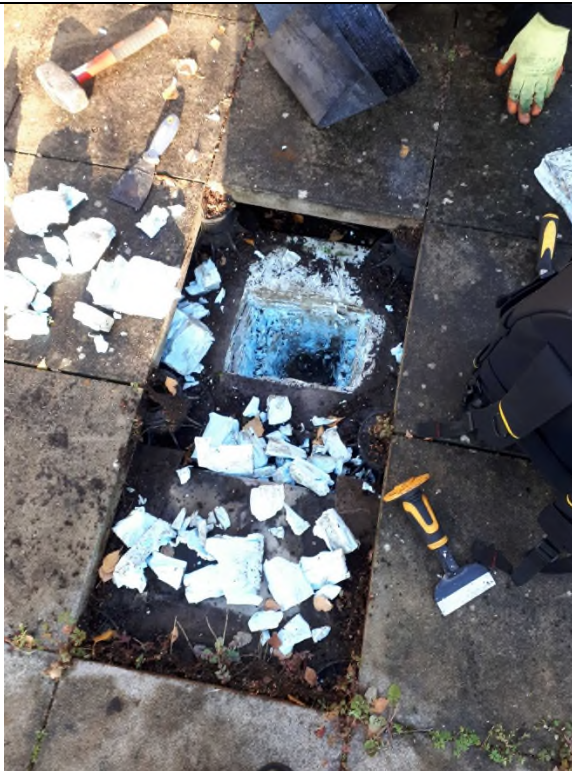
- 3.3 It clear that rainwater from either the main roof terrace, the planters or the channels is penetrating the waterproof roof membrane including upstands above. At the beginning of this year a more detailed investigation was carried by a specialist waterproofing manufacturer to verify the make-up of the main roof terrace. This confirmed that the existing make-up was as described above.

27. TRA Hall – Roof terrace – Investigation to confirm existing roof terrace construction

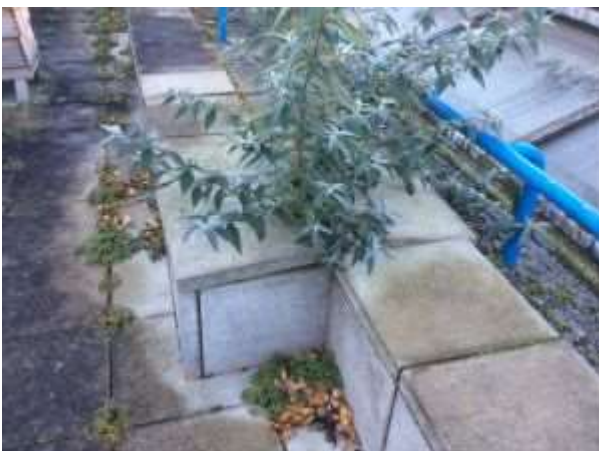
Photograph: 110681

Heavy vegetation and plant growth through the paving slabs is likely to be taking root within the waterproofing allowing water ingress.

Vegetation growth likely to be penetrating waterproofing allowing water ingress.

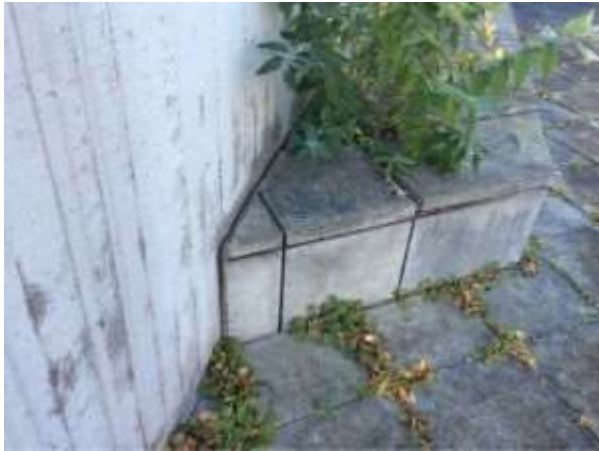
Photograph: 110685

As above.

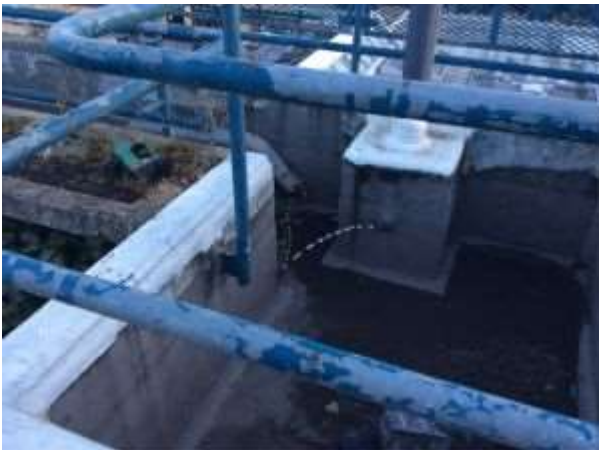
Photograph: 110678

There is a gully present to the outside edge perimeter with vegetation growth taking root within the waterproofing allowing water into the building fabric. Water is also ponding within this area due to poor falls.

Asphalt gully area.

Note the liquid coating as an attempt to prevent further water ingress.

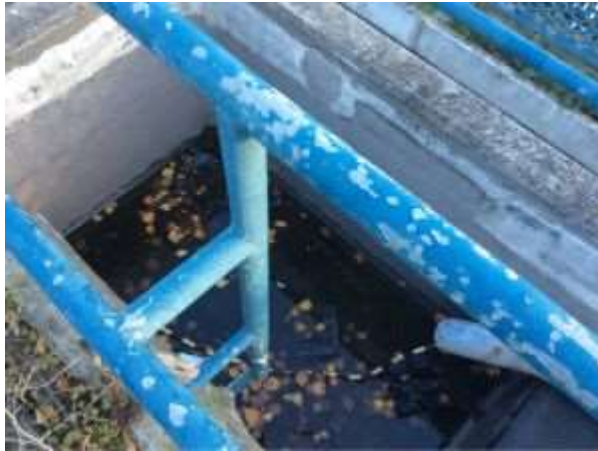
Photograph: 110738

Ponding water to above area due to poor falls.

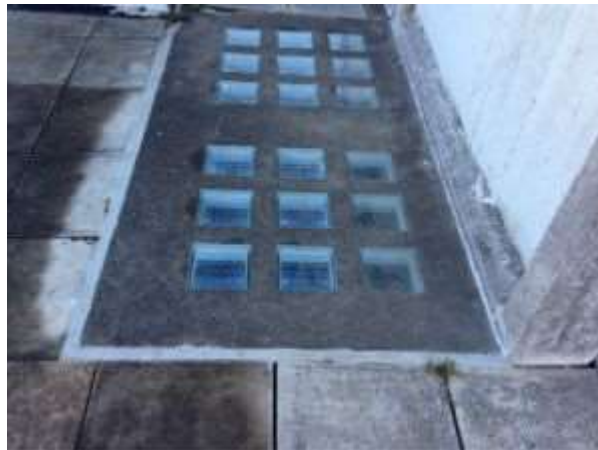
Photograph: 110746

Pavement rooflights are level with the paving slab surface finish and are currently a weak detail allowing water to seep into the building below.

Pavement lights are a weak detail allowing water to seep in through the edges.

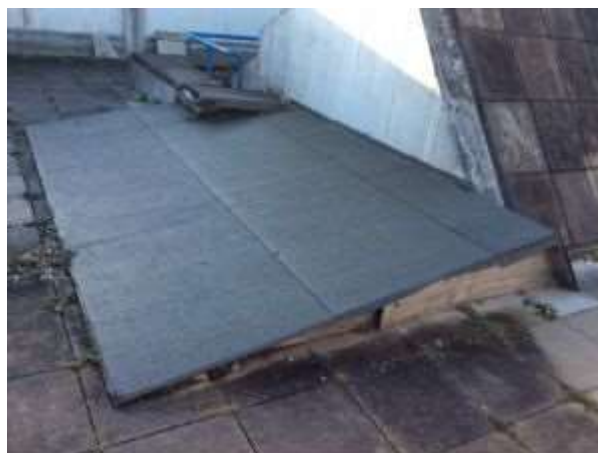
Photograph: 110744

There is 1 No previously boarded over rooflight unit which should be removed to allow for sufficient waterproofing.

Previously over boarded rooflight unit to be removed and made flush with the new waterproofing system.

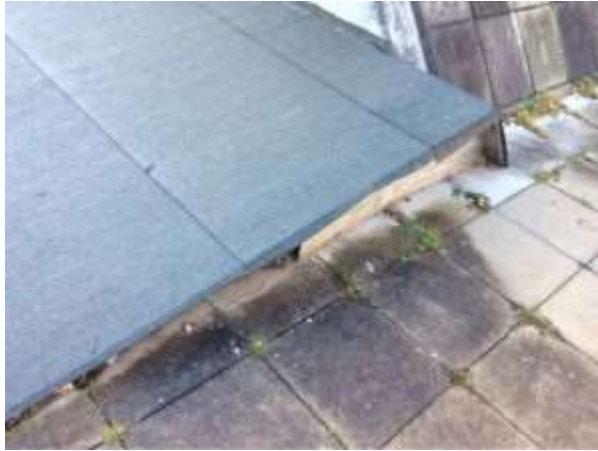
Photograph: 110677

As above, timber still exposed allowing water ingress.

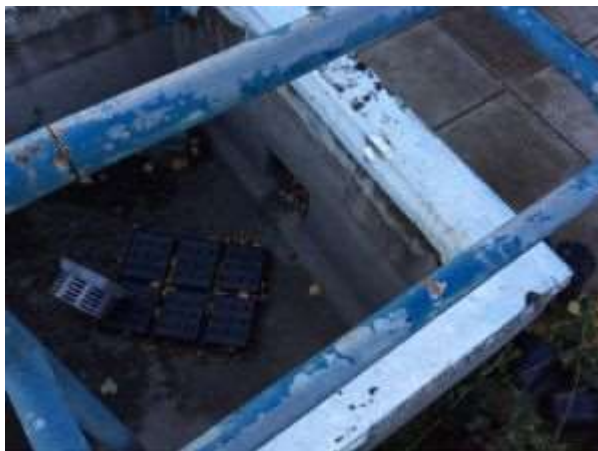
Photograph: 110689

As above.

Note the chute outlet draining into this area.

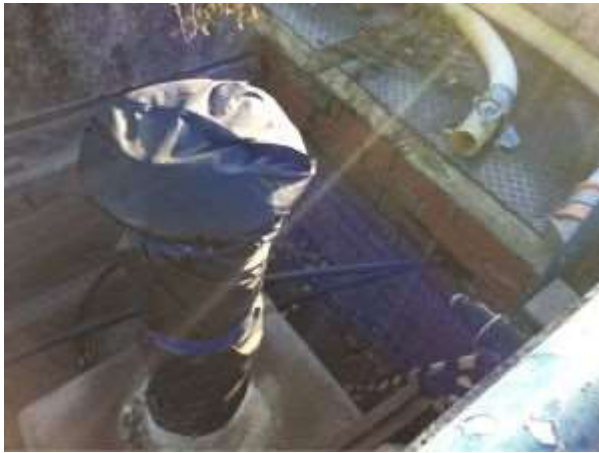
Photograph: 110686

Likely redundant pipe has been poorly covered allowing water ingress.

All redundant penetrations to be removed and over boarded with 18mm WBP, exterior grade plywood

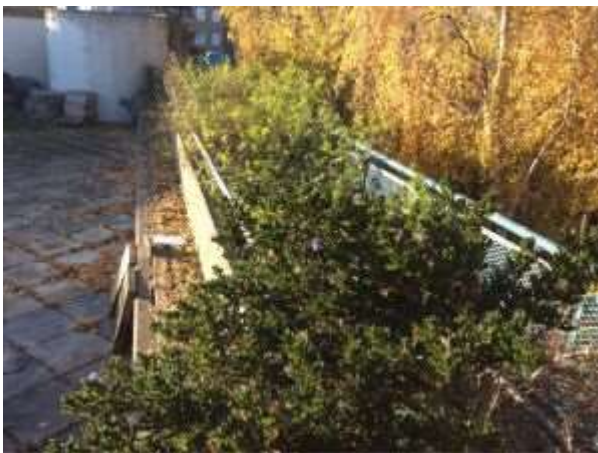
Photograph: 110702

There are garden flower beds around the perimeter of the roof with no root inhibiting membrane offering little protection from water ingress.

Garden flower beds have no root inhibiting membrane providing no protection from root penetration.

Garden flower beds to be stripped and re-lined with new waterproofing system incorporating Graviflex to prevent roof penetration.

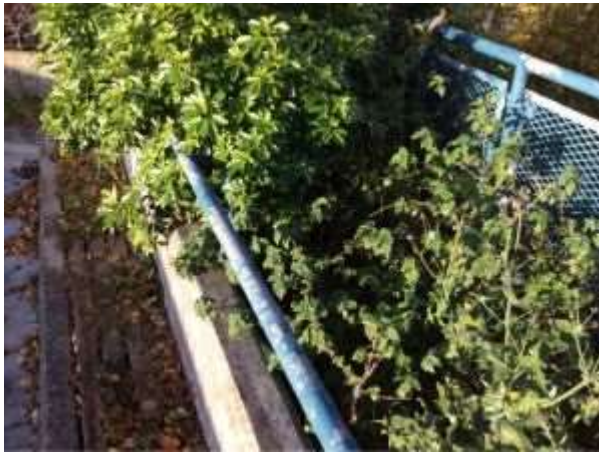
Photograph: 110697

As above.

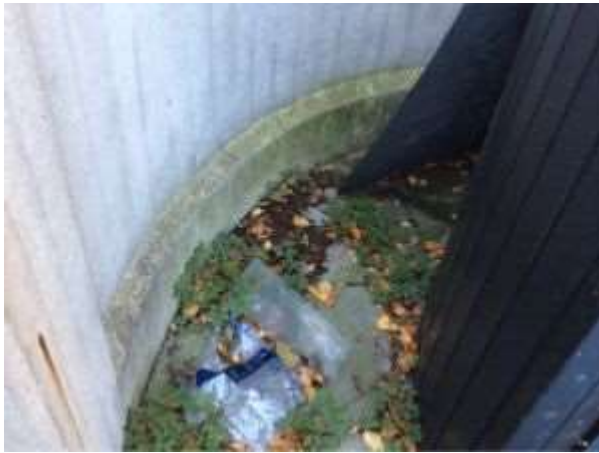
Photograph: 110714

As above. Note the vegetation growth likely to be taking root in the waterproofing allowing water ingress.

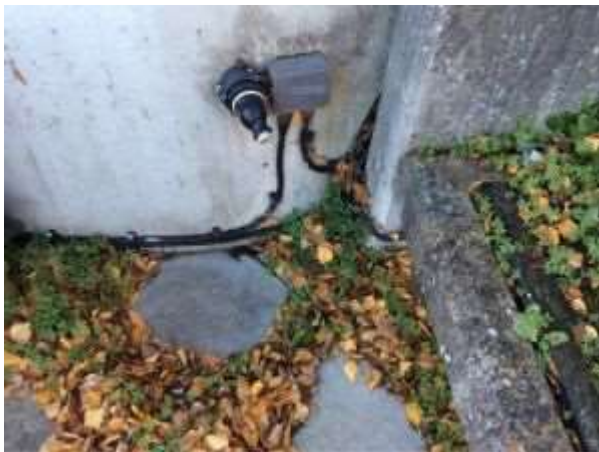
Photograph: 110718

Cables fixed to rendered upstands
