St Anne's Close Ltd,
St Anne's Close,
London, N6 6AR

Our reference: T41
22nd August 2023

Inspection of willow tree at St Anne's Close, London, N6 6AR

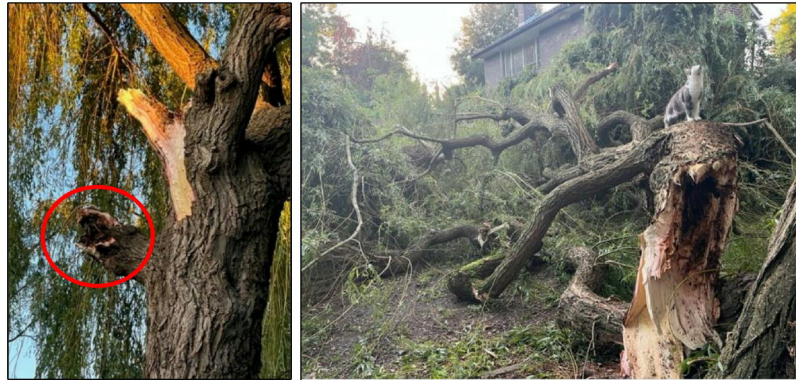
3. In the early morning of 15th August 2023 a large branch, which had been growing in an easterly direction, failed and collapsed to the ground. You sent me photographs of the failure site, and of the collapsed branch, in an email on 16th August 2023 (Figure 1).

4. The photographs clearly identify that the branch had a significantly decayed core, and that was the principal reason for its failure. The timing of damage is consistent with a phenomenon known as 'summer branch drop' whereby branches fall, usually in early morning during summer, in still conditions. The physiological reasons for failure are not known, but frequently the failure is associated with wood decay, at or near the point of attachment. The likelihood is that the decay will extend into the remaining trunk and limbs, and therefore the remaining crown could pose a serious hazard, and risk of failure.

Figure 1. Photographs of the willow tree failure point, and the fallen branch, taken on 16th August 2023. The red circle indicates a decayed branch stub (circled in red), which had supported a live branch in 2020.

13. I have inspected the willow tree at St Anne's Close, and the fallen branch, and confirm that it failed due to massive internal decay. The timing of the collapse, early morning in summer, is consistent with 'summer branch drop'.
14. The decay that caused the branch to fail extends into the main crown break, and therefore the remaining limbs arising at a height of about 5m are also likely to be decayed. I was unable to assess the extent of decay from ground level, but I consider that the risk of further branch failure is high.
15. I recommend that the willow should be crown reduced to a height of no more than 9m and a diameter crown spread of no more than 8m.
16. The willow should be re-inspected one year after the crown reduction has taken place.

9. In my opinion the willow does not need to be felled, as the lower trunk itself is sound, but it does need the weight of branches bearing onto the decayed crown break point at 5m to be reduced significantly. Crown reduction back to the previous pollarding points at 13m will not be sufficient, and I consider that a major crown reduction is required to make the tree safe, in this high occupancy location.

10. In my view the crown needs to be reduced, sensitively, to retain as much of the form of the tree as possible, to a height of no more than 9m (i.e. a height reduction of about 6.6m) and a diameter crown spread of no more than 8m (i.e. a reduction of 3m in the northerly and southerly directions, a reduction of 2m to the east and 5m to the west).

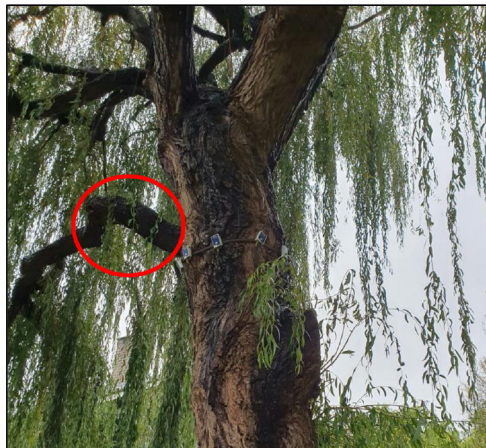
5. Comparing the photographs in Figure 1 with one taken during Kim Gifford's investigation shows that the branch below the failed one had broken since his inspection, and that its core had also been decayed (Figure 2).

Figure 2. Photograph of willow tree taken on 21st October 2020 showing Picus sensors on the trunk at a height of about 3.8m, and a live branch circled in red, which failed at some time before the present branch collapse.

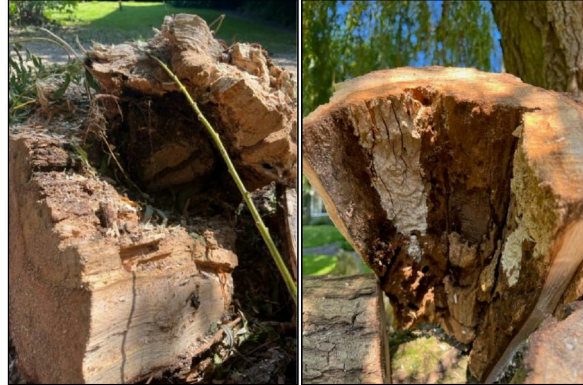
6. I carried out an inspection of the willow tree on the morning of 19th August 2023. The tree stands at the north-eastern corner of a square of grass which forms the main communal garden area. The fallen branch came from the eastern side of the tree, and had been cut up, but the larger parts were still on site and had been piled near to the tree trunk. I did not measure the fallen branch, but at its point of attachment I estimated it had a diameter of about 350mm. The branch was very substantially decayed by fungal colonisation (I was not able to identify the casual fungus), resulting in up to about two-third of the radius of the branch being hollow (Figure 3). A ground-level visual examination of the wound site, which was at 5m above ground level,

confirmed that decay extended into the main trunk at the crown break (the point at which the trunk divides into the main structural limbs of the crown).

Figure 3. Photograph of internal decay within the fallen branch.

8. The fact that a very large branch has failed due to fungal decay in calm conditions is of significant concern. The crown break is at a height of about 5m, and all the major branches emanate from the trunk at that height. My concern therefore, is that decay may have extended into the other large branches, which are connected to the failed one. I did not climb the tree, so I cannot be absolutely sure of the extent of decay, but the fact that two branches (on the eastern side) have failed within the space of about two years raises the likelihood that the remainder of the tree is not safe, and poses a hazard.

11. Once the tree has been crown reduced it will need to be checked for safety on a regular basis, and I recommend after one year in the first instance, followed by two-yearly checks.
