**RE: Arboricultural Survey & Consultancy**  
**SITE: 110 Chetwynd Road, NW5 1DH**

As instructed, the above site was visited on 26th April 2023 to assess the trees growing within influencing distance of the site in relation to the (i) Structural integrity of the property;  
(ii) Light structures; and  
(iii) Health and Safety.

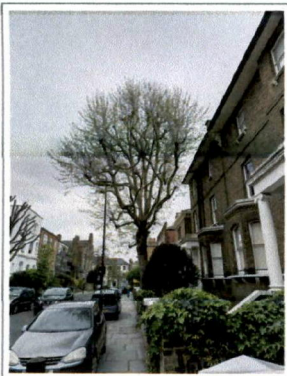
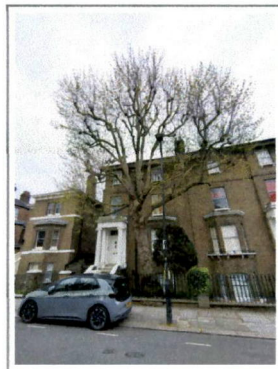
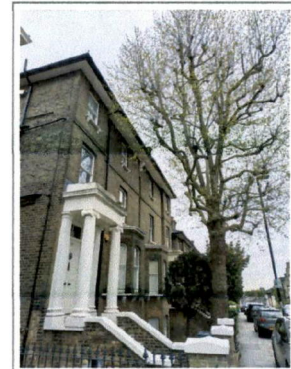
Site photos.

- Tree:** T1: London Plane; Platanus  
**Data:** Approx. 20m tall, 780mm stem diameter, a mature tree growing within the front garden at site with hard surfaces, boundary treatment, and slope down to lower ground level reached by stairs and lift.  
**Notes:** Cavity at 7-8m, multiple-stems above cavity, which is most likely to be the original or most historic crown removal/pollard point. Crown formed of multiple stems above cavity, 10 - 15m current growth forms ultimate crown, with multiple stem upper canopy and pollard, encroachment of front elevation, windows, roof gutters, 2-4m growth since 2020 pruning. Front wall is displaced by T1.

The crown of T1 is currently conflicting with the front elevation, windows and roof gutters of the property. Hence, it is considered the previous pruning points and current pruning frequency of 4 - 5 years are no longer suitable to allow for crown regrowth to be clear of the building. Therefore, it is recommended to reduce the pruning frequency and to reduce the overall height of the tree and lateral spread on the building side to allow for crown regrowth without building conflicts between pruning.

**T1 - Work** - reduce height from 18m to 15m (window level of 2nd floor), balance upper canopy edges to provide 3m clearance from the property's front elevation.

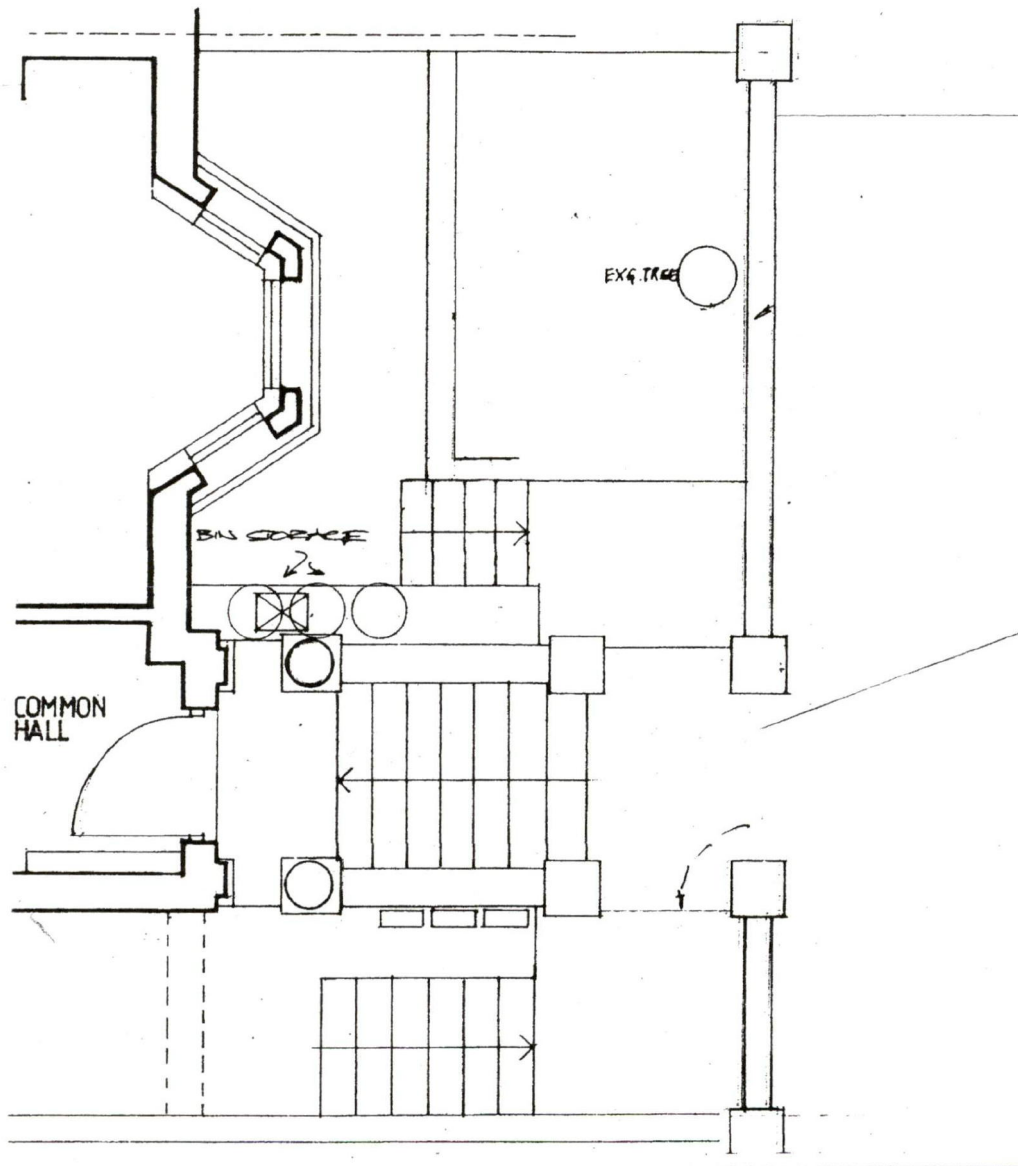
Plan of front area showing position of tree

The site comprises a residential property split into flats. The surveyed tree is situated within the site's front garden; the trees location is illustrated on the attached sketch plan which is at Appendix II.
