# **LONDON BOROUGH OF CAMDEN**

## **ARBORICULTURAL REPORT**

Address of Property: **170 Maygrove Road, NW6 2EP**  
Department/s responsible for tree/s: **LBC – Highways**  
Date of inspection and Officer: **Liam Vincent inspected on 23/3/2023**

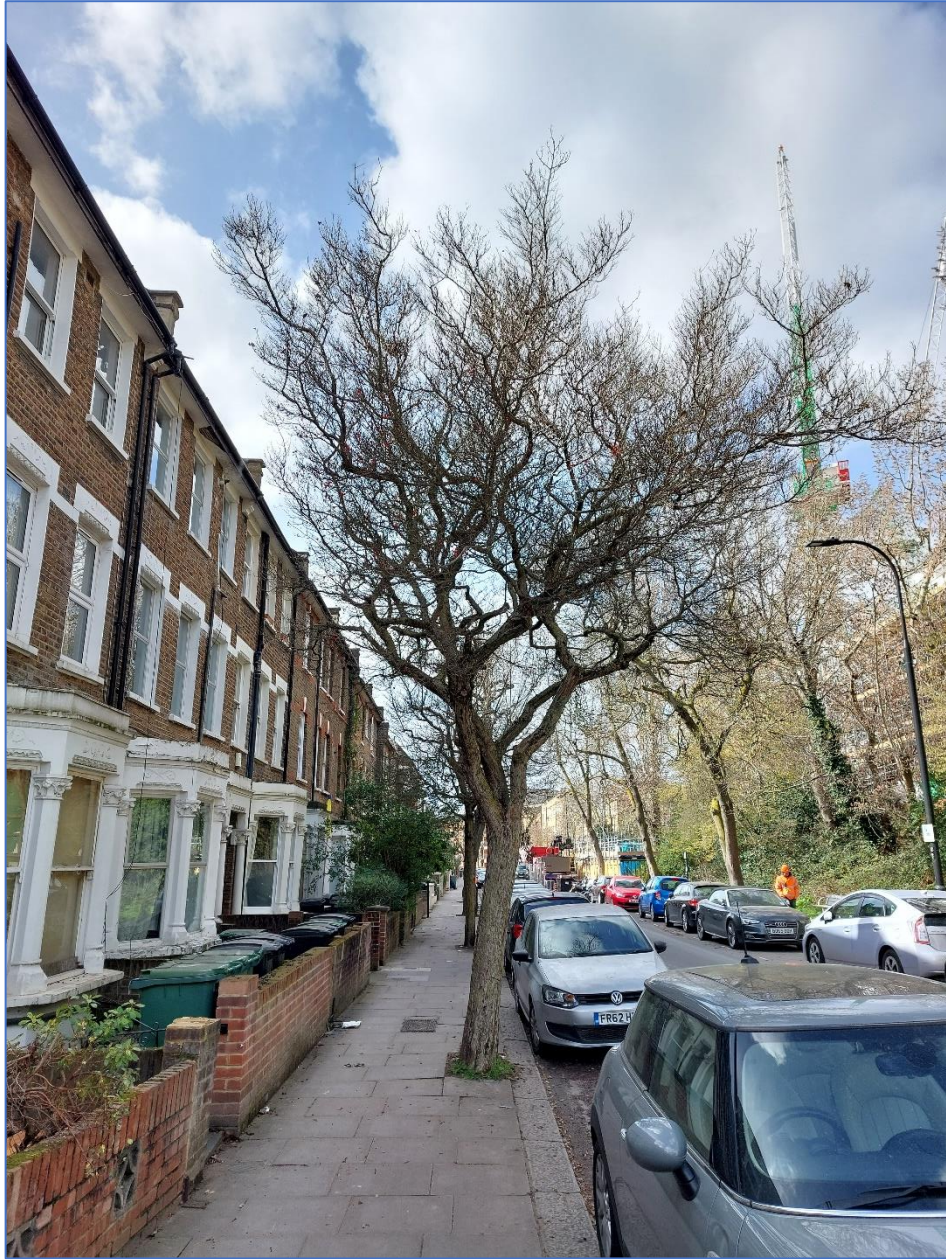
- The trees inspected for this investigation within Highway to the front of the claim address and the Public Open Space (POS) opposite the claim address on the other side of the highway are a semi-mature Cockspur Thorn (Seq 27, photo 1) and four mature Aspen trees (Seq 49, 53, 54 & 55, photo 2). See Fig.1.

- The Thorn tree was found to be in good physiological condition, the crown having a reasonably healthy appearance. The structural condition was only assessed as being 'Fair' due to evidence of previous crown reduction works. There were no other defects apparent.

Photo 1: Seq 27 Cockspur Thorn FO 168 Maygrove Road

- The LBC maintained tree T4 / Seq 27 will be laterally crown reduced by 30%, equivalent to 1.5m to be removed from the crown tips and added to the Highways biennial re-reduction regime to control its canopy size in future.
- The four eastern-most Poplars TG1 / Seq 49, 53, 54 & 55 will also be laterally crown reduced by 30%, equivalent to c.1.5-2.5m to be removed from the crown tips and added to the biennial re-reduction regime to control their canopy size in future.
- It would be preferable if the prescribed drainage repairs are carried out before any other tree works are considered to rule out any undiagnosed issue.

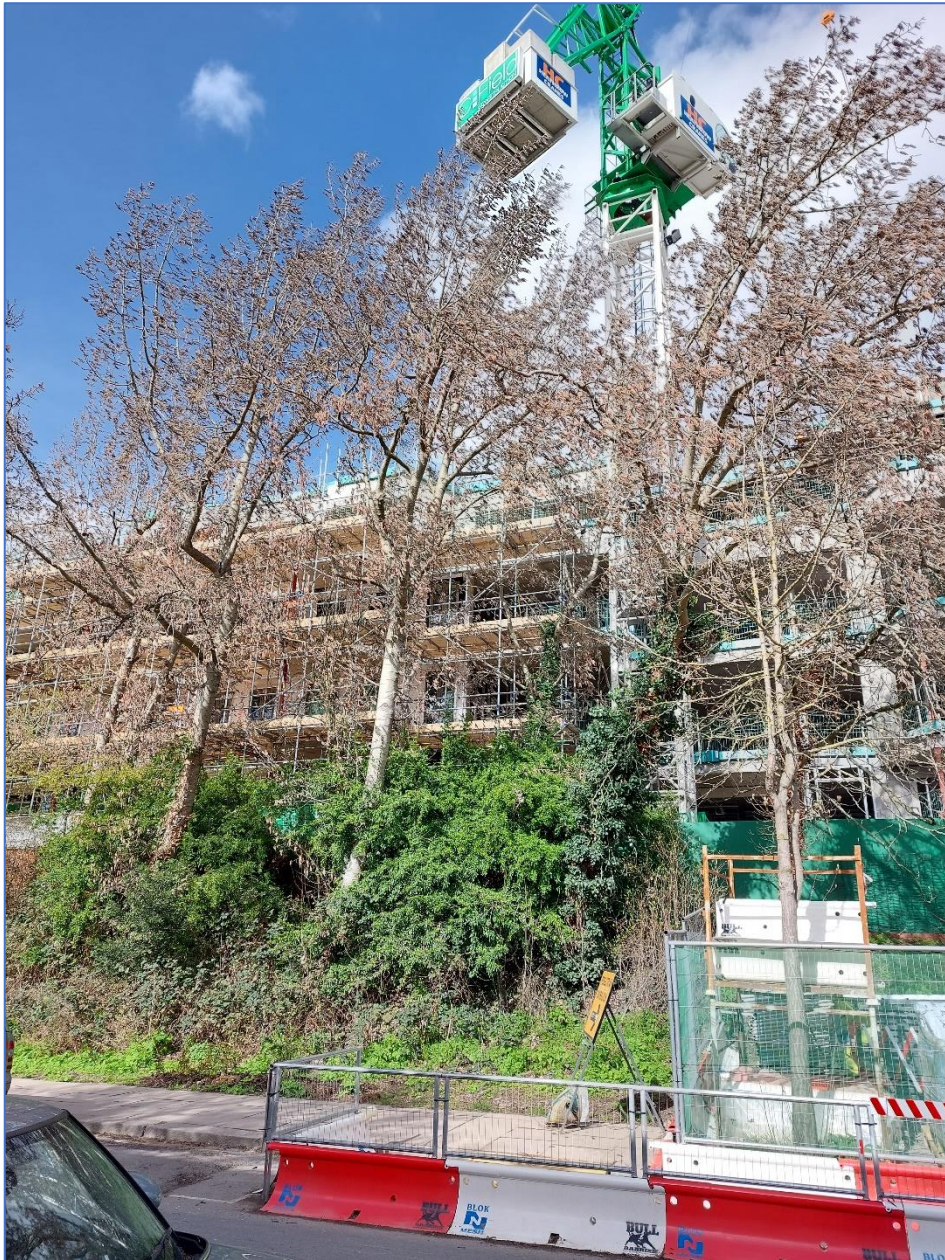
- The four Aspen trees were observed as being in good physiological condition, their crowns having a healthy appearance. Their structural condition was only assessed as being 'Fair' due to evidence of previous crown reduction works. There were no other defects apparent.

- There is a Ginkgo tree on the footpath opposite the claim address (see photo 2), but it is only mentioned as a possible 'future risk' within the claim so does not appear in Table 1. It is currently within fencing for a development site so could not be fully inspected but appeared to be in a fair physiological and structural condition.

Photo 2: Aspen trees Seq 49, 53, 54 & 55 POS opp claim address; Ginkgo (Seq 17) in foreground

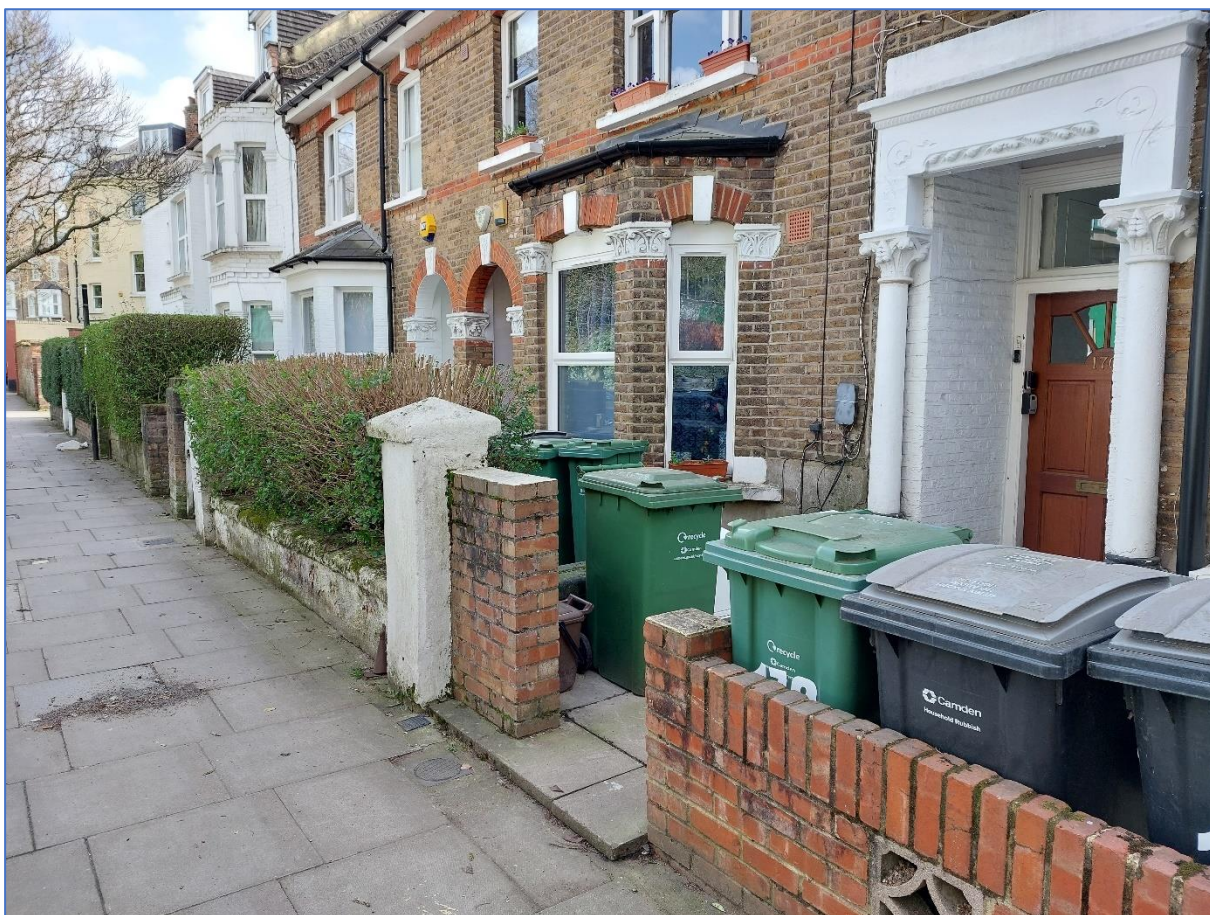
- There is a Privet hedge in the front garden of no.172 Maygrove Road (Claimant ref HG1, photo 3). This is acknowledged within the claimant's Arboricultural report.
- This appears to have been recently reduced in height, and the front and back faces of the hedge appear to have been formally clipped on a regular basis.

Photo 3: Privet hedge FG 172 Maygrove Road and location near to claim address

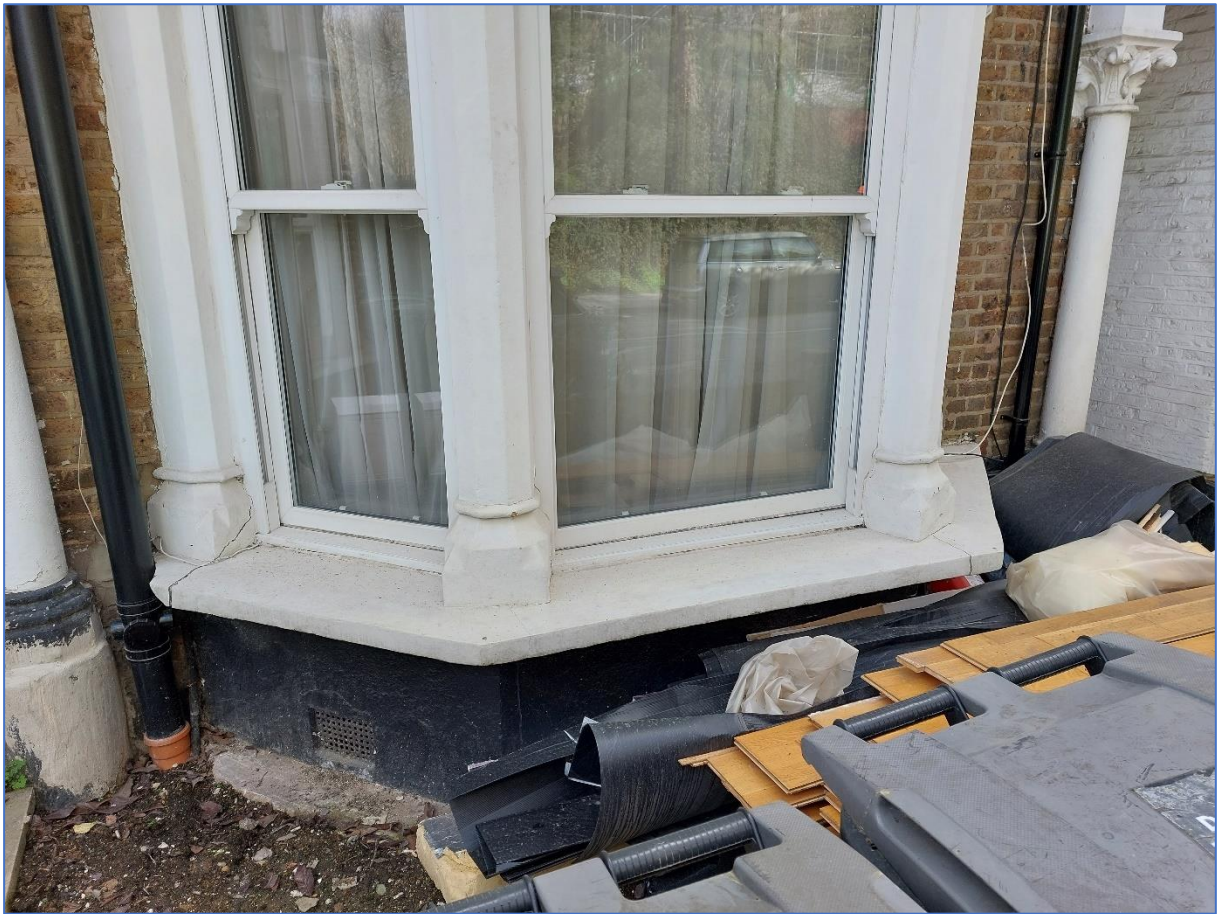
1. Some exterior building / structural damage was observed, notably the cracks in the bay window structure (photo 4), around the window (photo 5) and in the frame of the front door (photo 6). The door aperture also appeared to be distorted (not true right angles).
2. The damage identified within the claim has been categorised as Category 3 (Moderate) of Table 1 of BRE Digest 251 (MWA Arb Appraisal Report, see below).

Photo 4: Cracks in bay window structure, claim address

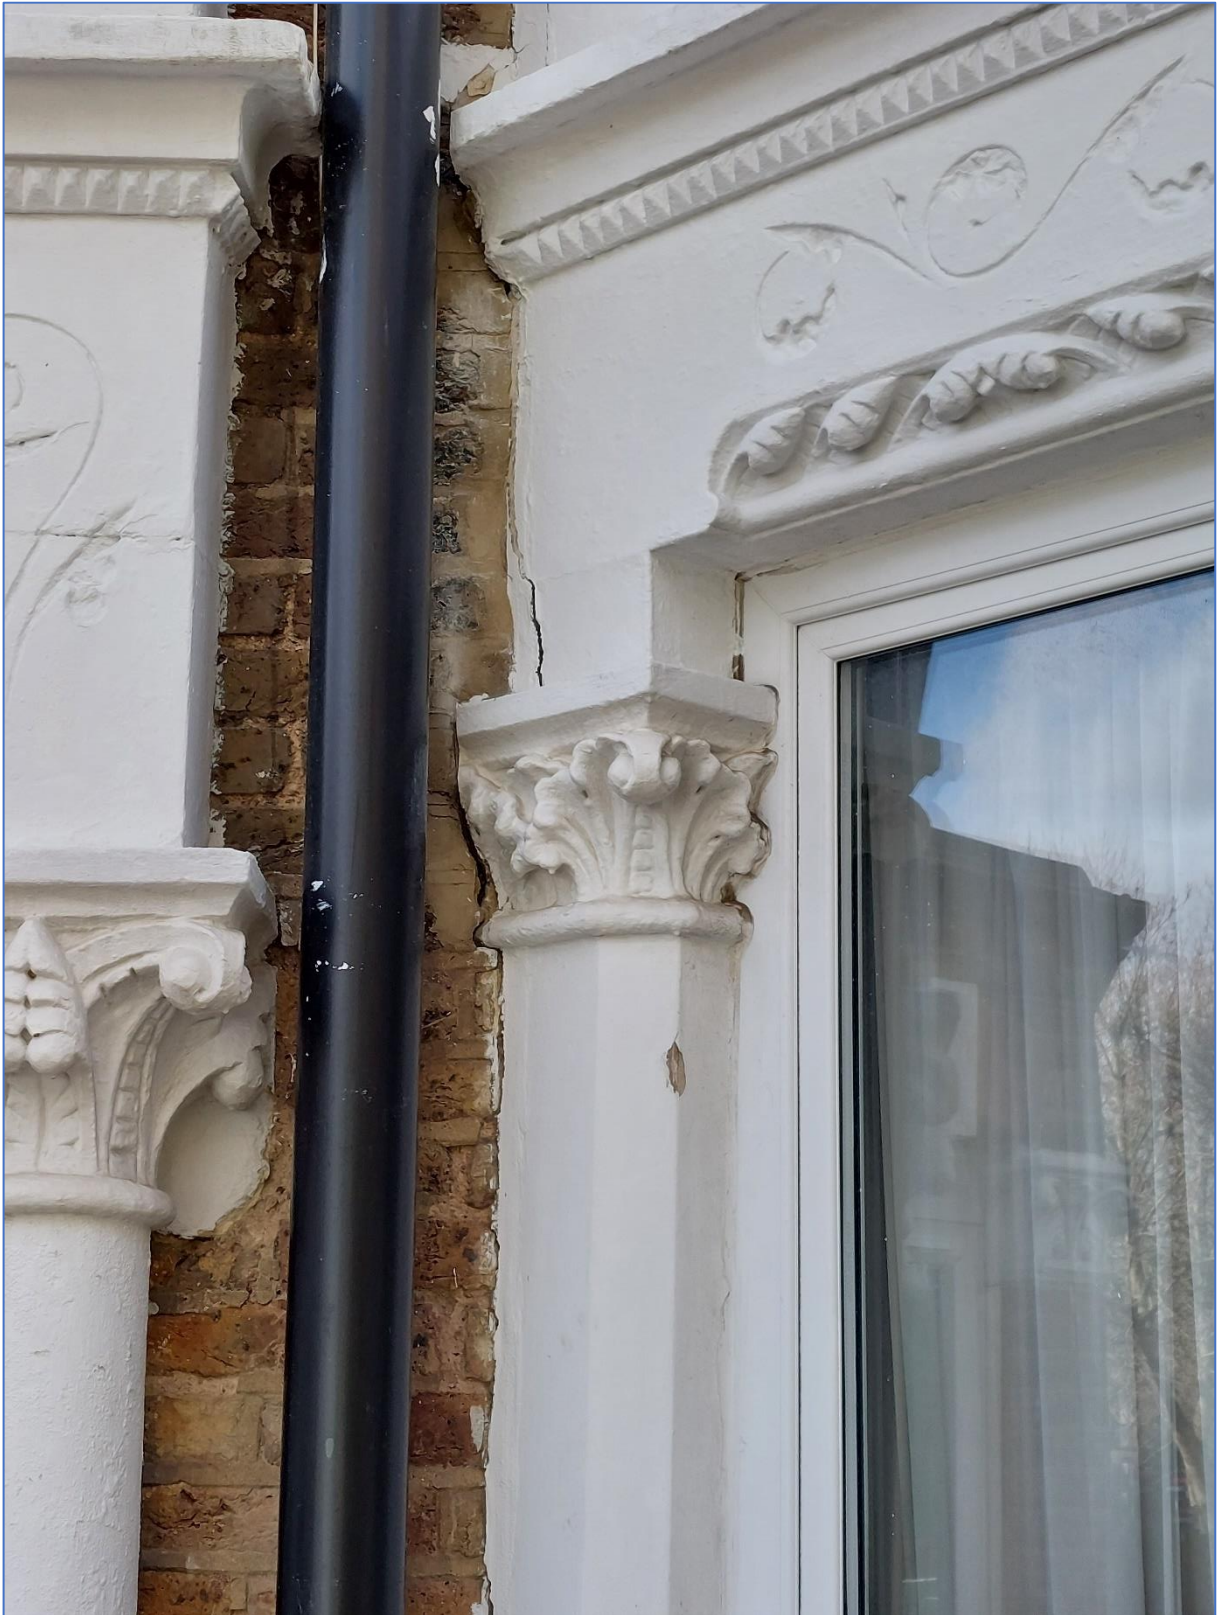
Photo 5: Cracks in window surround, claim address

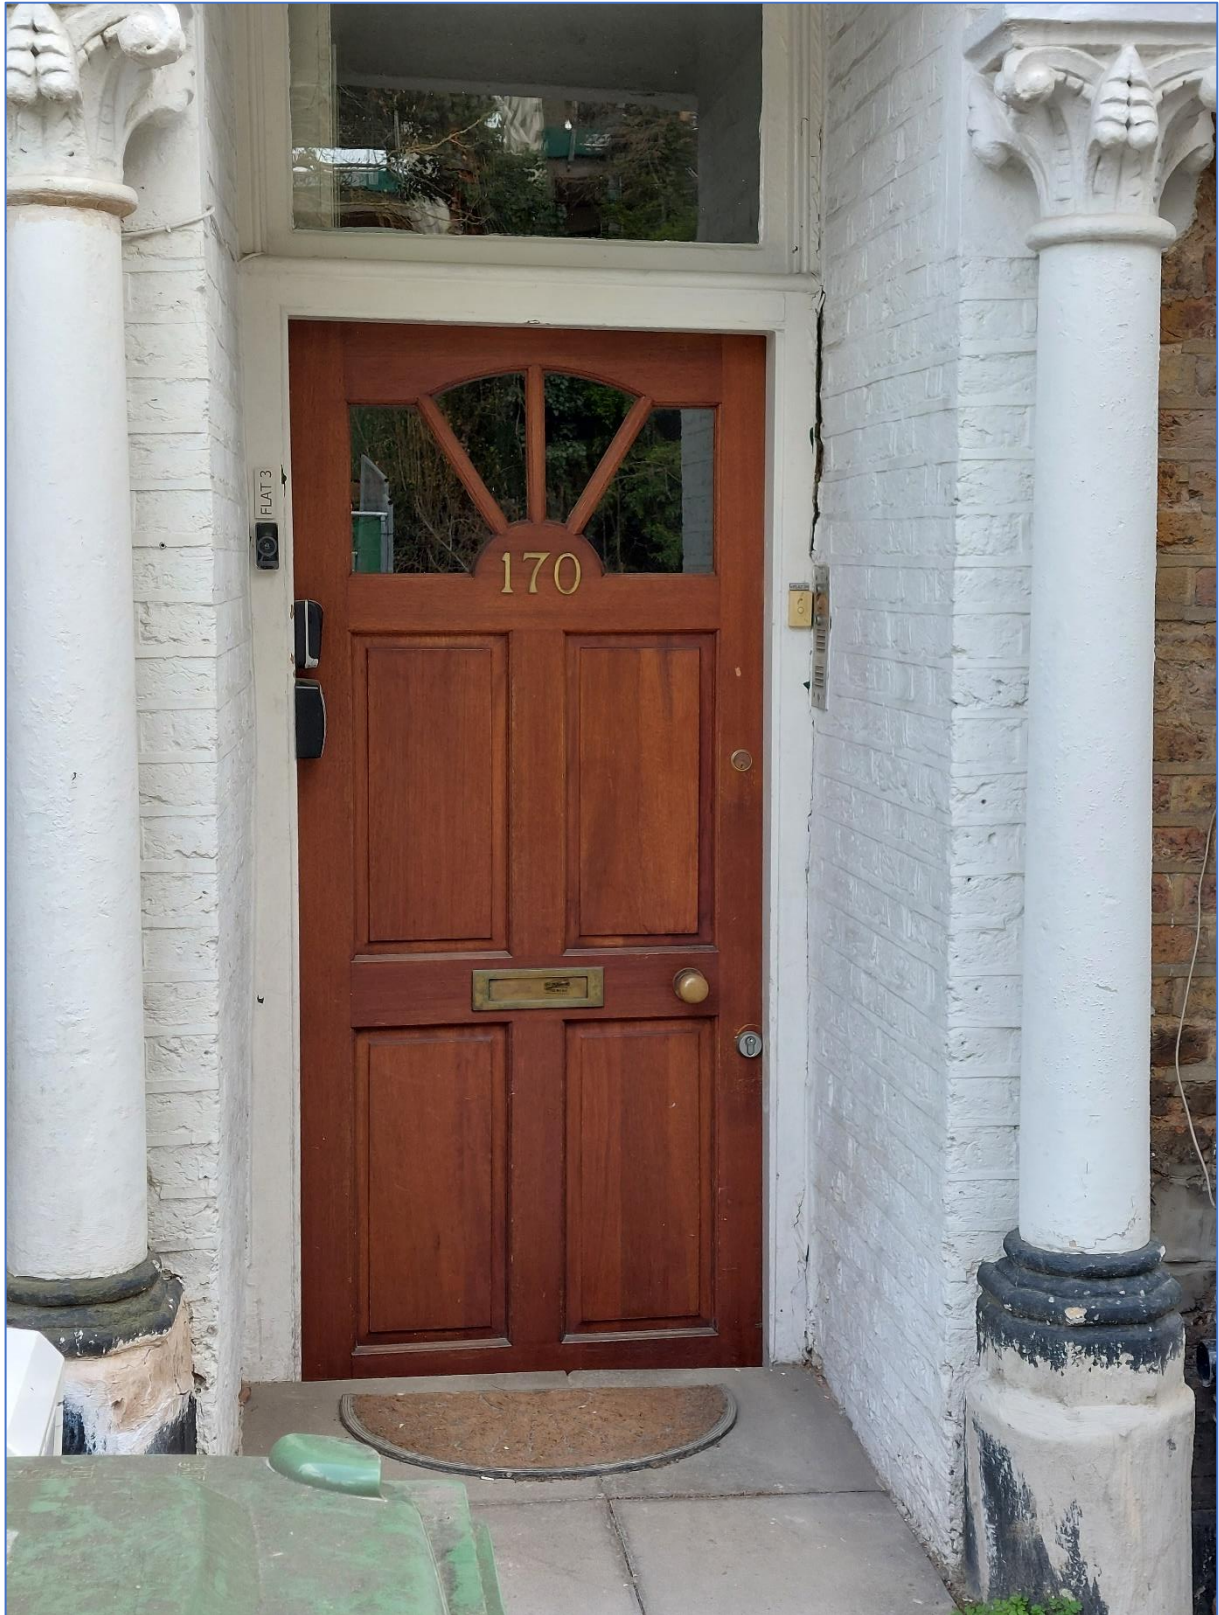
Photo 6: Front door with distortion and cracks around frame, claim address
